Y1A Taycan

On Board Charger (OBC) Fault P31D200 "Charging Socket – Overtemperature"

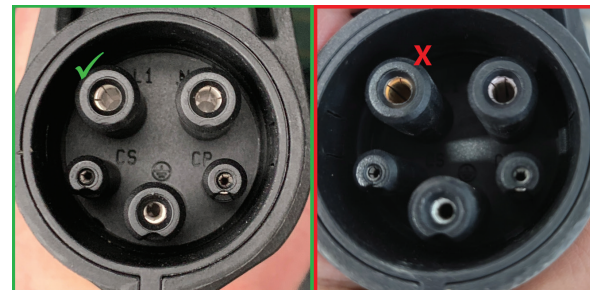
Figure 3

Visually inspect the pins in the vehicle cable connector for signs of overheating, paying particular attention to the L1 Pin. A vehicle cable and L1 Pin which was significantly or repeatedly overheated will show signs of discoloration (refer to Figure 3).
