GROUP	NUMBER		
CAMPAIGN	22-01-023H-2		
DATE	MODEL(S)		
NOVEMBER 2022	APPLICABLE VEHICLES BELOW

DTC P1326 - ENGINE BEARING INSPECTION / ENGINE REPLACEMENT (SERVICE CAMPAIGN T6G)

This TSB supersedes 22-01-023H-1 with additional information on page 13 for Hybrid Starter Generator (HSG) compatibility for certain 2016MY Sonata Hybrid/Plug-in (LF HEV/PHEV) vehicles.

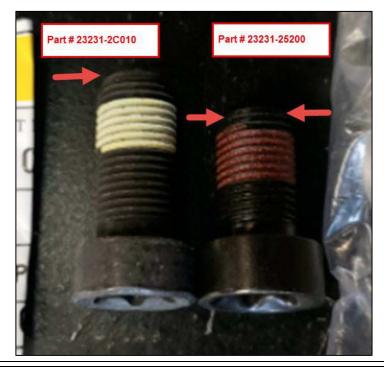
Example of Crankshaft with drill-through type drive plate mounting holes. Use thread-locking sealant.

For 11-12MY Sonata Hybrid (YF HEV):

When installing a new engine, the drive plate bolts must be replaced with P/N 23231-25200.

- Due to changes to the crankshaft design, the existing bolts are ~2mm too long and will result in improperly fastened drive plate if reused.
- The 13-15MY version drive plate bolts (P/N 23231-25200) are correct length for the new engine and will provide proper fastening during engine installation.

Certain types of engines may have crankshaft with drill-through type drive plate mounting holes. Apply thread-locking sealant to prevent any oil seepage through the drive plate bolts.

Apply on all threads a low/medium strength thread-locking adhesive that seals fasteners and are tolerant to engine oil.

[Suggested Products] ThreeBond 2403, LOCTITE 200, LOCTITE 204, LOCTITE 243 (or equivalent)

Be sure to lightly brush all the bolt threads free of debris/residue and clean off any oil prior to applying the thread-locking sealant for installation.

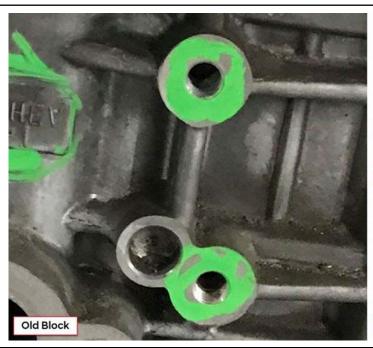
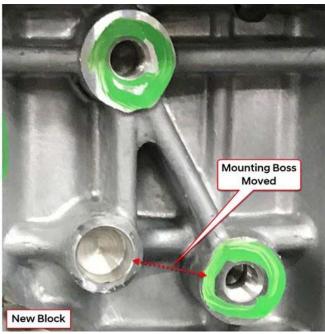
For 16MY Sonata Hybrid/Plug-in (LF HEV/PHEV) <u>vehicles produced before April 2015*</u>, the Hybrid Starter Generator (HSG) mounting boss type at the cylinder block must be checked.

There are HSG mounting boss differences between the Old and New style cylinder blocks.

New vs Old Block Guidelines HSG Mounting Boss Location HSG Mounting Flange Change ** OLD style cylinder block** (Most 16MY Sonata Hybrid/Plugin vehicles built until April 2015) Old Style Block → Engine R&R: Order a new style HSG (P/N) 37390-2E930-SJ) with the long block (P/N 21101-2EG15FFF). ** NEW style cylinder block ** Drill Depth: 18 Tab Depth: 15 (Most 16-19MY Sonata Hybrid / Plug-in vehicles produced from April 2015 and all replacement 21101-2EG15FFF long blocks) New Style Block → Engine R&R: > Reuse the existing HSG. Boss moved 20mm

- ▶ If the existing engine has the "Old" style cylinder block, install a new style HSG (P/N 37390-2E930-SJ) compatible with the replacement long block (P/N 21101-2EG15FFF).
- ▶ If the existing engine already has the <u>"New"</u> style cylinder block, <u>transfer the existing</u> <u>HSG</u> to the replacement long block (P/N 21101-2EG15FFF) engine. <u>Reuse the HSG</u>.
- *(Exceptions to affected production dates may exist due to variations in engine supply.)

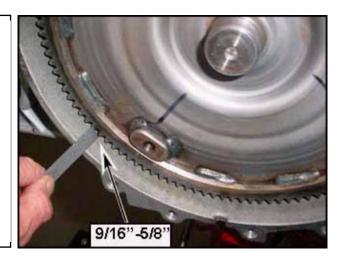
Check the depth of the torque converter to confirm it's fully installed in the transmission otherwise the oil pump may be damaged resulting in transmission failure.

(For Automatic Transmissions equipped w/ torque converters only) If the torque converter has moved from the fully inserted position, carefully push inward and rotate the torque converter until the converter is recessed approximately 5/16" - 9/16" (8 -14 mm) into the transaxle case when reinstalling the automatic transaxle.
