**Taycan: Vehicle Unlocks Itself Immediately After Locking with Comfort Access**

**Vehicles Affected**

Models	Model Year	Model Type	VIN Range	Vehicle-Specific Equipment
Taycan	2022	Y1A/ Y1B/ Y1C	N/A	N/A

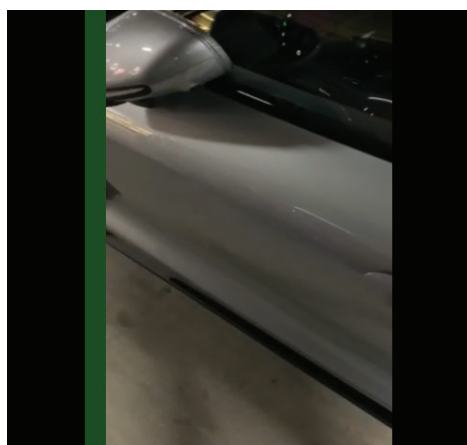
**Figure 1: Vehicle Locking After Unlocking**

Customer states that the vehicle locks itself immediately after locking via the Comfort Access feature (see Figure 1). This is sometimes possible with both the front and rear door handles. Proper function of the system may be possible after at least one additional attempt to lock the vehicle.

This issue may be caused by the incorrect positioning of the printed circuit board (PCB) inside the door handle body. An incorrect position of the PCB may cause the door handle to continuously transmit unlocking requests after locking the vehicle via the touch sensor on the outside of the handle.

The manufacturing process of inserting the PCB into the door handle has been optimized to increase the robustness of the Comfort Access function. Door handles with updated software for enhanced signal filtering are expected summer 2023.
