V8 S/C 5.0L PETROL – Misfire/rough running and MIL

18-22MY Range Rover Sport SVR

SSM 75866

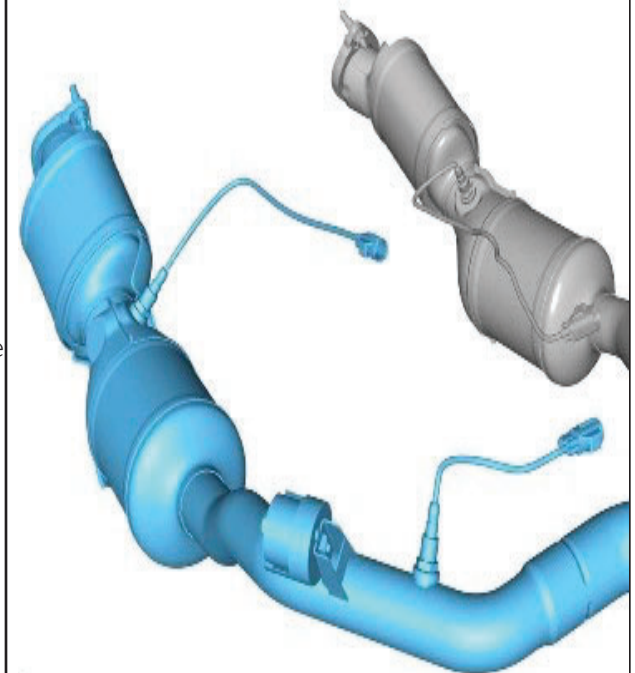
- Customers will be reporting a MIL illuminated and misfire/rough running condition.

- PCM code P0420-00 Catalyst System and/or P0430 Catalyst System will be set.

- If in the event the vehicle has a noticeable misfire remove the catalyst physically from the vehicle and check for a blockage.
- You will have to remove the oxygen sensor and use a borescope to thoroughly check the catalyst for any blockages at the rear section. (TOPIx section 309-00B)
- If the root cause of the DTC is not concluded, for example the engine is not misfiring on one bank or the catalyst isn't contaminated, then both catalysts need to be replaced during the one retailer visit.
- It is very important that all other possible root causes of the catalyst DTC's are investigated first prior to replacing both catalysts.
- Please hold all catalyst removed as we will need them for PRR.
