**ANB4 - Retrofitting Locking Caps on the Front Left and Right Headlights (Stop Delivery / Recall Campaign)**

Model Line: **Carrera GT (980)**

Concerns: **Caps on headlight**

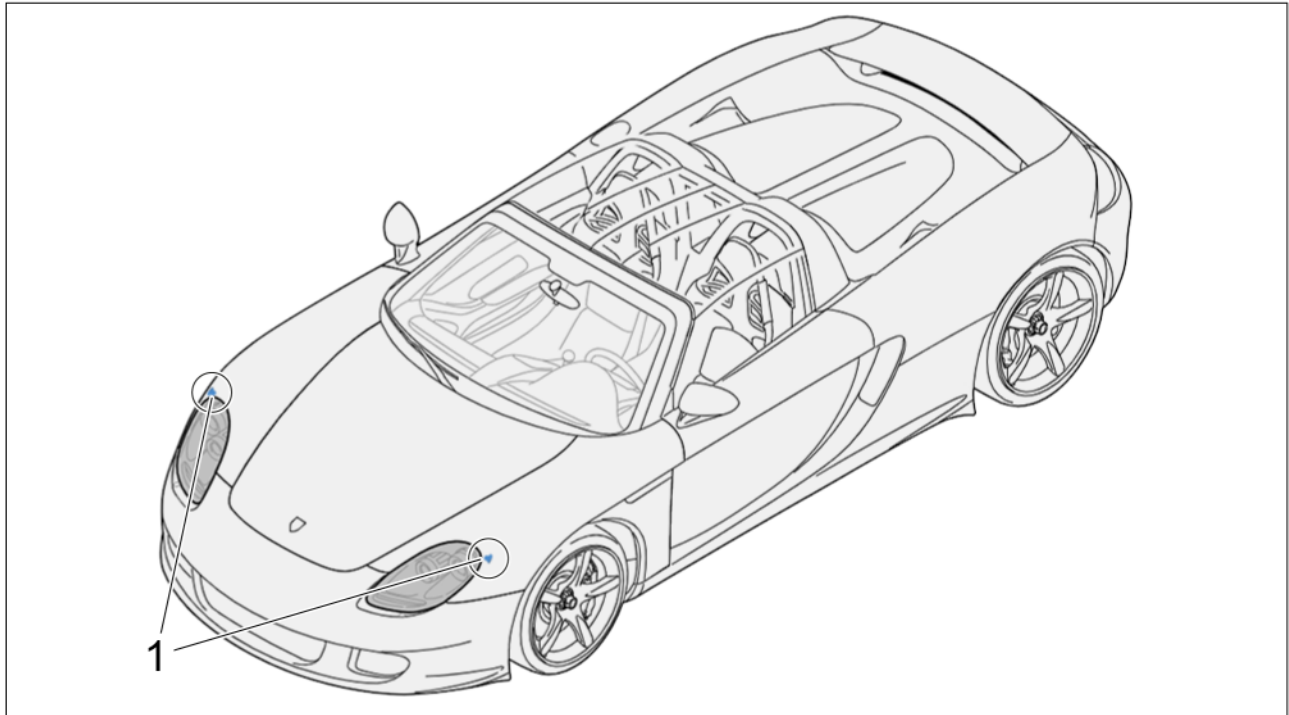
*Installation position of caps*

Information: **There is a possibility that a locking cap that prevents the adjustment of the headlights in the horizontal direction was not installed during vehicle assembly on the affected vehicles. If this is the case, certain legal requirements will not be met in the USA and Canada markets.**

1 – Caps (retrofit)

Action required: Check installation of the caps and retrofit a cap on the adjusting screw for horizontal adjustment on the left and right headlights if necessary.

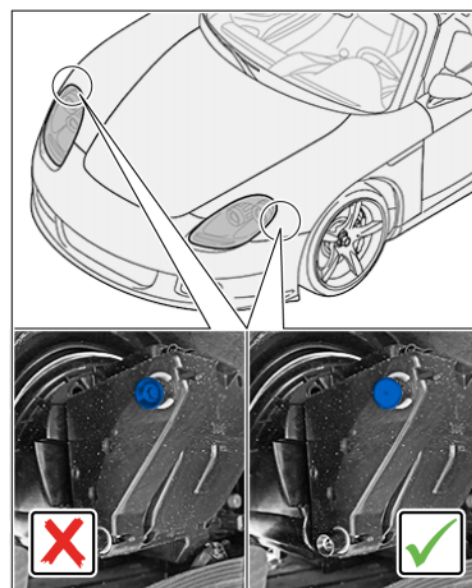
- 4 Check that a cap is installed on the adjusting screw for the horizontal adjustment on the left and right headlight. ⇒ *Checking sealing caps*

Assessment		Action
(✓)	A cap is installed on the left and right headlight.	End of remedial action. Continue with Step 6.
(✗)	There is <b>no</b> cap or only one <b>cap</b> installed on <b>one</b> headlight.	Retrofit cap. Continue with Step 5.

- 5 Press the cap on the left and right headlight into the adjusting screw for horizontal adjustment.
- 6 Install section of front wheel housing liners **A**.  
For instructions, see Workshop Manual: **505619 Removing and installing wheel housing liner front**
- 7 Install wheels on the front axle.  
For instructions, see Workshop Manual: **440519 Removing and installing wheel**
- 8 Lower vehicle.  
For instructions, see Workshop Manual: **OX00IN Lifting vehicle**
- 9 Enter the campaign in the Warranty and Maintenance booklet.
