Service Bulletin

Bulletin No.: 21-NA-224

Subject: Vehicle Will Not Charge and Hybrid Loss of Isolation with DTC P0AA6 and/or P1FFF, P1F0E, P0DAA

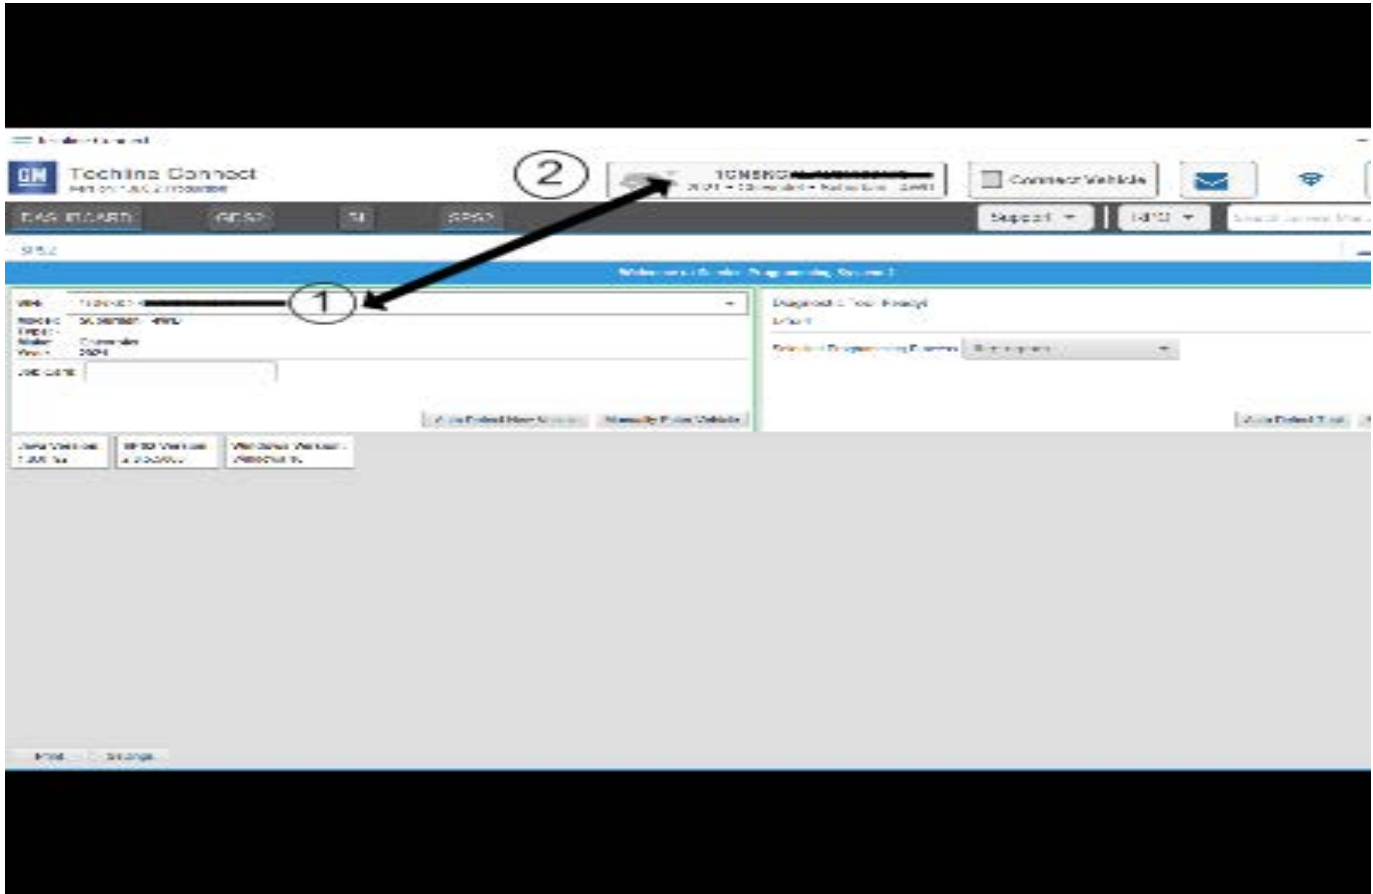
Caution: Be sure the VIN selected in the drop down menu (1) is the same as the vehicle connected (2) before beginning programming.

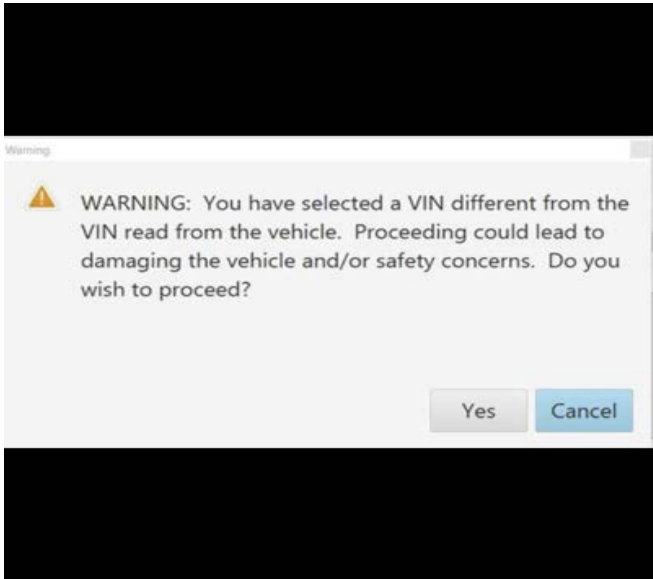
5877000

Important: If the vehicle VIN DOES NOT match, the message below will be shown.
