**Squeaking Noise Symptom When Retracting and/or Extending the Rear-View Mirror:
Greasing Mirror Base Seal (SY 224/22)**

Model Line: **Cayenne (9YA / 9YB)**

Model Year: **As of 2019**

Concerns: **Rearview mirror**

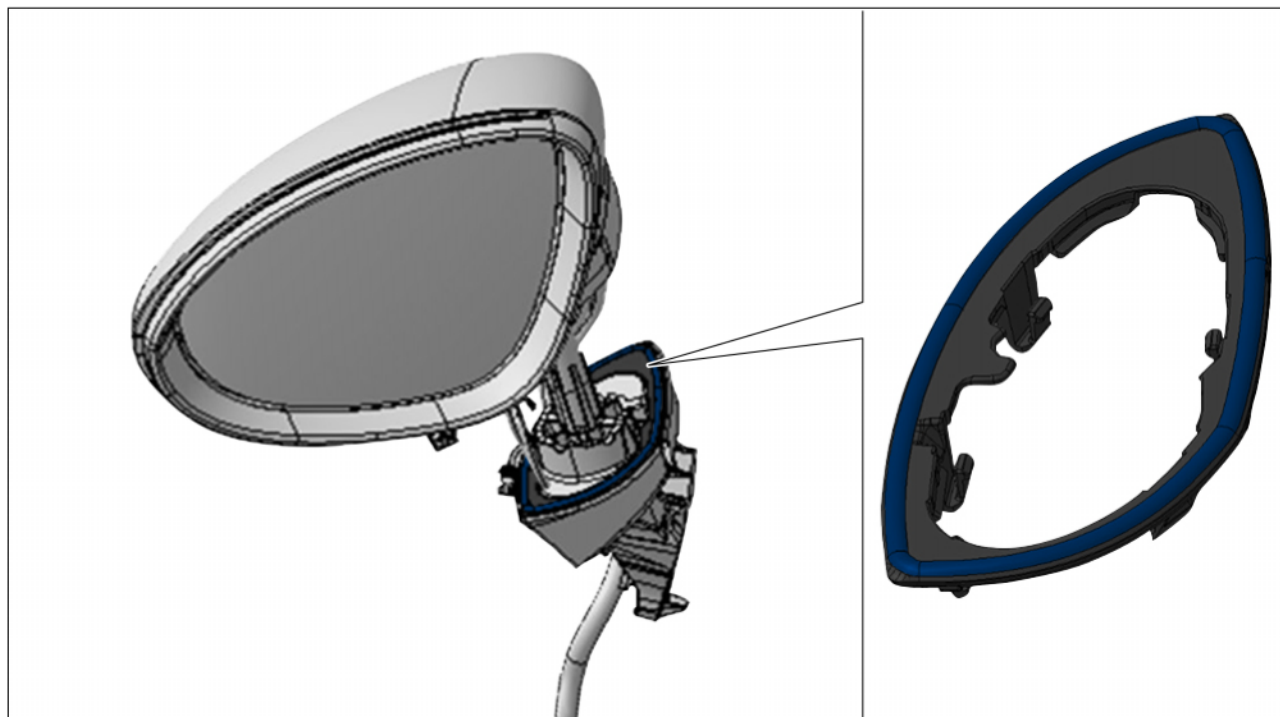
Installation
Position:

Symptom: Squeaking noises can be heard when retracting and/or extending the rear-view mirrors.

Cause: The noises can be caused by a lack of lubricating film on the mirror base gasket.

Mirror base seal

Action required: In the event of a complaint, check the mirror base seal and grease or replace it, depending on the result of the check.

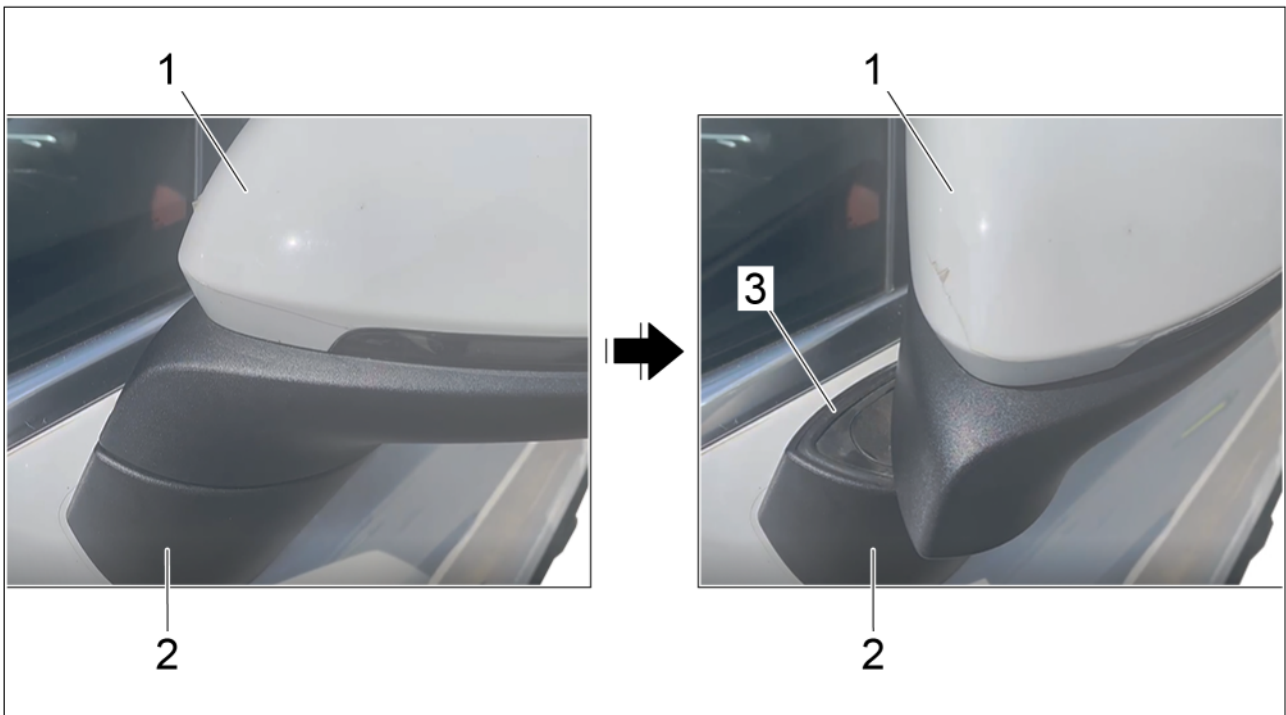
*Rearview mirror*

- 1.1 Guide rearview mirror ⇒ *Rearview mirror -1-* in and out at the left and right and check for squeaking noises.
- 1.2 Retract ⇒ *Rearview mirror -1-* rearview mirror at the left and right and check the mirror base seal ⇒ *Rearview mirror -3-* in the mirror support ⇒ *Rearview mirror -2-* for damage.

Assessment		Action
(✓)	The mirror base seal is not damaged .	⇒ <i>Rearview mirror -3-</i> Clean mirror base seal and grease with Krytox lubricant.
(x)	The mirror base seal is damaged .	Replace mirror base seal and grease with Krytox lubricant. For work procedure, see: ⇒ <i>Workshop Manual '667919 Removing and installing rear-view mirror housing (lower part)'</i>

If the mirror base seal must be replaced, grease it before assembling the rearview mirror.
