Service Bulletin

Bulletin No.: 20-NA-142

Subject: Shudder/Surging While Driving

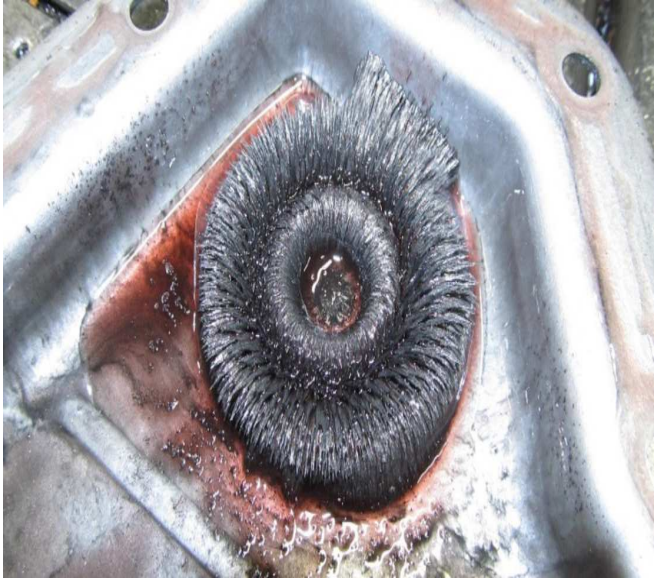
<p style="text-align: right;">5360216</p> <ul style="list-style-type: none"> • If metallic debris is present (similar to graphic above), remove transmission and replace the torque converter and replace the transmission filter. Refer to Torque Converter Replacement in SI. • If metallic debris is not present, drain and clean the oil pan, replace transmission fluid filter and reinstall transmission oil pan following Service Information and follow the Service Procedure below that corresponds with the vehicle fill setup.
-------------------	--
