Service Bulletin

Bulletin No.: 22-NA-236

Subject: Unable to Learn Key Fob or Transmitter

Brand:	Model:	Model Year:		VIN:		Engine:	Transmission:
		from	to	from	to		
Chevrolet	Silverado 1500 New (RPO J22, VIN Digit 5 = A or D)	2022	2022				
	Silverado 1500	2023	2023				
GMC	Sierra 1500 New (RPO J22, VIN Digit 5= H or U)	2022	2022				
	Sierra 1500	2023	2023

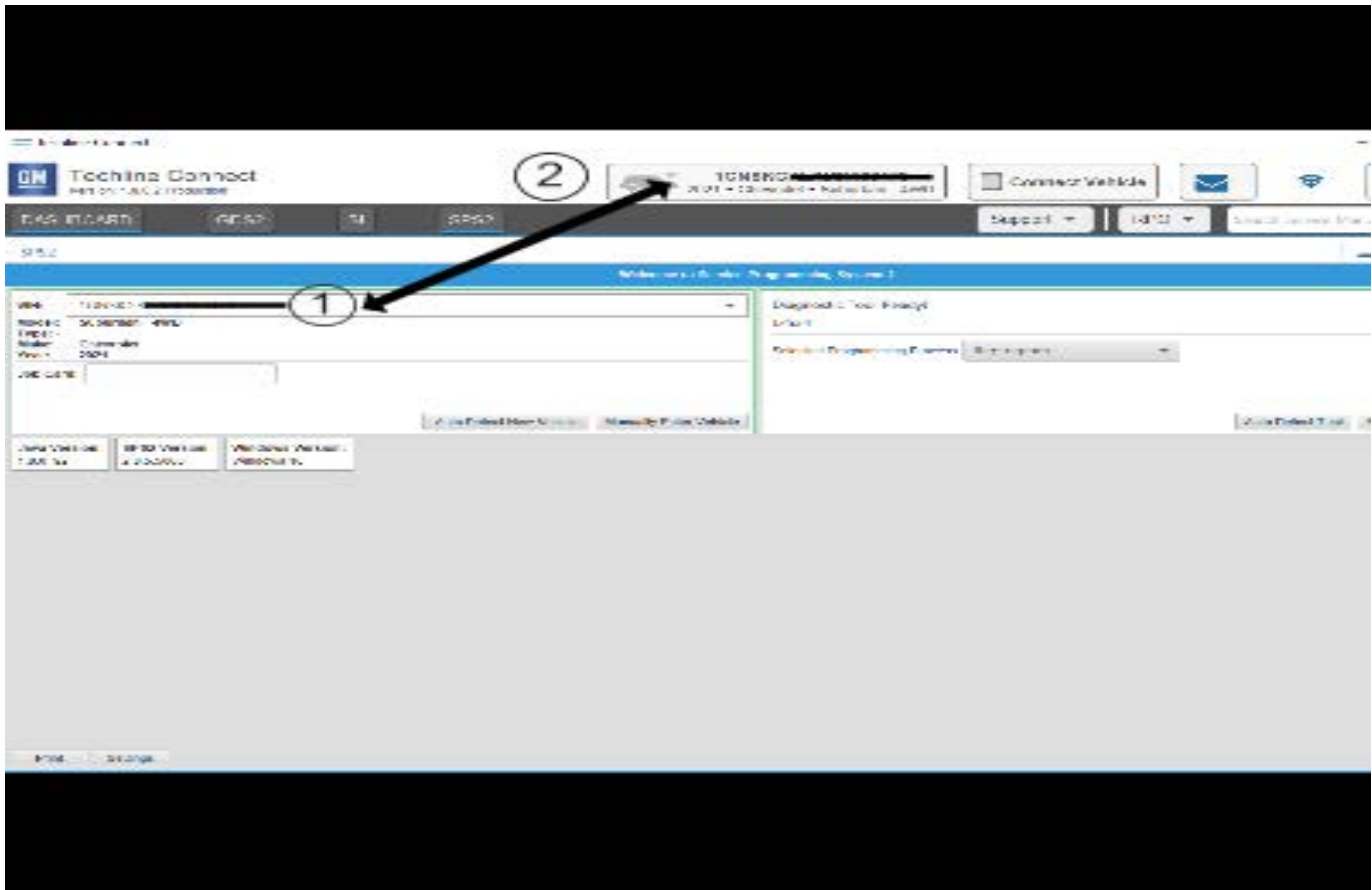
Caution: Be sure the VIN selected in the drop down menu (1) is the same as the vehicle connected (2) before beginning programming.
