JLRTB02076NAS2

**TECHNICAL BULLETIN**

Intermittent Passive Entry Operation

MODEL:	MODEL YEAR:	VIN:	ASSEMBLY PLANT:
Defender (LE)	2020-2022	000001-107434	Nitra (Slovakia)

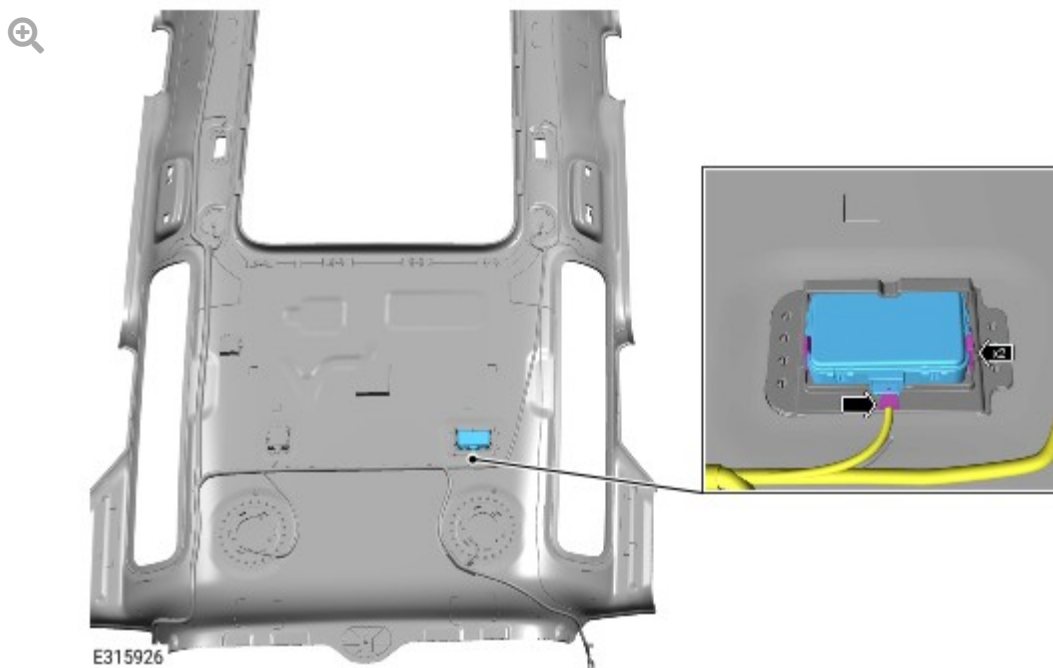
Defender 110 RF receiver shown, Defender 90 is similar.

Remove the RF receiver.

- Disconnect the electrical connector.
- Release the 2 clips.

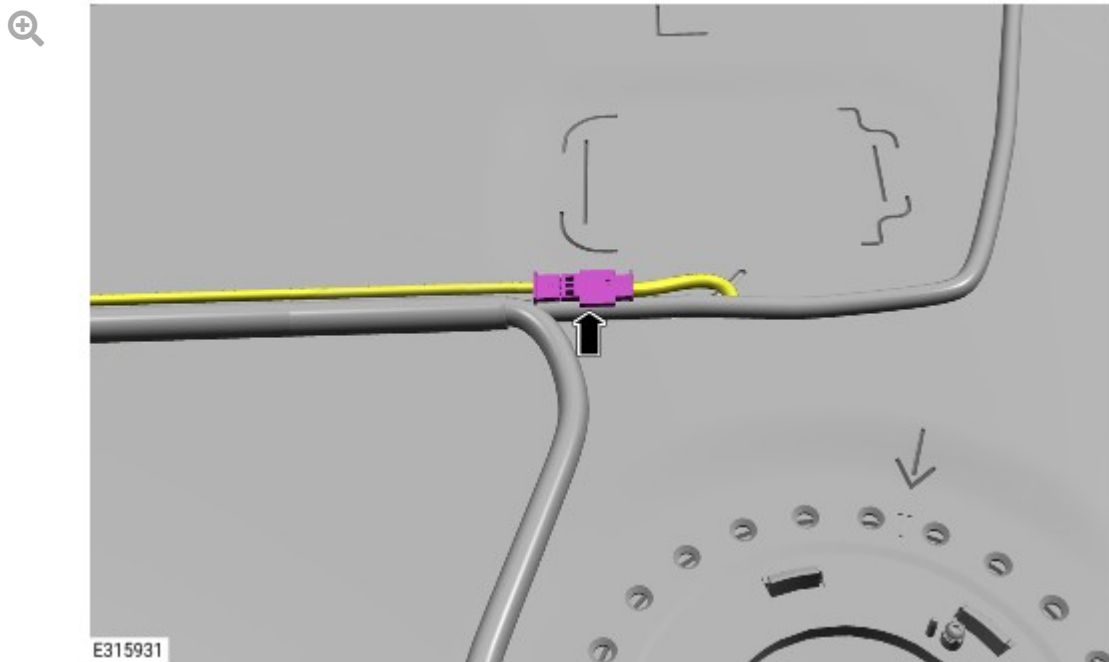
Defender 110 connector location shown, Defender 90 is similar.

Connect the overlay harness to the original RF receiver electrical connector.

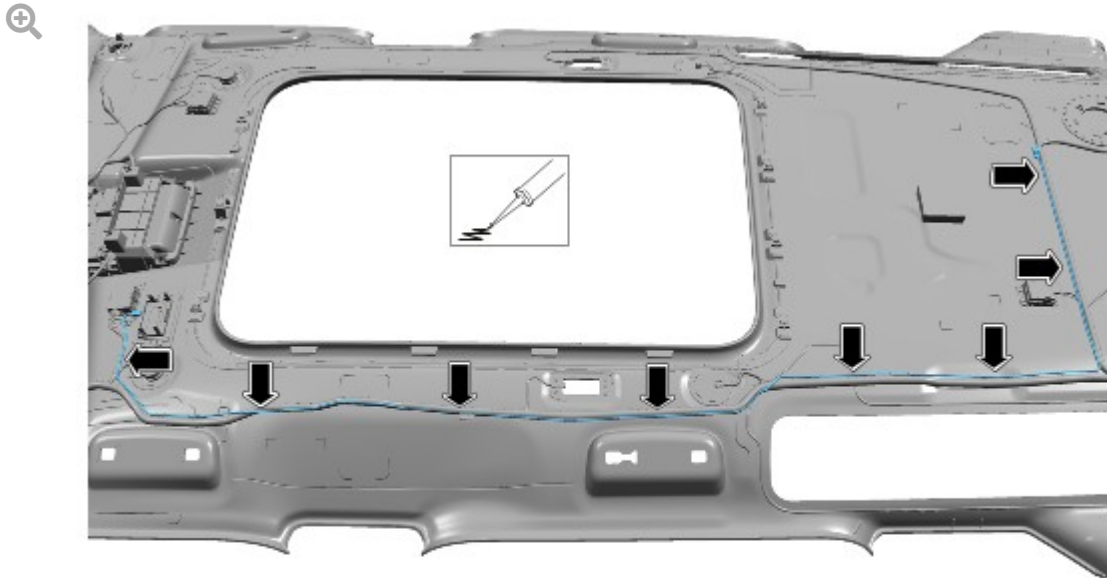
E315929

The overlay harness must follow the route of original headliner wiring harness, unless instructed otherwise, to avoid the risk of introducing electrical interference issues.

**Defender 110 vehicles** - Using hot melt adhesive and the applicable applicator, secure the overlay harness to the headliner and original headliner wiring harness as shown in the illustration.

- Following the hot melt adhesive manufacturer's instructions, allow the hot melt adhesive to cure.

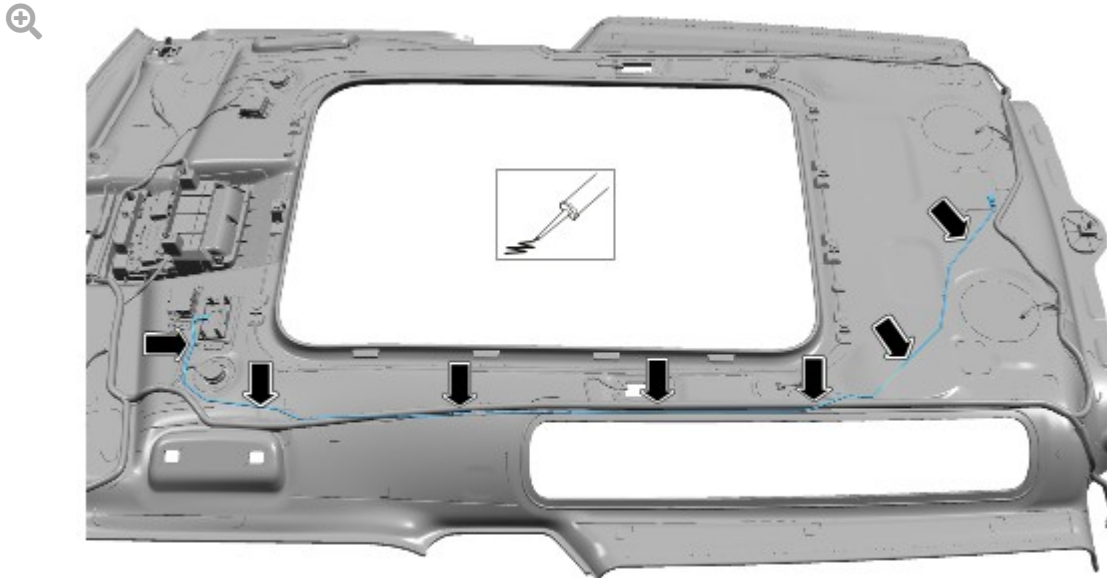
E315930

The overlay harness must follow the route of original headliner wiring harness, unless instructed otherwise, to avoid the risk of introducing electrical interference issues.

**Defender 90 vehicles** - Using hot melt adhesive and the applicable applicator, secure the overlay harness to the headliner and original headliner wiring harness as shown in the illustration.

- Following the hot melt adhesive manufacturer's instructions, allow the hot melt adhesive to cure.
