Countries: CANADA, UNITED STATES, MEXICO Document ID: IK0700115
 Availability: ISIS, Bus ISIS, FleetISIS, IsSIR Revision: 16
 Major System: EXHAUST Created: 8/26/2021
 Current Language: English Last Modified: 11/18/2022
 Other Languages: [Français](#) Author: William Knoth
 Viewed: 31233

Title: QLS Emergency Calibration

Applies To: 2016 and Newer B6.7, X15 and L9, and all A26

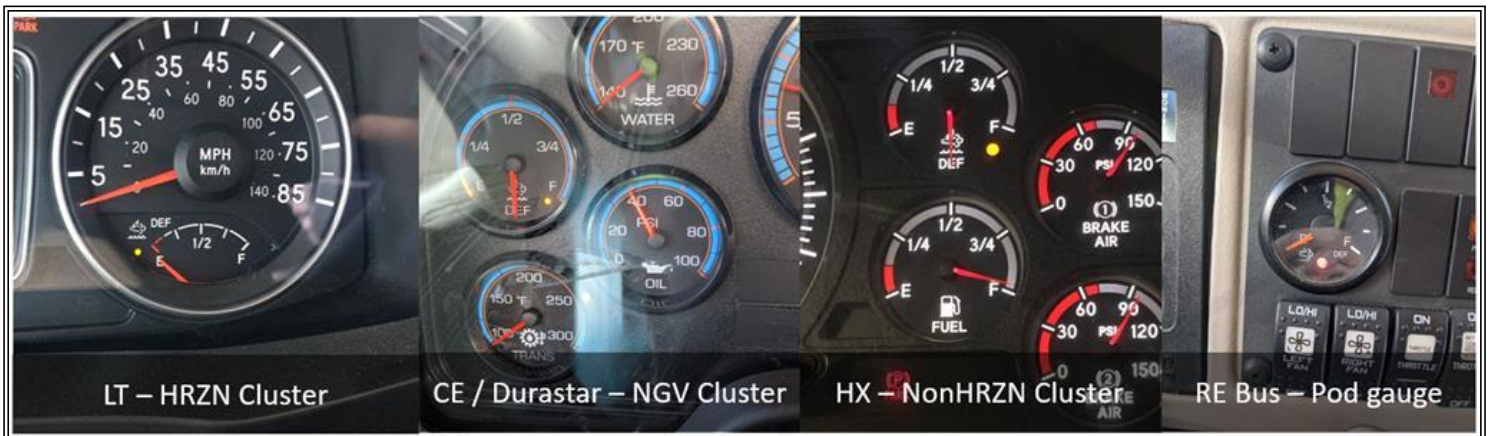
Figure 1: DEF Level Gauge Reaction

The DEF tank level gauge will NOT function with the QLS emergency calibration. It may show incorrect or empty at all times.

Item 1: DEF Level Gauge

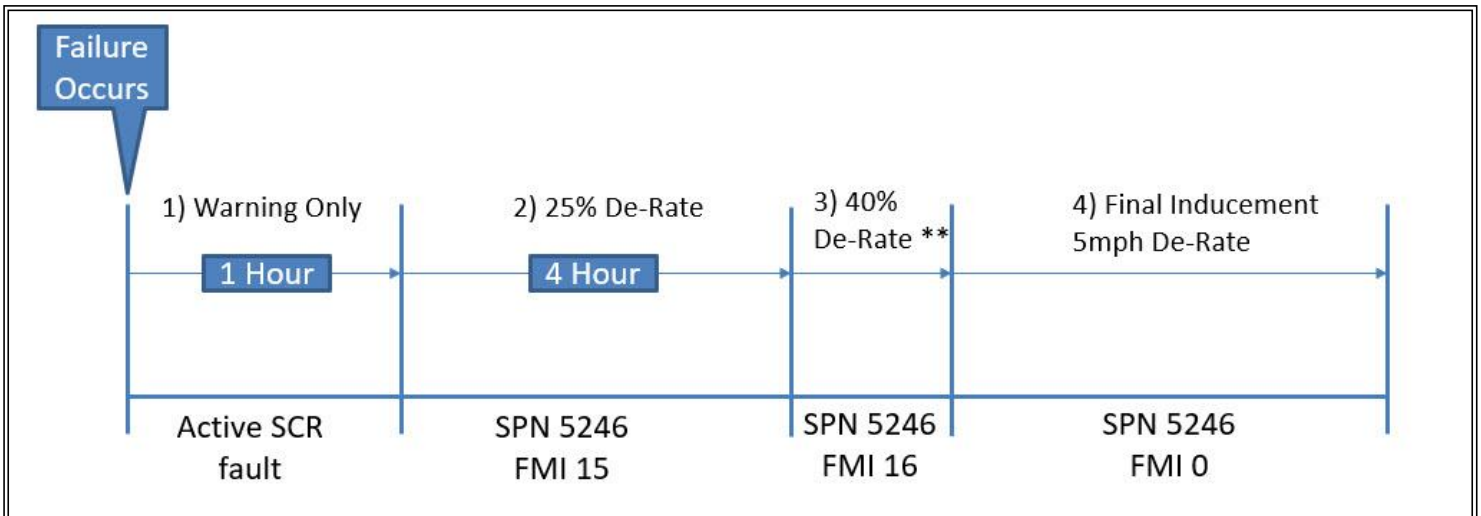
Figure 2: SCR System Tampering Inducement Faults

Item 1: For the first hour after a failure or tampering occurs there is a warning only, with no de-rate.

Item 2: Hour 1 to hour 5 there will be a 25% de-rate accompanied with fault code SPN 5246-15 AFT SCR operator inducement severity - Least severe.

Item 3: After 5 hours from initial awareness the vehicle will ramp to 40% de-rate and will search for the final inducement trigger accompanied with fault code SPN 5246-16 AFT SCR operator inducement severity - Moderately severe.

Item 4: Once final inducement is triggered the vehicle will ramp to a 5mph de-rate accompanied with fault code SPN 5246-0 AFT SCR operator inducement severity - Most severe.

Note: **The time between stage 3 and 4 will be determined based on the fault code and triggers. If repeated tampering occurs the time window between stages will be reduced.

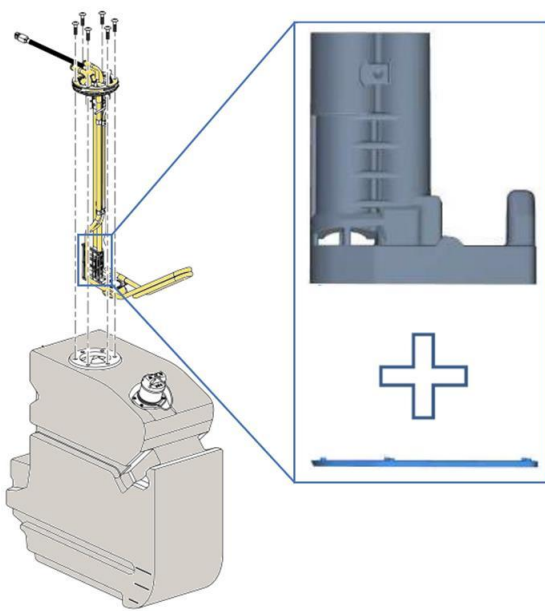
Figure 3b: QLS Cover Update

All QLS sensors have been updated to include a cover to prevent DEF ingress into the sensor assembly. This went into production:

Note: 3% vs 1% sensors are in reference to the sensors DEF quality accuracy (i.e. sensor can read DEF quality at $-+3\%$ or $-+1\%$). The cover is the corrective action not the change in sensor accuracy.

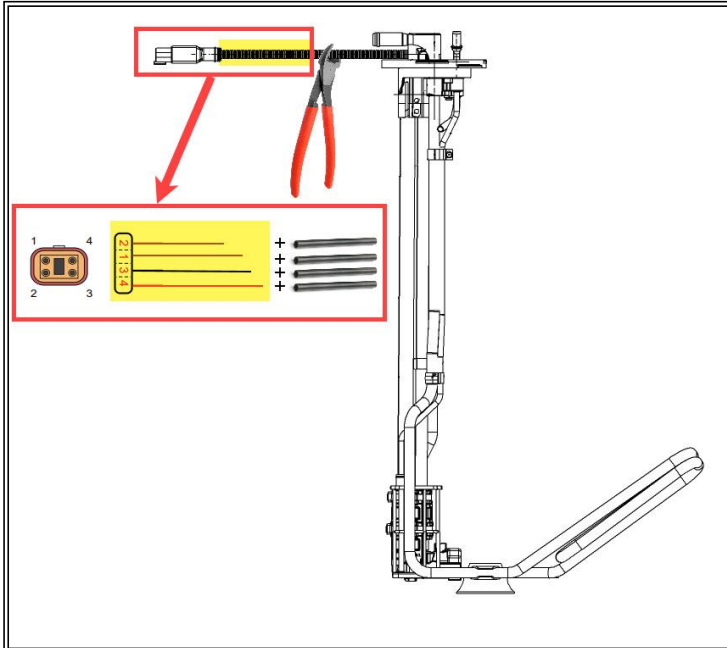
Figure 5: QLS Pigtail Modification

Item 1: QLS Pigtail

1. Ensure the QLS is disconnected from the chassis harness. **If the sensor is still connected it could result in shorting of the power circuit.**
2. Using wire cutters, cut the QLS pigtail harness as least four inches from the connector (Refer to figure #5). Once cut the pigtail can be moved to a bench for ease of installation.

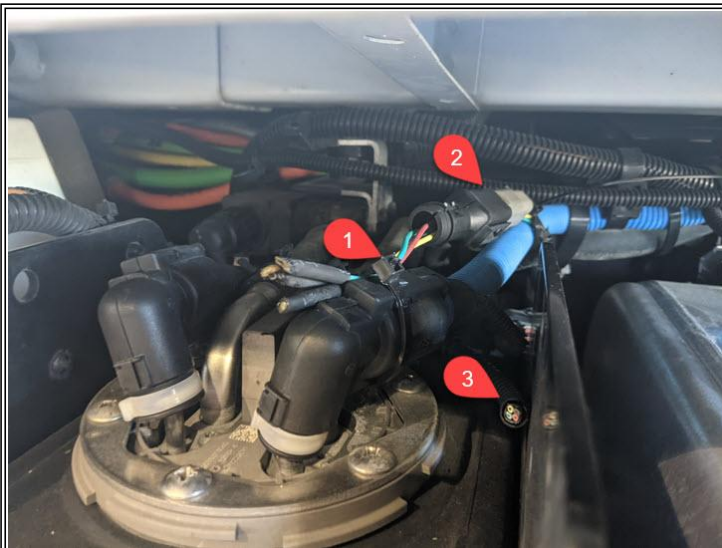
Figure 8: QLS Pigtail Installed

- Item 1: Zip tie securing the harness
- Item 2: Pigtail connected to chassis connector
- Item 3: Harness to QLS left unsealed

8. Secure the harness using a zip tie (Refer to figure #8).
