GROUP	MODEL
ELE	2022MY EV6 (CV)
NUMBER	DATE
276	December 2022

TECHNICAL SERVICE BULLETIN

SERVICE ACTION: EXTERNAL AMP REPLACEMENT FOR NOISE/NO SOUND ISSUES (SA520)

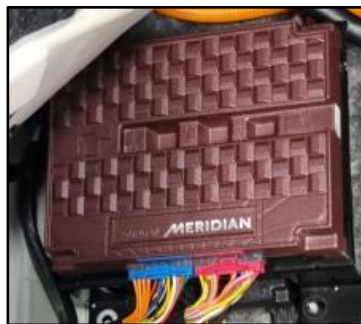
External Amplifier

This bulletin provides the procedure to inspect the audio sound system in different modes and, if necessary, replace the AMP on some 2022MY EV6 (CV) vehicles produced from November 17, 2021 through January 7, 2022. Depending on the inspection results, the external AMP may or may not need to be replaced. Follow the procedure outlined in this publication to perform a sound inspection on the external amplifier and, if necessary, replace the external amplifier. Before conducting the procedure, verify that the vehicle is included in the list of affected VINs.

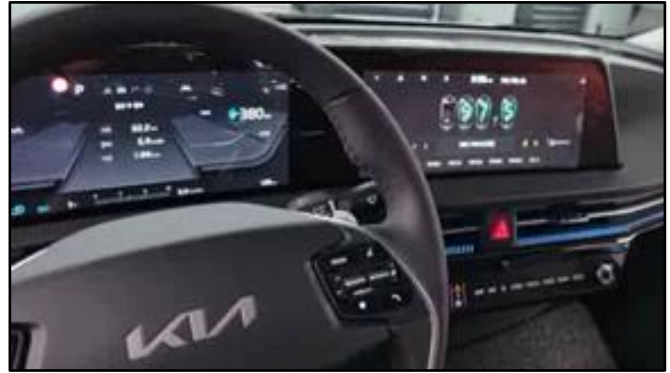
- 1a. Check for sound issues by listening for **at least one minute** in each of the following modes:
 - Radio (AM & FM)
 - Bluetooth music
 - Voice recognition
 - Phone call
 - Nature Sound
 - USB device

- 1b. Listen to identify if any of the following conditions are present:
 - Noise (clicking/popping/static)
 - No sound (brief, or for 30 seconds after switching to a Radio station)
 - Intermittent noise
 - Intermittent no sound
