Technical Service Bulletin: TSB210266

Fault Code 7327 Closed Crankcase Ventilation (CCV) Breather Troubleshooting

- ISX12N CM2380 X120B

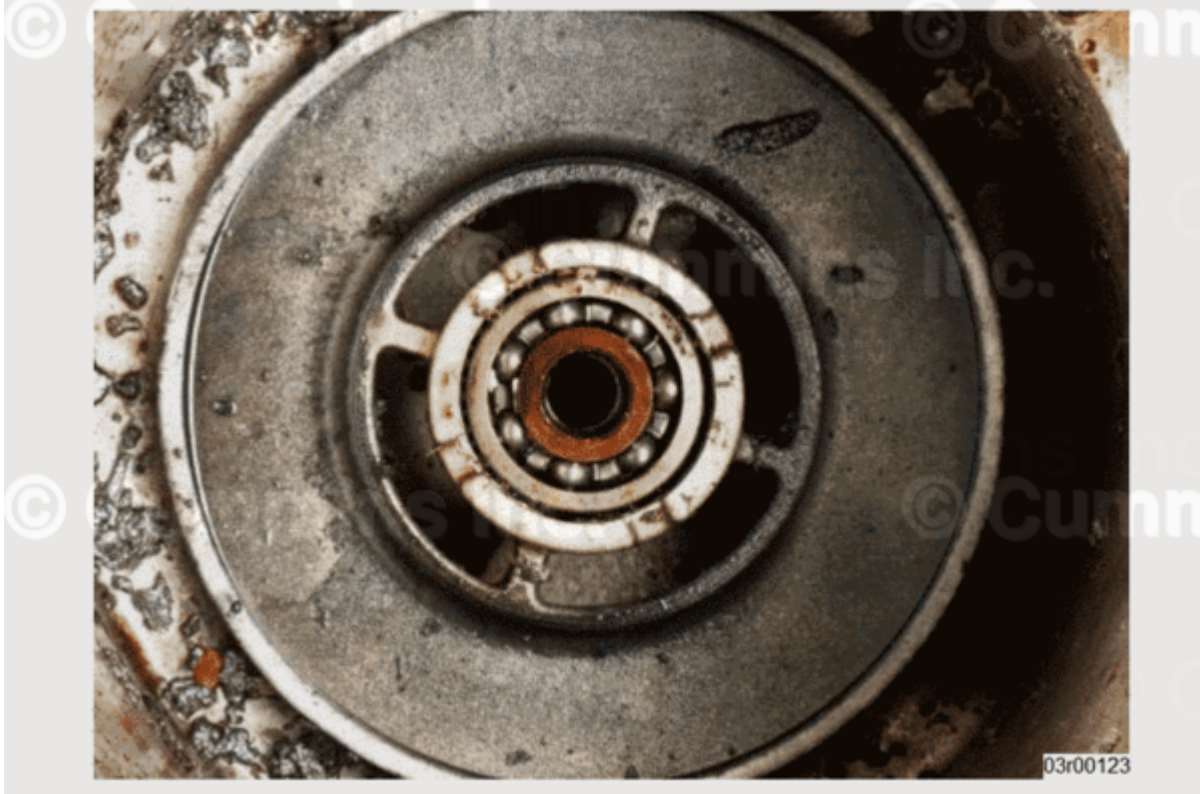
Figure 1, CCV Housing Lower Bearing Face Moderate Corrosion and Heavy Debris (Top View).

If visual inspection shows lower bearing corrosion and/or debris, replace crankcase breather assembly. See ISX12N CM2380 X120B Service Manual, Bulletin Number 5504152. Refer to Procedure 003-024 in Section 3. (</qs3/pubsys2/xml/en/procedures/525/525-003-024.html>)

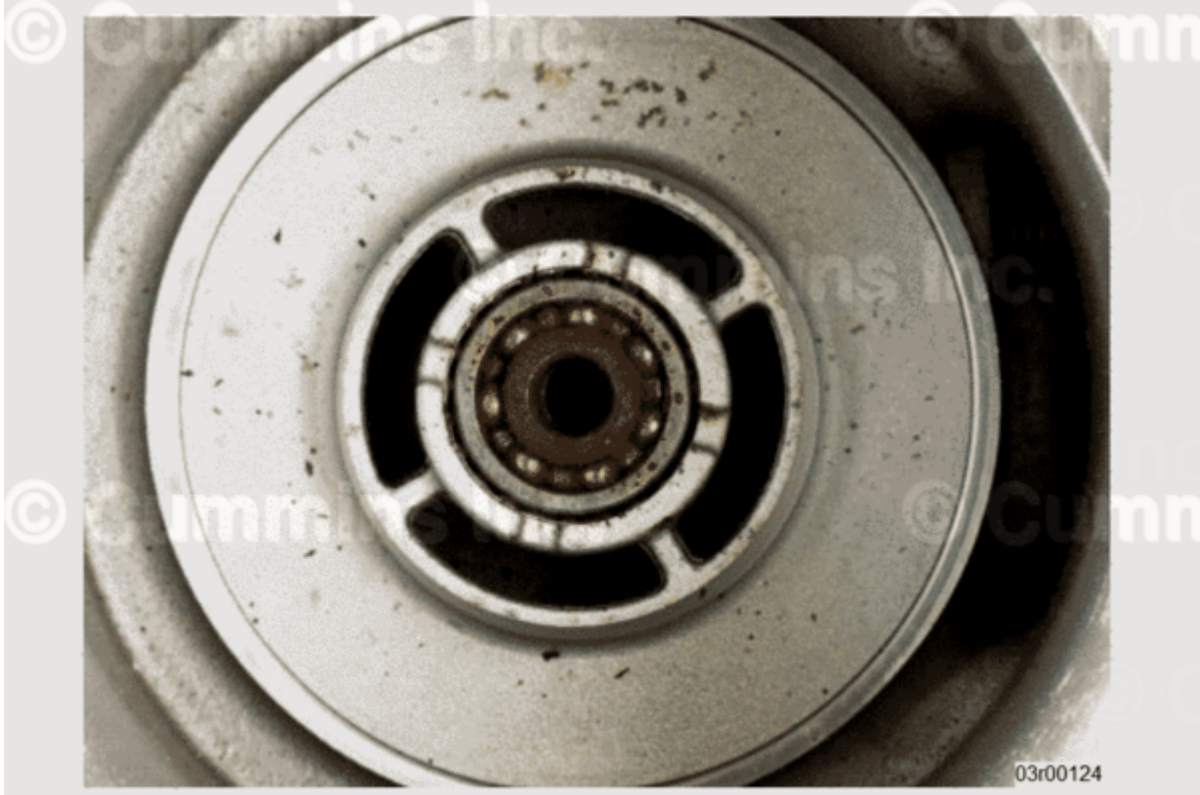
Figure 2, CCV Housing Lower Bearing Face Heavy Corrosion and Light Debris (Top View).
