SIB 16 03 22

## FUEL FOUND IN NVLD, CHARCOAL CANISTER AND TANK VENTILATION VALVE

F97 (X3 M Sports Activity Vehicle)	F98 (X4 M Sports Activity Coupe)	G01 (X3 Sports Activity Vehicle)	G02 (X4 Sports Activity Coupe)
------------------------------------	----------------------------------	----------------------------------	--------------------------------

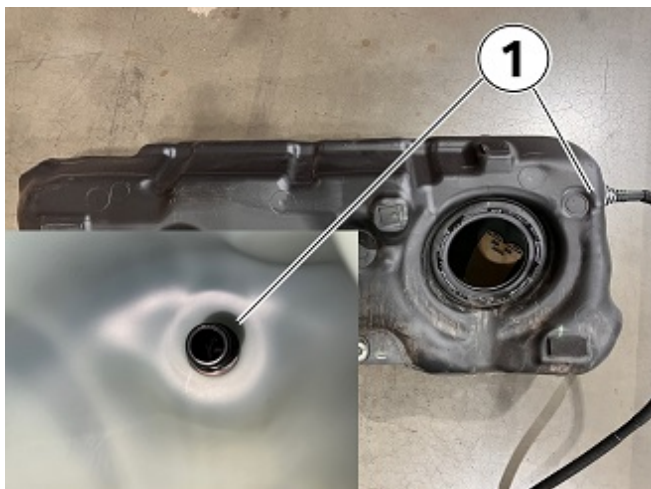
The vent line inside the fuel tank is disconnected.

The port in the tank is located at the vent line for the filler neck (1)

Attach the vent line to the port and ensure the line “locks” into place.

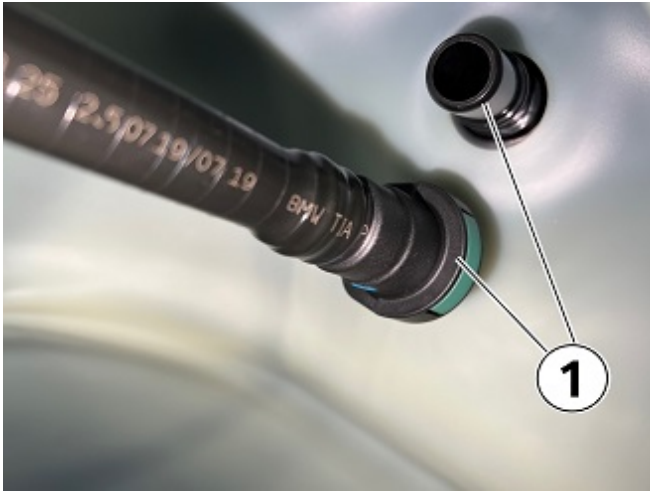
**NOTE:** The vent line may be turned and resting on the saddle of the tank (vent line is still in the parking (assembly) position).
