SIB 51 16 22

2022-10-10

**TAILGATE SPOILER CONTACTS THE ROOF TRIM WHEN OPENING**

E-Series	Model Description	Production Date
I20	iX Sports Activity Vehicle	Up to August 31, 2022

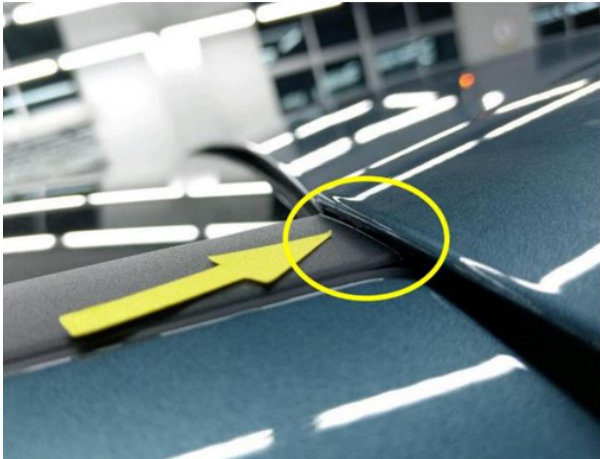
The tailgate spoiler contacts the roof trim while opening (Rear driver's side view shown).

Reposition the roof trim.

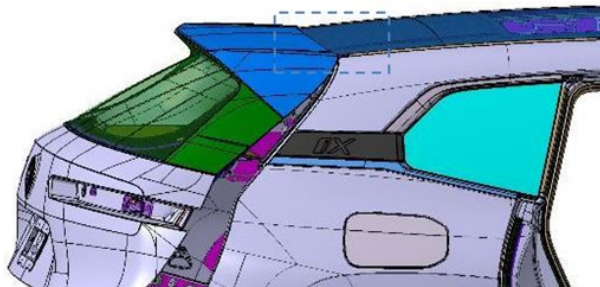
The roof trim and tailgate's spoiler expand when the outside temperature is warm. This can cause rear spoiler to contact the roof trim.
