SIB 51 17 22

**SERVICE ACTION: CHECK THE LIN MODULE IN THE MIRRORS**

# Service Information Bulletin

Body Equipment

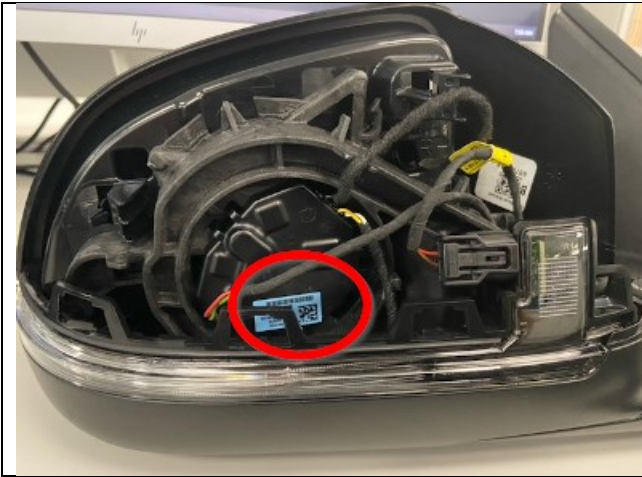
After the cover caps of the exterior mirrors have been removed, the stickers (circled) on the Local Interconnect Network modules are visible.

Disassemble the two exterior mirror caps as described in the **repair instructions 51 16 041 “Removing and installing/replacing the cover cap on the left or right exterior mirror”**.

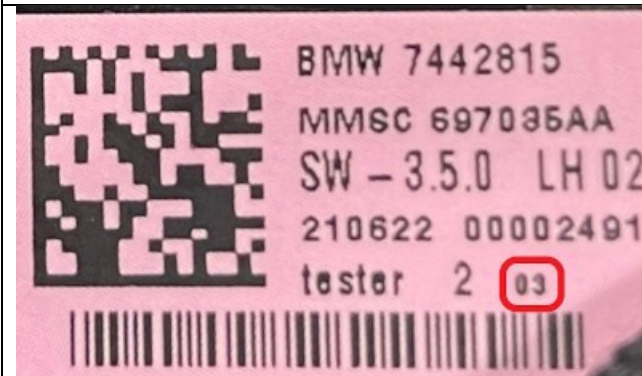
**If 03 appears on the bottom line of the sticker, replace the exterior mirror.**

To replace the exterior mirror(s), follow the repair instructions **51 16 002 Replacing the exterior mirror on the front left or right door**.

*When checking the stickers on the Local Interconnect Network modules, if it is determined that one or both exterior mirrors need to be replaced, the cover caps must be re-mounted. The parts must then be ordered, and a new appointment scheduled with the customer to exchange the exterior mirror(s).*

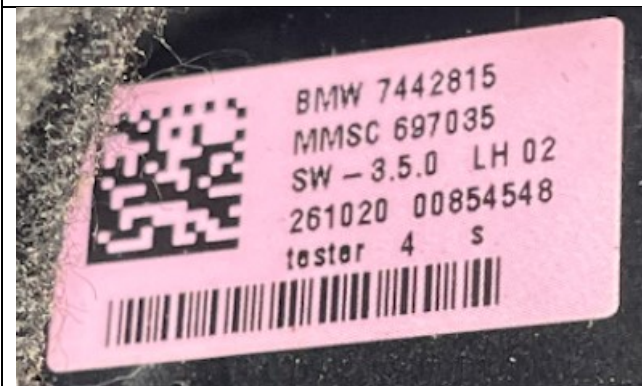
The sticker of a Local Interconnect Network module that is OK can be seen in the picture.

**Only exterior mirrors with the 03 identification on the sticker of the Local Interconnect Network module must be replaced.**
