SIB 51 19 22

## CENTER CONSOLE ARMREST DIAGNOSIS RESOURCE

E-Series	Model Description
G05	X5 Sports Activity Vehicle
G06	X6 Sports Activity Coupe
G07	X7 Sports Activity Vehicle

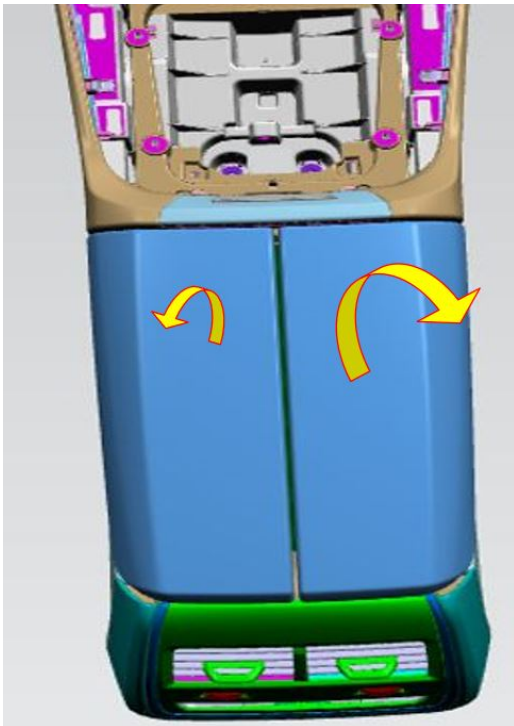
One of the center console armrest doors is slow to open, instead of both opening evenly at the same time.

It is possible that the spring which actuates the “slow” door is not in the correct retaining channel.

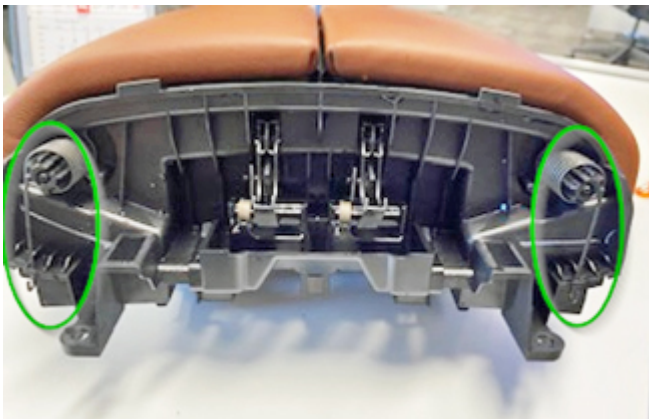
**Note:** The position of the spring adjuster does not have to be in the same channel from left to right. Instead, having the 3 channels on the armrest enables the proper/matching spring tension for the armrest doors to open at same speed.

Adjust the spring on the “slow” door to match the speed on the opposite door.
