E-Series	Model Description	Production Date
I20	iX Sports Activity Vehicle	SOP

SITUATION

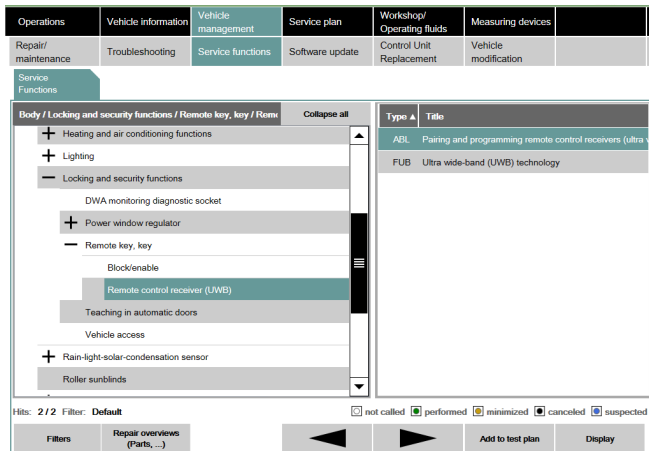
Communication between the FBD5 aerials and BCP fails.

- ABL-DIT-AS6100_BCPFEPAA - Pairing and programming the remote-control receivers.

- Connect approved battery charger to the vehicle
- Connect the diagnosis system to the vehicle (ISTA)

- Select “Vehicle management”
- Select “Service functions”
- Select “Body”
- Select “Locking and security functions”
- Select “Remote key, key”
- Select “Remote control receiver (UWB)”
