**SIM 41 01 22**

**CRACKING SOUND IS HEARD AT THE BOTTOM OF THE A-PILLAR**

| E-Series | Model Description |
|---|---|
| F60 | MINI Countryman |

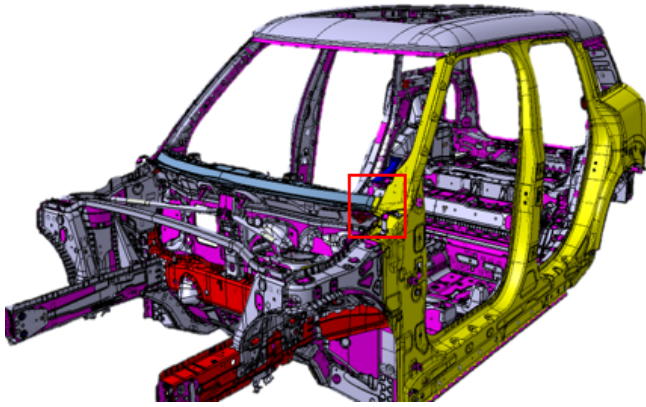
A cracking sound is heard at the bottom of the A-pillar (left or right side) when driving over uneven roads.

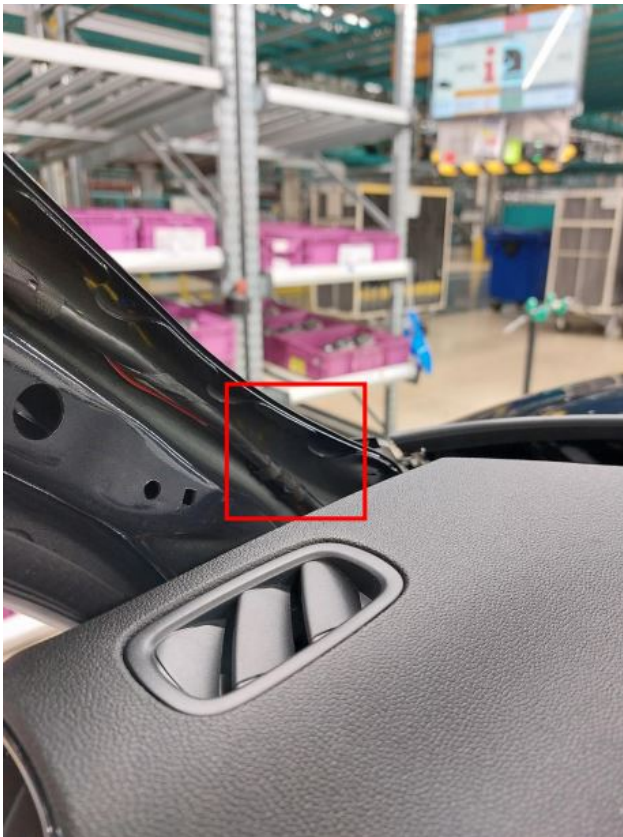
Movement in the sheet metal panels at the A-pillar (general location per red box).

Bend the panel at the A-pillar using a flat screwdriver.
