Bulletin No.: PIP5674A Published date: 11/10/2022

PIP5674A Ticking Noise or P0016, P0017, P0018, Or P0019 Set, Oil Very Dark, Possible Coolant Loss.

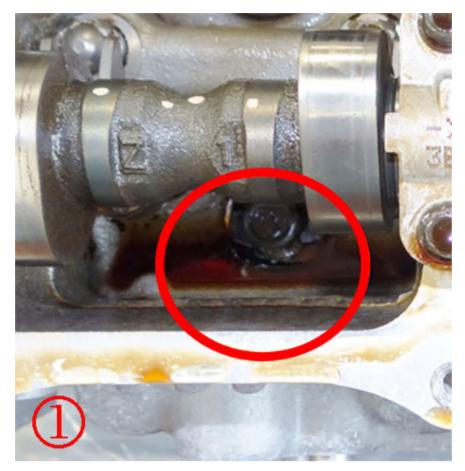
1) Moderate Leak

Involved Region or Country	North America
	A customer may come in with any of the following concerns; SES/MIL on with any of P0016, P0017, P0018 or P0019 setting, ticking noise, coolant loss, or the oil looks very dark or black.
Cause	The cause for this concern may be coolant contaminating the engine oil due to internal porosity on the cylinder head at the outer bolt area.

Observe for 15 to 30 minutes watching for bubbles like the pictures shown below.

In this case the affected cylinder head will need to be replaced.
