Bulletin No.: PIT5958
Published date: 11/17/2022

PIT5958 Loose / Side To Side Movement At The 2nd Row Bucket Seat And/Or Pop Clunk Click Noise

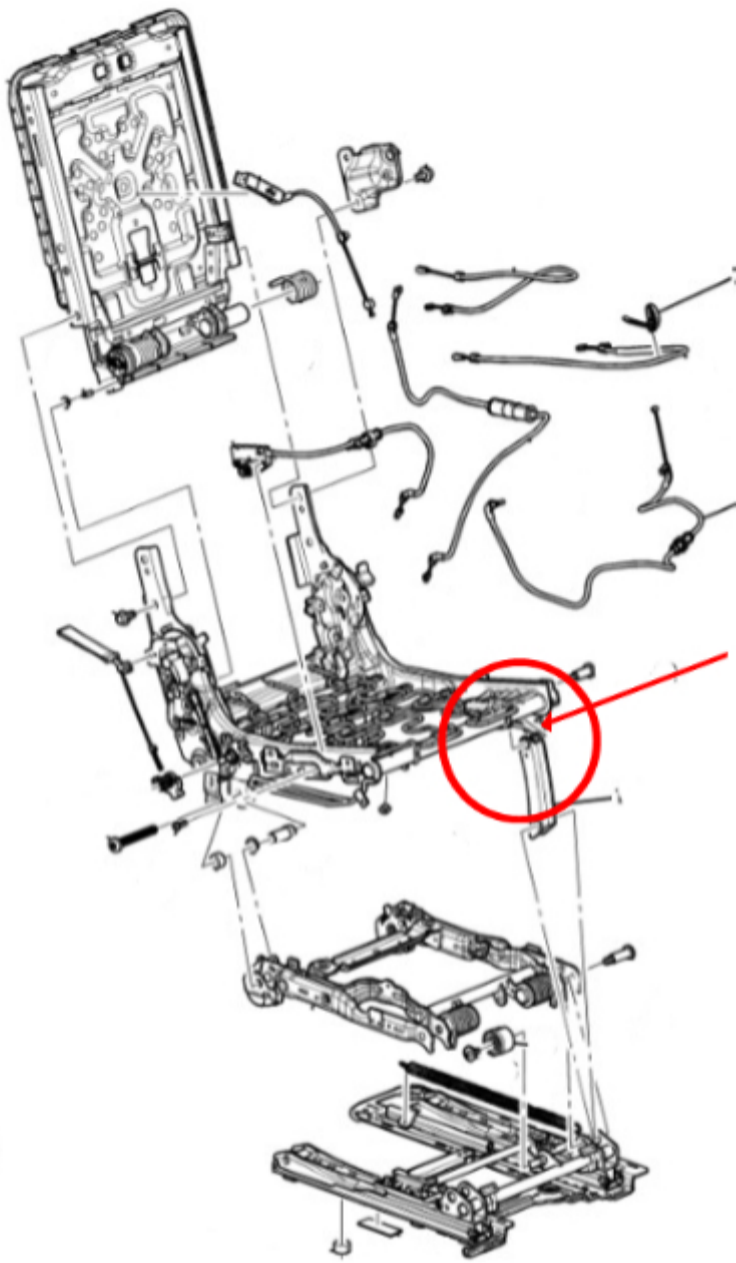
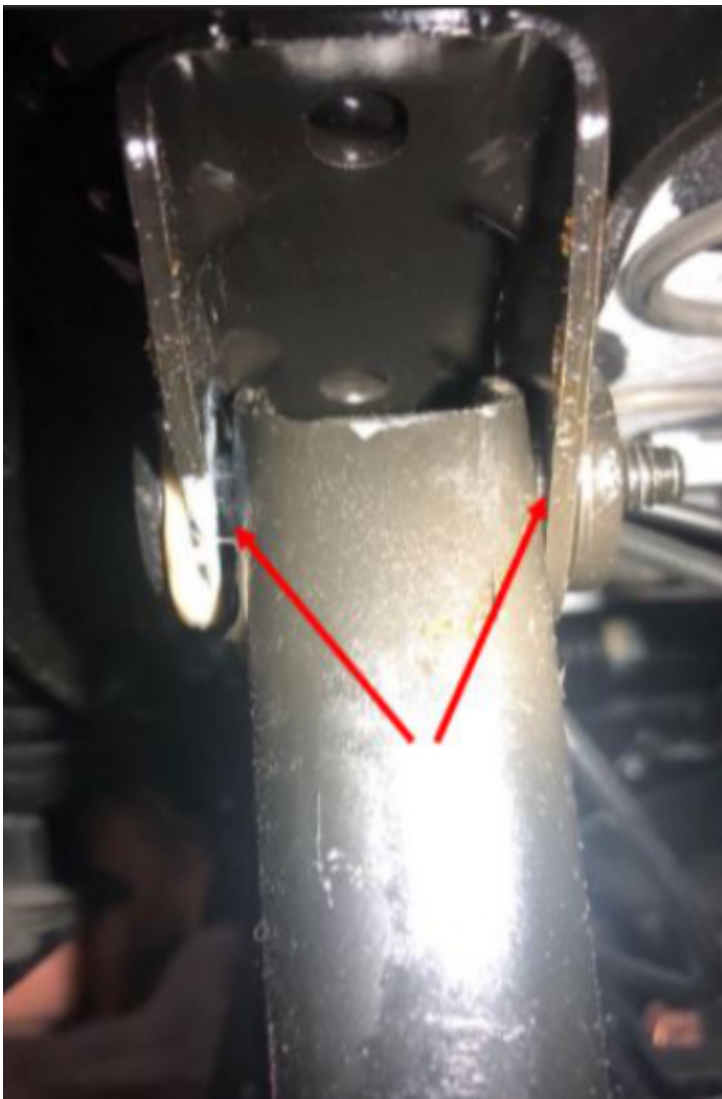
FRT

Involved Region or Country	North America
Additional Options (RPO)	2nd Row Bucket Seats
Condition	Some customers may comment that either the left and/or right 2nd row bucket seat has side to side movement or feels loose. In some cases, a pop/clunk/click type noise may be heard from the seat movement.
Cause	The cause of this concern could be excessive clearance between the seat riser link and seat cushion frame, as shown below.

If it is found that the concern is caused by excessive clearance between the seat riser link and seat cushion frame, as shown above, then GM Engineering is working on a fix. At this time, do not replace any parts.
