Preliminary Information

PIT5959 Hitch Guidelines Not Centered

Brand:	Model:	Model Years:	VIN:		Engine:	Transmissions:
			from	to		
Chevrolet	Silverado	2020 - 2023	All	All	All	All
GMC	Sierra	2020 - 2023	All	All	All	All

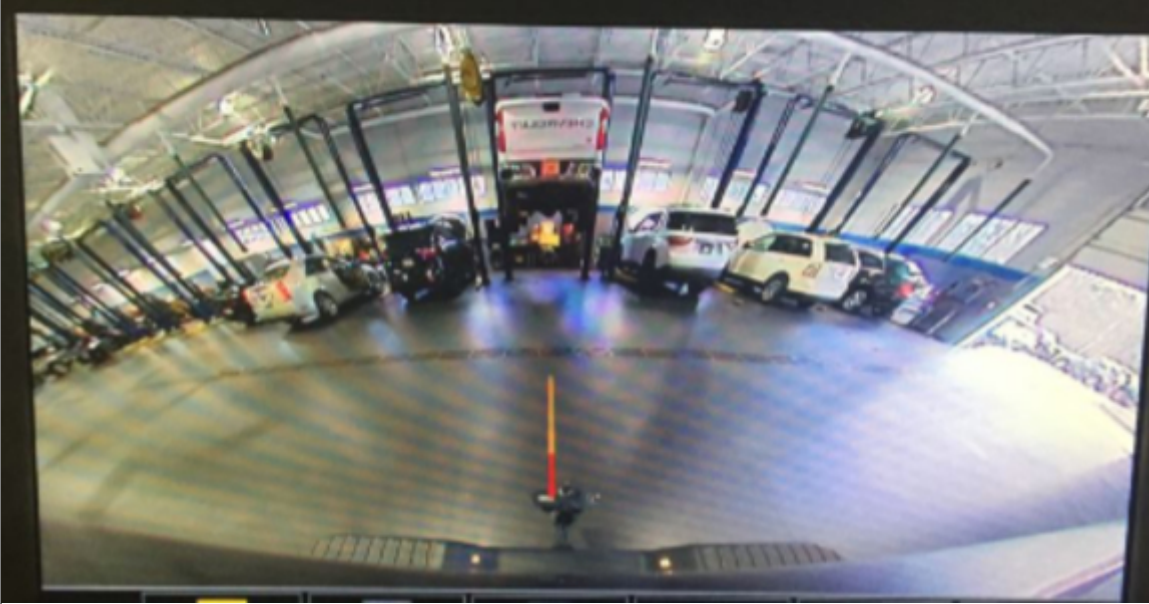
Involved Region or Country	North America
Additional Options (RPO)	UVS with UVN
Condition	Some customers may comment that when attempting to reverse, the hitch guideline will not be centered.

Cause	The cause of this condition is unknown, the engineering team is aware of the issue and is working on a fix.

Engineering is working on identifying the cause and is working on a remedy for this condition.

Do not replace any parts for this concern.
