Preliminary Information

PIT5832D Diagnostic Tip: No Start Or Unable To Perform Theft Relearn After Replacing Or Programming A Module / DTC U1962

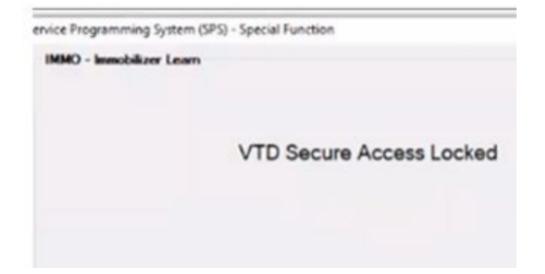
- 1. If a module was replaced, make sure the new module was SPS programmed correctly or the SDAC will fail and not complete correctly.
- 2. If a module such as the BCM is replaced, and the immobilizer learn needs to be completed after replacement, the tech needs to make sure that the SDAC completes correctly, or a pop-up message like the one below will be displayed:

3. If a vehicle will not complete the SDAC, run the SDAC (using the Serial Data Authentication selection in Techline Connect) again. Select the box in SPS controller list in the lower right-hand corner labeled "Serial Data Authentication Configuration".
