Bulletin No.: PIC6289C Published date: 11/29/2022

## PIC6289C Noise from Exhaust Valves

Brand:	Model:	Model Years:	VIN:		Engine:	Transmissions:
			from	to	Eligilie.	Transmissions.
Chevrolet	Camaro	2016 - 2023	All	All	LGX, LT1, LT4	All

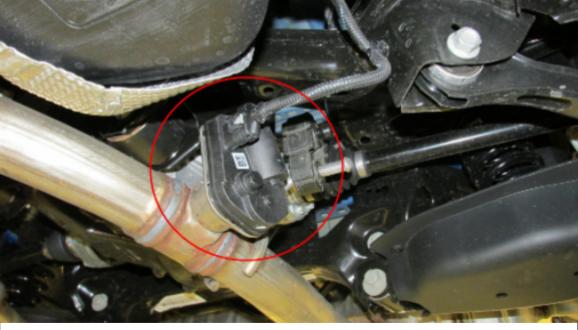
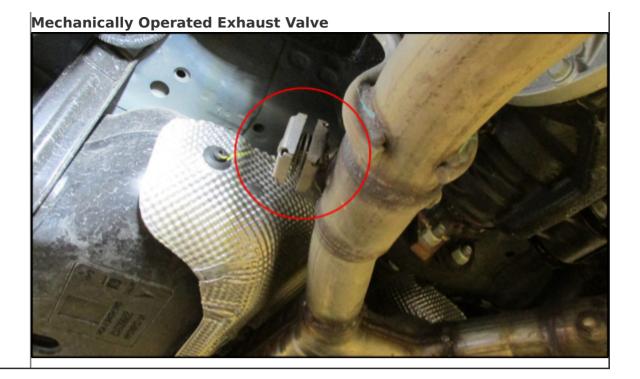
Involved Region		United States, Canada, Mexico, United Kingdom, Sweden							
Condition	exha Upor	Some customers may comment on a Check Engine Light (CEL) or an exhaust noise.  Upon further inspection, dealership technicians may find a P12FD or a P12F0 set.							
Cause	but t This	This concern may be caused by an exhaust actuator that was installed but the learn procedure was not completed.  This concern will occur on new vehicles with low mileage, or on vehicles that recently had service work done to the exhaust system.							
	valve Some pure They cont Phot		uipped w nature. ated and of valve o	they an b	Passive Extract ale	naust Va	lives (PEVs) that are

Dealership technicians are to relearn the Cylinder Deactivation Valves using GDS2 to resolve

These valves are also referred to as the Active Fuel Management (AFM) valves.

They are located before, or in front of, the muffler.

Do not replace any parts for this concern.
