## STAR ONLINE PUBLICATION

Case Number: S2223000071

Symptom/Vehicle Issue: 2<sup>nd</sup> And Or 3<sup>rd</sup> Row Seat Back Trim Loose Or Separating

From Carpet.

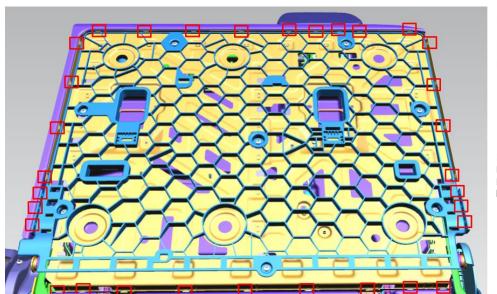
Metal lance (tabs) locations indicated with red squares.

Push plastic retainer in at all 32 locations on the frame. Plastic retainer must be pushed under metal lance to have proper retention.
