STAR ONLINE PUBLICATION

Case Number: S2123000069 Rev. A

Release Date: October 2022

Symptom/Vehicle Issue: Hood Flutter Movement Or Bounce While Driving

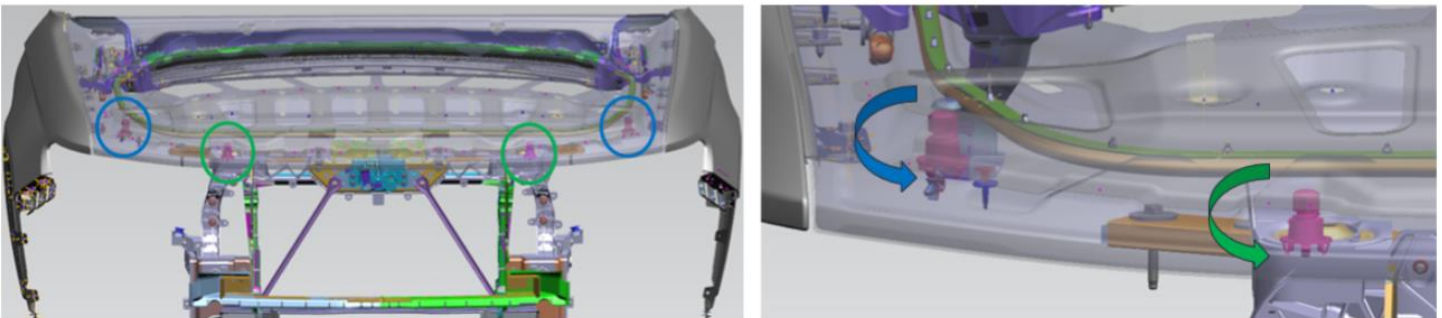
Hood bumper locations- inner and outer

For hood movement, high closing efforts, or overflush hood to fender:

1. Close the hood and view the flushness of the hood, relative to fenders. The hood should be flush or slightly under flush along the fender cutline.
2. If the hood is too far under flush, adjust the outboard up/down hood bumpers to raise the hood. This can be done by opening the hood and turning the outboard bumpers counterclockwise until your desired flushness.
3. Ensure all four up/down bumpers have contact with hood inner. Place paper over each up/down hood bumper, close hood. You should not be able to slide the paper from between the bumper and hood surface. If paper slides from between any of the four up/down bumpers, raise that bumper by turning it counterclockwise until

paper cannot easily be removed. Adjust bumpers in small intervals to prevent increased closing efforts.

4. Verify hood closing effort remains acceptable. If the closing effort is high reduce the inboard up/down bumper height slightly by turning the bumpers clockwise. Be sure the bumpers remain in contact with the hood inner.

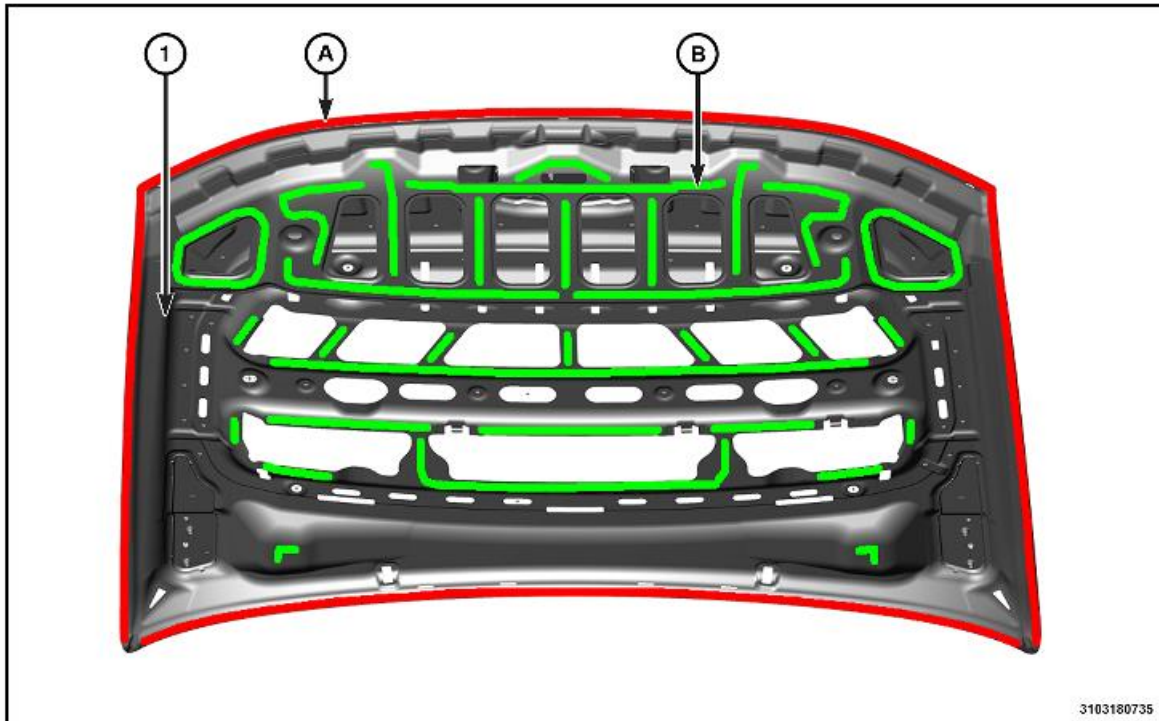
Figure 1 - Hood (1 of 2)

1. Open hood
2. Remove silencer pad by removing push pins (10) and sliding pad from locating slots on hood inner – graphic 1.
3. Inspect antflutter adhesive path (item be in graphic below) for breaks in the pattern or broken connections between the inner and outer panel

- 1- Inner Hood Panel
- A- Structural Adhesive
- B- Anti-Flutter Adhesive

4. Apply windshield urethane adhesive in areas noted if there is a gap or break in antiflutter – graphic 2.

Pull down and hold the hood inner panel by hand

Wipe the flanges of excess dust or dirt at the defective locations

Apply a 5 mm (0.2 in) diameter windshield urethane (MOPAR #04187367AB) bead as needed

Once applied, verify that the urethane is bonded to both the hood inner and outer surfaces
