## STAR ONLINE PUBLICATION

**Case Number:** S2221000004

**Symptom/Vehicle Issue:** Harsh Shift During Transition From Electric Vehicle (EV) To Hybrid Engine Mode.

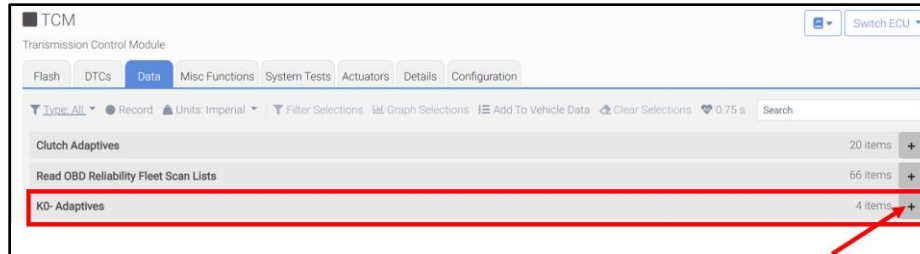
Figure 2.

2. Using wiTECH, navigate to the K0- Adaptives group in the TCM Data Tab. Click on the “+” symbol to expand that group. Please see (Figures 2 & 3)

3. Record the values for the following:
  - a. K0- Filling Counter
  - b. K0- Fast Filling Counter
4. Are the K0 Filling and Fast Filling counters greater than **5**
  - a. Yes>>> Perform the TCM Adaptation Drive Learn Routine. For detailed instructions, please refer to Service Library Service Information Section 28 – DTC Based Diagnostics > Module, Transmission Control (TCM), 8P75PH > Standard Procedure > Transmission Control Module (TCM) Adaptation. **If the concern is still present after performing the Drive Learn Routine, please contact STAR.**
  - b. No>>> Proceed to Step 5.
5. Start the vehicle.
6. Place the vehicle in EV mode by pressing the Electric mode button on the left side switch bank. Please see (Figure 4)
