STAR ONLINE PUBLICATION

Case Number: S2208000177

Symptom/Vehicle Issue: Speed Control Operates Intermittently

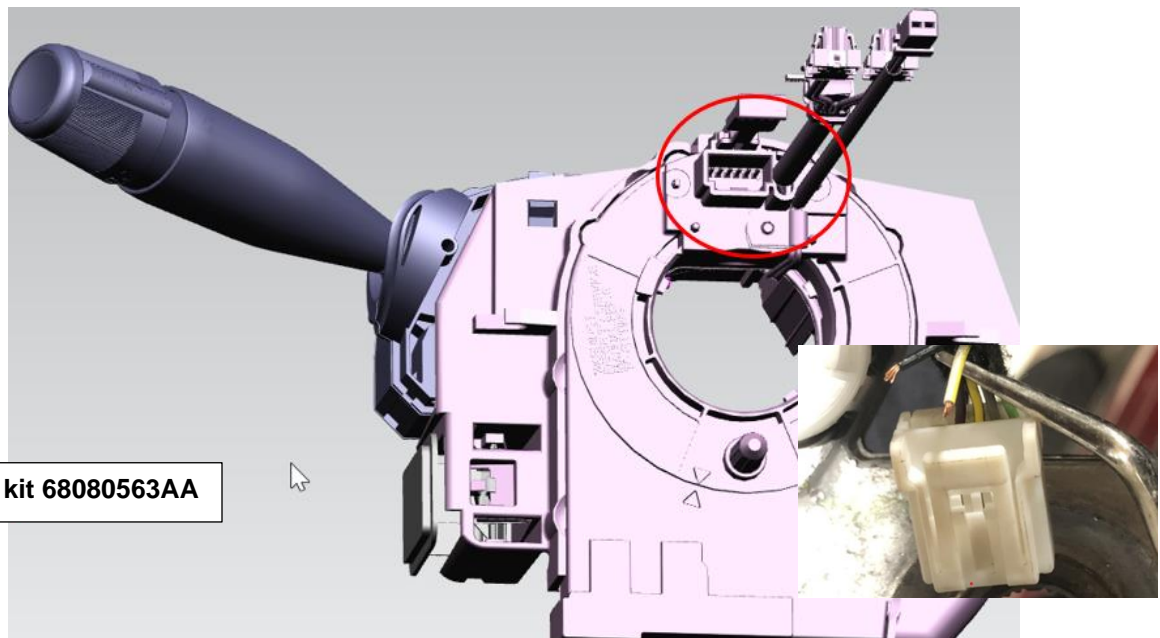
Owner Complaint/Technician Observation: Owner complains that Cruise/Speed control operation is intermittent. Technician observed the Steering Column Control Module (SCCM) set Diagnostic Trouble Code (DTC) **P0579-00-Speed Control Switch 1 Performance** as stored or active.

Discussion: Disconnect the SCCM steering wheel harness connection at the SCCM (see image below). Examine the connector D3816F for any loose or broken terminals, repair as needed. Apply dielectric grease to male terminals of SCCM and circuits at the speed control switch, reconnect and test switch voltage values as needed per the diagnostic test for P0579-00 within Service Library to confirm proper operation Fig 1 and 2.

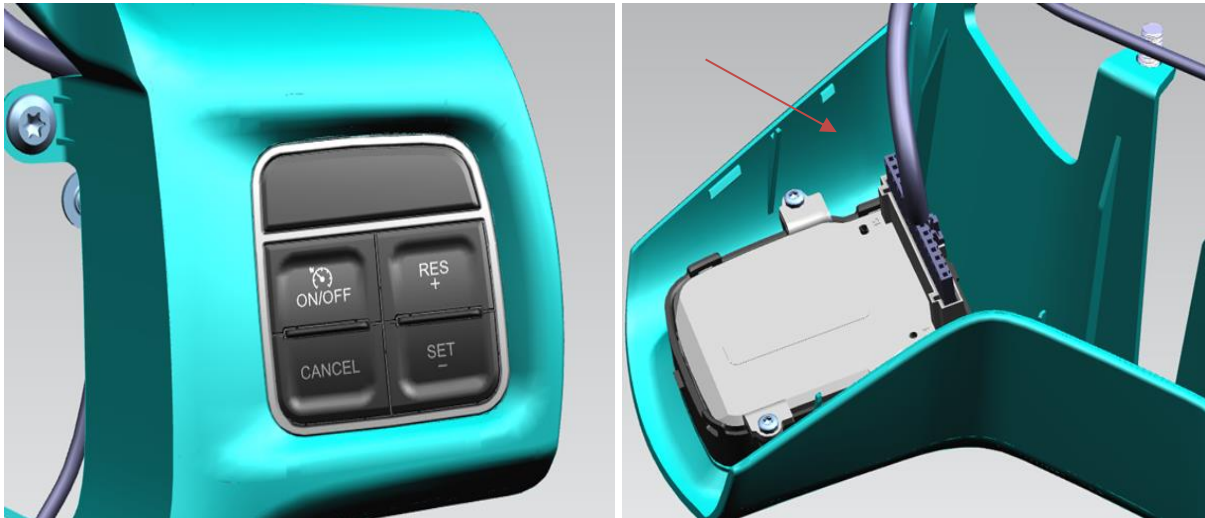
Fig 2

15-way black connector

13	V38	YE/BK	0.35	S/C SIGNAL 2
14	V937	GY	0.35	S/C SWITCH GROUND
15	V37	GN	0.35	S/C SIGNAL 1
