## STAR ONLINE PUBLICATION

Case Number: S2208000178

**Symptom/Vehicle Issue:** Battery Warning Lamp On, Battery Charging Voltage Fluctuates

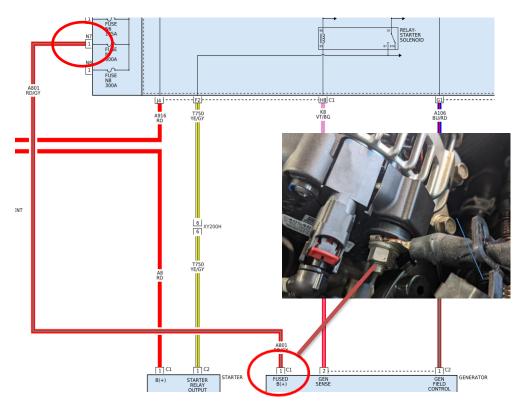
Owner Complaint/Technician Observation: Owner complains that the battery warning lamp turns on, and battery charging fluctuates lower and higher than expected. Technician observed Diagnostic Trouble Codes (DTCs) P065A-Generator System Performance, P2504-00 Charging System Output High, P2503-00 Charging System Output Low.

**Discussion:** If one of the above DTCs are present inspect the A801 circuit connections at the High Current Fuse Array (HCFA) and the alternator/generator B+. Secure alternator connection D3000A nut at the back of the alternator as needed to 14NM (10ft lbs).
