Revision (4) October 2022

Dealer Service Instructions for:

Emissions Recall U90

Catalyst Efficiency

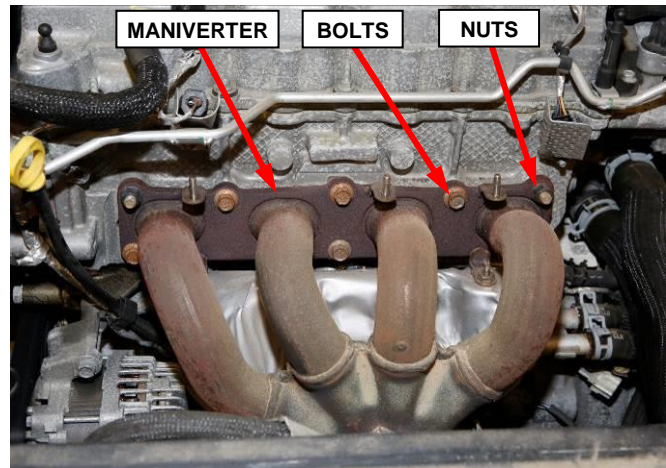
Figure 17 – Maniverter to Engine

CAUTION: Use care when removing the bolts that secure the maniverter to the engine cylinder head. Aluminum cylinder head fastener threads are susceptible to damage if the bolts are not removed with care. Use hand tools **ONLY**.

25. Remove the fasteners, six bolts and two nuts, securing the maniverter to the engine cylinder head (Figure 17).
