October 2022

Customer Satisfaction Notification Z91

Telematics Box Module

2022 (DT) Ram 1500 Pickup

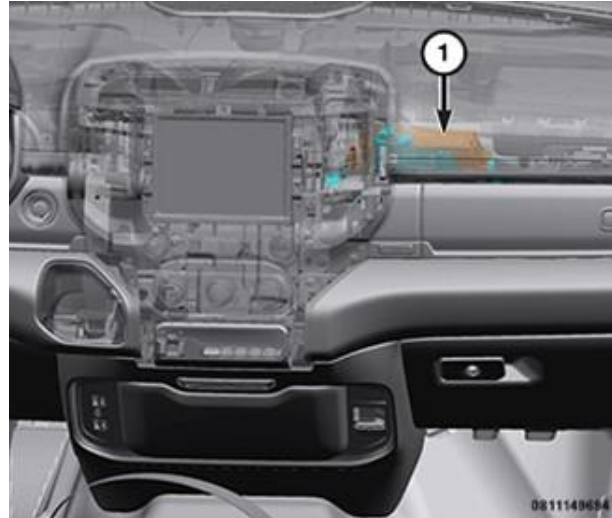
Figure 1 – TBM2 Location

NOTE: The Global Telematics Box Module (TBM2) is mounted on a bracket which is bolted to the Instrument Panel (IP) carrier next to the passenger airbag (Figure 1).
