NUMBER: 08-183-22

DATE: October 5, 2022

Flash: Telematics Box Module (TBM) Updates

2021 (WL) Jeep Grand Cherokee

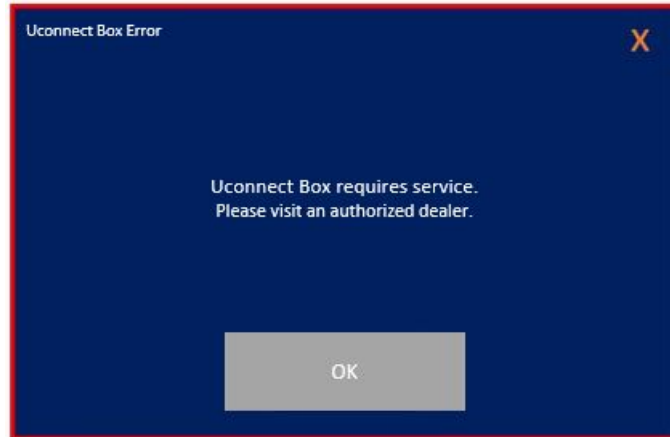
Fig. 1
Error Message

- ****Message displayed on the radio screen, "Uconnect Box requires service. Please visit an authorized dealer." (Fig. 1) , with no active or stored Diagnostic Trouble Codes (DTCs) set by TBM or Occupant Restraint Controller (ORC).**

NOTE: Uconnect box "requires service" message can be triggered by different reasons. For an issue on a new vehicle recently switched to customer mode, please follow the New Vehicle Preparation procedure to resolve Uconnect box require service message. Always fix TBM / ORC DTC issues first. If the issue could not be fixed, then reflash the TBM software.

1. ****Is the vehicle on the RSU VIN list?**
 - YES>>>Proceed to [Step 2](#).
 - NO>>>Proceed to [Step 3](#).
2. Does the TBM have the latest software already installed?
 - YES>>>This bulletin has been completed, use inspect LOP (18-20-37-9A) to close the active RSU.
 - NO >>>Proceed to [Step 3](#).**
3. Reprogram the TBM module with the latest software. Detailed instructions for flashing control modules using the wiTECH Diagnostic Application are available by selecting the application's "HELP" tab.
4. Wait two minutes after the TBM flash has been completed.
5. Reset the Electric Power Steering (EPS) - Guided diagnostics menu -> ECU reset -> EPS, Click Continue and follow wiTECH prompts.
6. Clear all DTCs that may have been set in any module due to reprogramming. The wiTECH application will automatically present all DTCs after the flash and allow them to be cleared.
