Sunroof Misaligned

This bulletin involves inspecting the sunroof glass to roof flushness and if needed, adjusting the sunroof glass.

2022 (WD) Dodge Durango

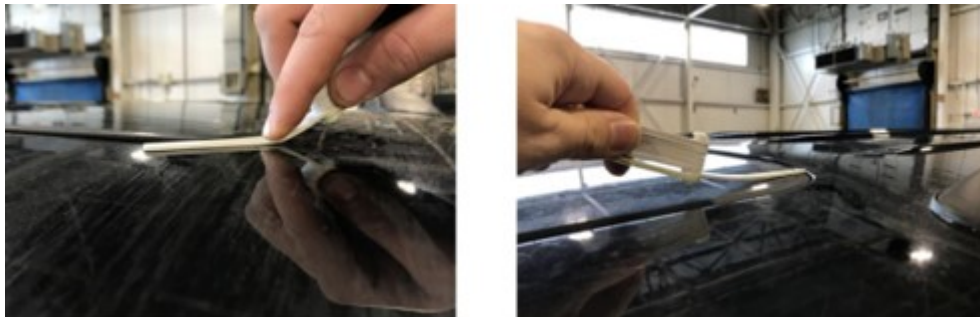
Fig. 1

1. Measure sunroof glass to roof flushness ([Fig. 1](#)). The sunroof glass should be between -2.5 mm (0.098 in.) to flush at the front and flush to +2.5 mm (0.098 in.) at the rear.

Measuring Sunroof Glass To Roof Flushness

2. Was the sunroof glass between -2.5 mm (0.098 in.) to flush at the front and flush to +2.5 mm (0.098 in.) at the rear (Fig. 1) ?
  - YES>>> Further diagnosis should be performed, use inspect LOP (23-30-65-9P) to close the active RSU.
  - NO>>> Proceed to [Step 1](#) of the Repair Procedure.

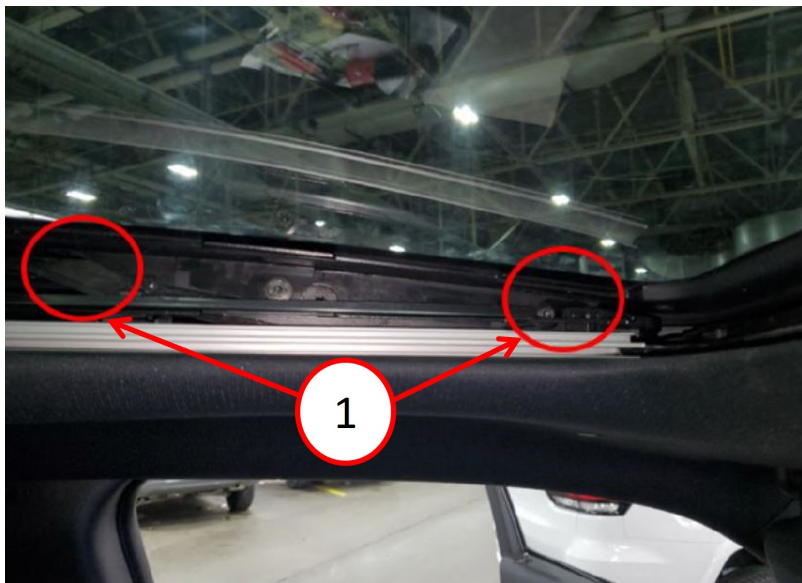
Fig. 2

Left Side Sunroof Adjusting Screws (Right Side Identical)

1 - Two Left Side Adjusting Screws To Adjust

**NOTE: No parts are required for this Repair Procedure. Only adjust the two outer screws on each side of the sunroof (Fig. 2) . Do not loosen the middle screw on either side of the sunroof.**

1. Adjust the sunroof glass (Fig. 2) . Refer to the detailed service procedures available in DealerConnect> Service Library under: Service Info>23 - Body / Sunroof, Single Pane / Glass, Sunroof / Adjustments.

2. Perform a sunroof glass seal leak test. Refer to the detailed service procedures available in DealerConnect> Service Library under: Service Info>23 - Body / Sunroof, Single Pane / Diagnosis and Testing.
3. Did the sunroof leak water?
  - YES>>> Repeat [Step 1](#) through [Step 2](#) until no water leaks are present.
  - NO>>> This bulletin has been completed.
