NUMBER: 08-193-22

Vehicle System Interface Module (VSIM) Jumper Harnesses Missing

2022 (WD) Dodge Durango

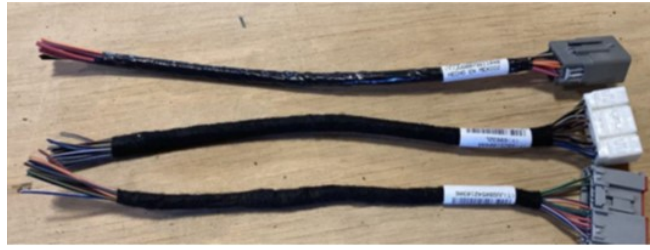
Fig. 1
Three VSIM Wiring Jumper Harnesses

Vehicles missing all three jumper harnesses from the trunk kit to use when installing police equipment (lights, sirens, etc.) to the VSIM.

1. Place all three wiring harness jumpers (Fig. 1) into the rear cargo area.
