**NUMBER:** 23-044-22

Noise from Rear Cargo Area of Vehicle

This bulletin involves repairing missing welds and repainting the rear wheel tub area.

2022 (VF) RAM ProMaster

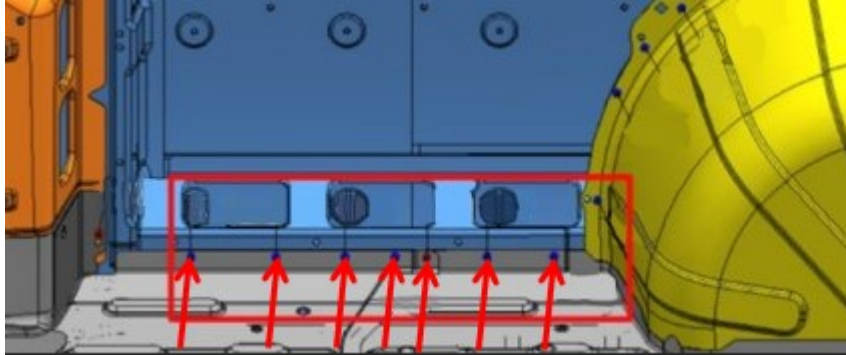
**Fig. 1**

1. Inspect the welds at the rear of the wheel tubs. Are they missing? (Fig. 1) , ( Fig. 2)
  - YES>>> Proceed to [Step 1](#) of the Repair Procedure.
  - NO>>> This bulletin has been completed, use inspect LOP (23-70-01-95) to close the active RSU.

**Long Wheelbase Missing Weld Points**

1. With a paint grinder or disk sander, grind all paint and e-coat at the missing seven (long wheelbase) (Fig. 1) , or two (Short wheelbase) (Fig. 2) weld flanges.

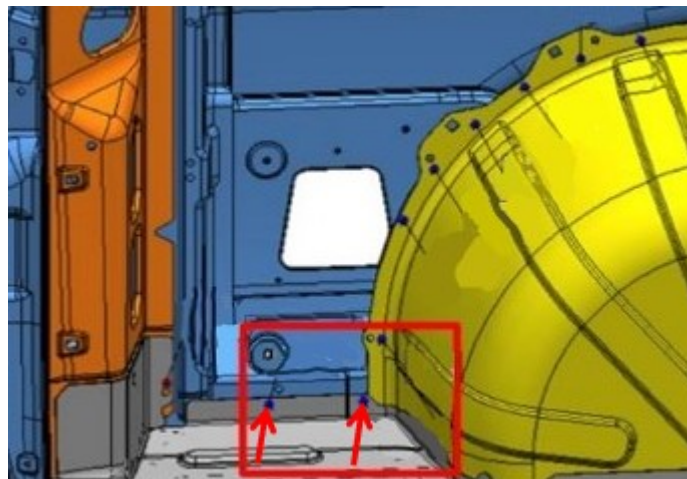
**Fig. 2**

**Short Wheelbase Missing Welds Points**

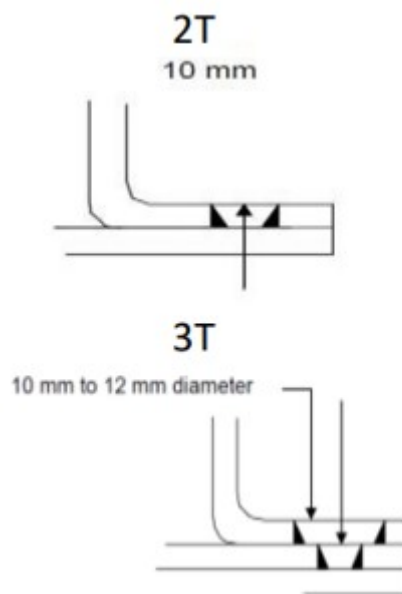
Fig. 3

Hole Saw Cutter Diameter Options

- Using a 10-12 mm ( 3/8"- 15/32") hole saw cutter or equivalent, drill holes in one or two metal thicknesses for 2T or 3T conditions, respectively (Fig. 3) .

**NOTE: Drill only the upper sheet if 2T, drill two sheets when 3T. Blow out with air after drilling.**
