# TECHNICAL SERVICE BULLETIN

Technical Service Bulletin: 37-1579

Forest River is alerting you to an issue involving certain 2023 Surveyor SVTG253RLS Travel Trailer recreational vehicles. Please see the information below which describes the issue and provides you with details on the steps you should take to have your vehicle repaired.

Make(s): SURVEYOR  
Model(s): SVTG253RLS  
Model Year(s): 2023

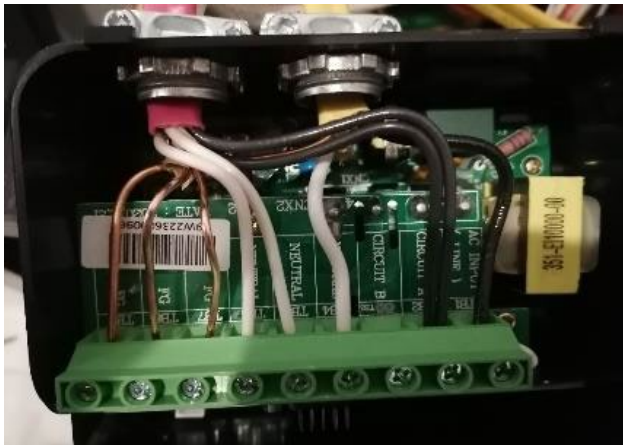
FIGURE 1

STEP 2: THE TRANSFER SWITCH IS LOCATED BEHIND THE DP (FIGURE 1);

- SLIDE THE TRANSFER SWITCH UP AND OFF THE DP;
- REMOVE THE TRANSFER SWITCH COVER TO EXPOSE THE WIRING;

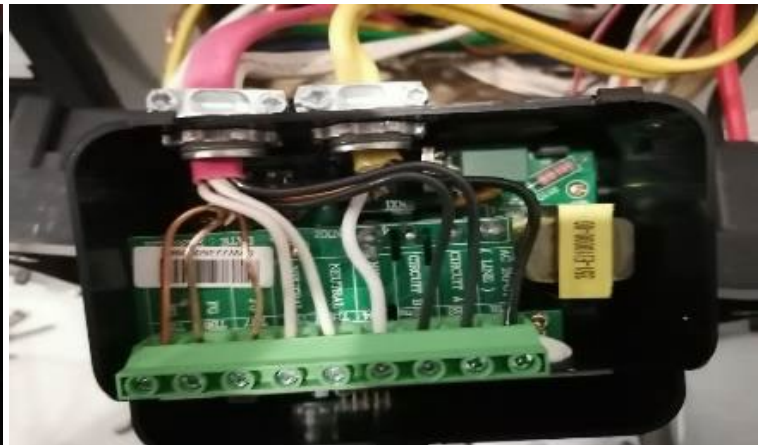
FIGURE 2

Concern:  
The fireplace and microwave may be wired to the same 15AMP breaker and bypass the transfer switch.

STEP 3: FIND THE TWO (2) BLACK WIRES LOCATED ON THE "A" CIRCUIT. LOCATE THE BLACK (POSITIVE) WIRE COMING FROM THE "WHITE" 110V WIRE AND MOVE IT TO THE "B" CIRCUIT (FIGURE 2).

- THE BLACK (POSITIVE) WIRE FROM THE "PINK" 110V WIRE WILL STAY IN THE "A" CIRCUIT. MAKE SURE WIRES ARE SECURE UNDER THE LUGS ON EACH CIRCUIT.
