# Service Bulletin

Bulletin No.: 22-NA-237

**Subject:** Service Cluster Message and DTC U3000 Set

Brand:	Model:	Model Year:		VIN:		Engine:	Transmission:
		from	to	from	to		
Buick	Envision	2022	2023

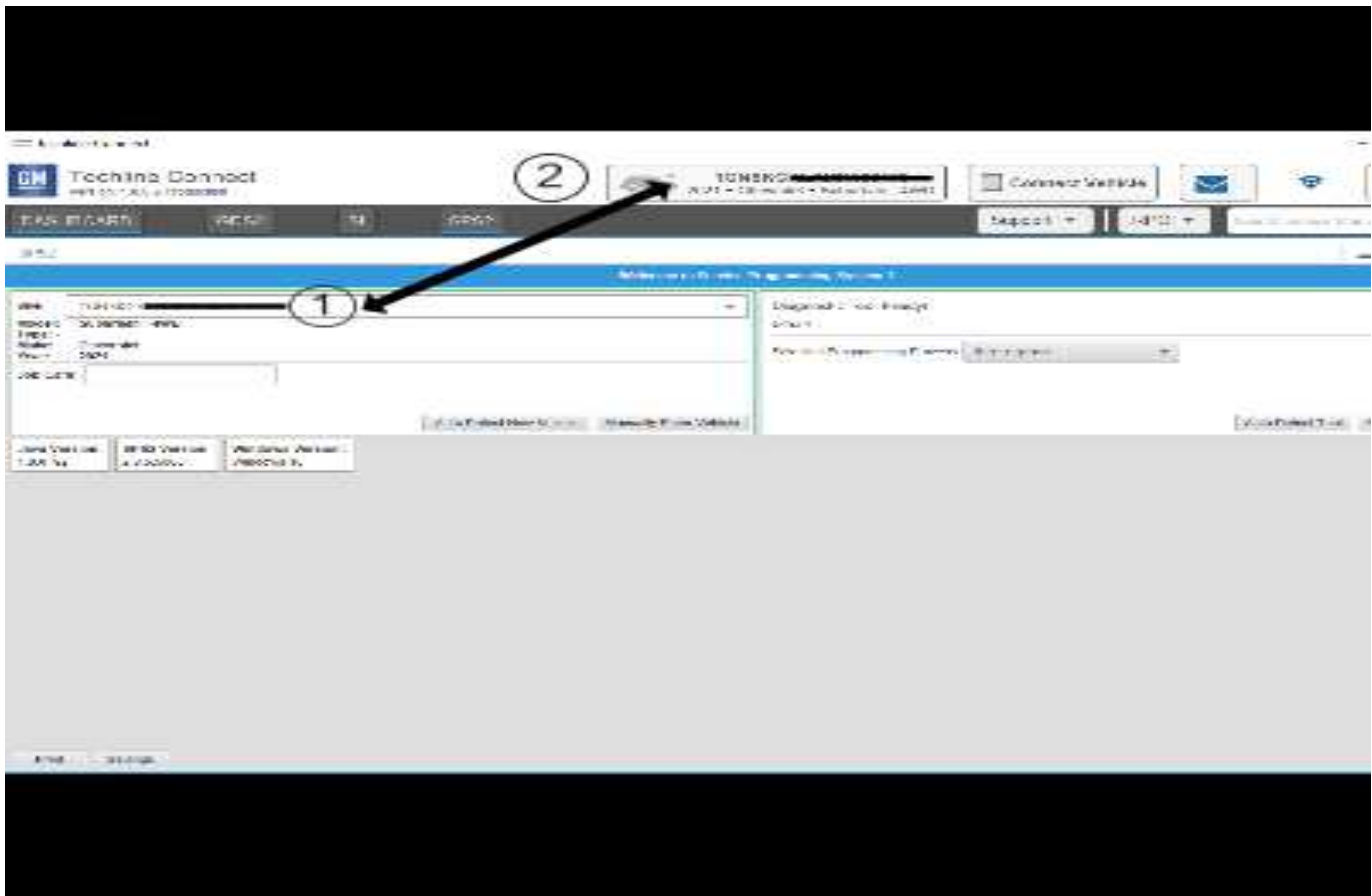
**Caution:** Be sure the VIN selected in the drop down menu (1) is the same as the vehicle connected (2) before beginning programming.
