GLOBAL SAFETY FIELD INVESTIGATIONS DCS6365 URGENT - DISTRIBUTE IMMEDIATELY

- Date: December 15, 2022
- Subject: REVISION: N212354522-05 Customer Satisfaction Program Heated Vented Seats Retrofit Front Seat Heater Vent Module, Rear Seat Heater Module and Programming Population Update
- Models: 2022 Buick Enclave 2022-2023 Buick Envision 2022-2023 Cadillac XT4 2022 Cadillac XT5 2022 Cadillac XT6 2022 Chevrolet Blazer 2022 Chevrolet Equinox 2022 Chevrolet Malibu 2022 Chevrolet Silverado 1500 New 2022 Chevrolet Suburban 2022 Chevrolet Tahoe 2022-2023 Chevrolet Trailblazer (Export Markets only) 2022 Chevrolet Traverse 2022 GMC Acadia 2022 GMC Sierra 1500 New 2022 GMC Terrain 2022 GMC Yukon 2022 GMC Yukon XL
- To: All General Motors Dealers

N212354522 Heated Vented Seats Retrofit - Front and Rear Seats

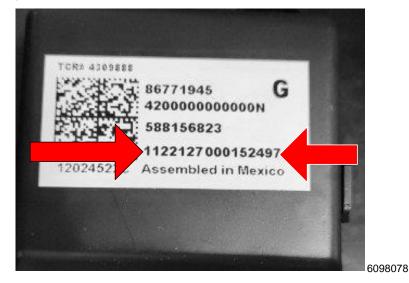
Record the serial number on the front and rear seat heater vent control module labels.

RECORDING REQUIREMENT. The replacement Front and Rear Seat Heater Vent Control Module serial numbers must be captured by the technician and recorded on the job card. The Warranty Administrator MUST enter the replacement Front and Rear Seat Heater Vent Control Module serial numbers in GWM (Global Warranty Management) or in DMS (Dealer Management System). Enter the serial number of the **replacement** Front and Rear Seat Heater Vent Control Modules in the '**General Comments**' comments section. Failure to enter this serial number will cause the claim to reject.

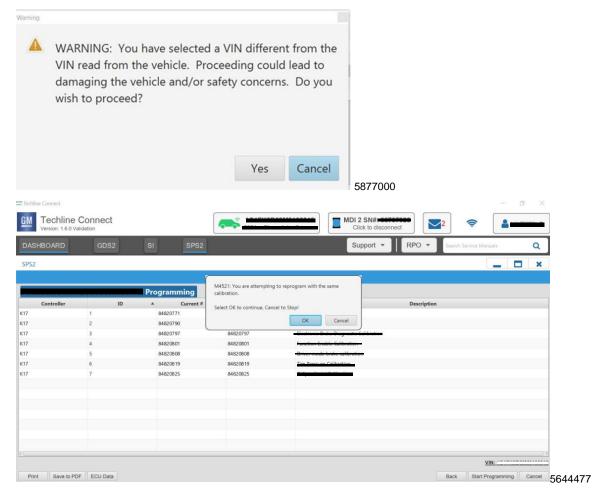
Important: If the vehicle VIN DOES NOT match, the message below will be shown.

- If the VIN that shows up in the TLC top center window after correctly reading the VIN from the vehicle does not match the VIN plate of the vehicle, manually type in the VIN characters from the vehicle VIN plate into the TLC top center window and use these for programming or reprogramming the subject module with the correct vehicle VIN and software and/or calibrations.
