Service Bulletin

Bulletin No.: 21-NA-149

Subject: Engine Wire Harness Chafing / IPC Gauges Sweep / IPC Warning Message / SES/Check Engine/MIL / No Start / No Crank / Runs Rough / Stalls / Reduced Engine Power / Various DTCs

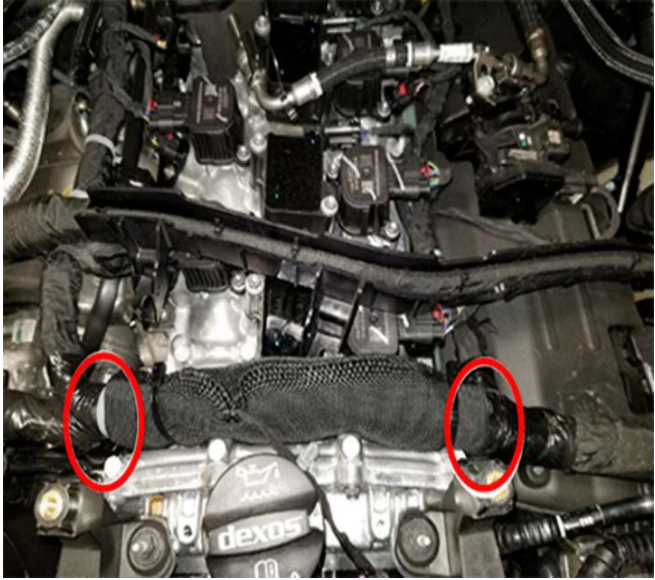
<p style="text-align: right;">5394681</p> <p>Example of engine wiring harness damage at Camshaft Carrier Cover shown below.</p>

<p>Cause 1</p>	<p>This Cause pertains to vehicles equipped with engine 2.7L, L3B only.</p> <p>These concerns may be caused by engine harness contact with under hood components.</p> <p>Caution: This Document Only Applies To VINs NOT Covered by Customer Satisfaction Program N192219370 Please Verify In VIS Before Proceeding</p> <p>Shown below are areas that should be inspected for this concern.</p> <p>Inspect the engine harness as it crosses over top of the Camshaft Carrier Cover.</p> <p>Harness damage can occur at any point across the Camshaft Carrier Cover.</p> <p>Typical inspection locations shown below.</p>

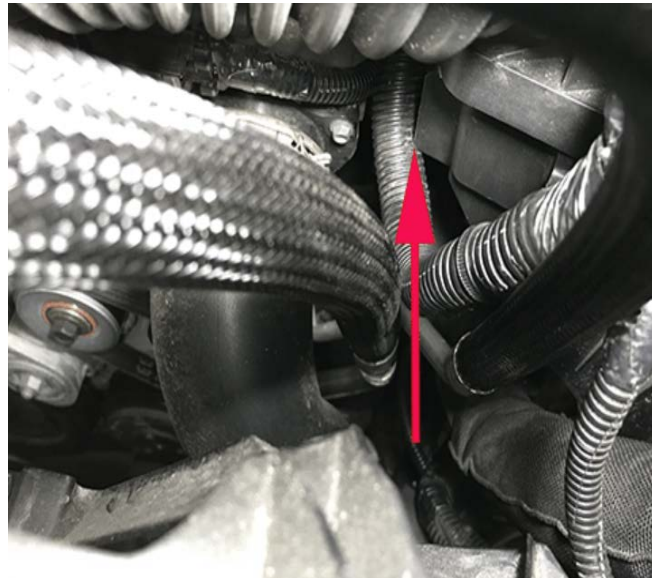
5394683

Inspect the engine harness at the Lower Air Cleaner Housing as shown below.

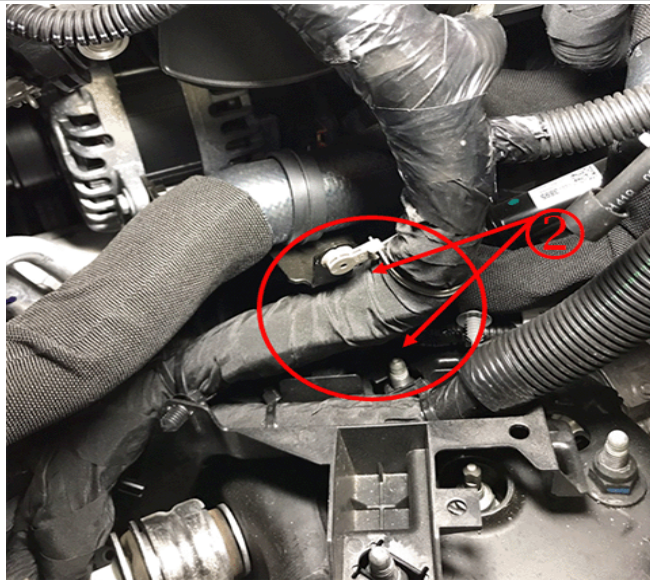
5324752

Example of engine harness damage, Lower Air Cleaner Housing removed shown below. Inspect the engine harness at the Generator Bracket and Left Front Coil Spring stud as shown below.

Note: Under normal driving conditions, the engine will rock back and forth in its mounts.

This may result in harness contact with this bracket that may not be present during engine off inspections.

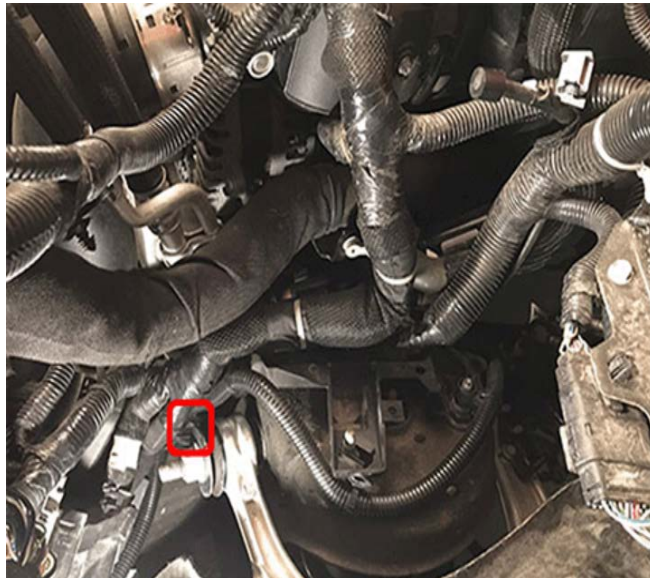
5394677

Inspect the engine harness at the Left Front Upper Control Arm Bushing as shown below.

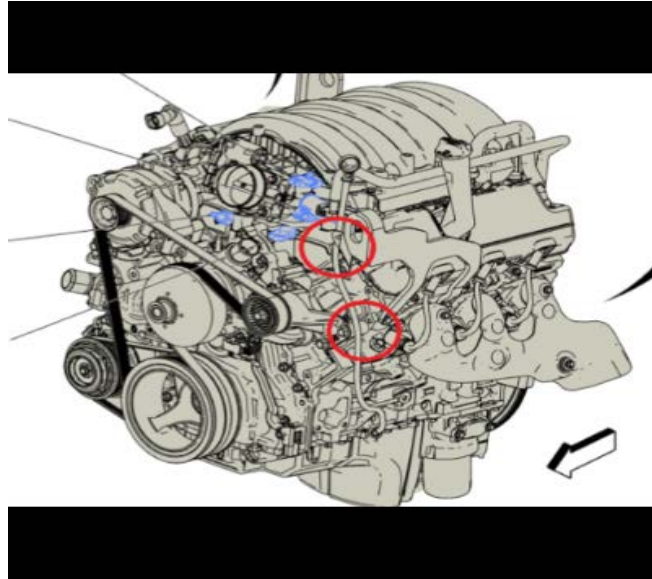
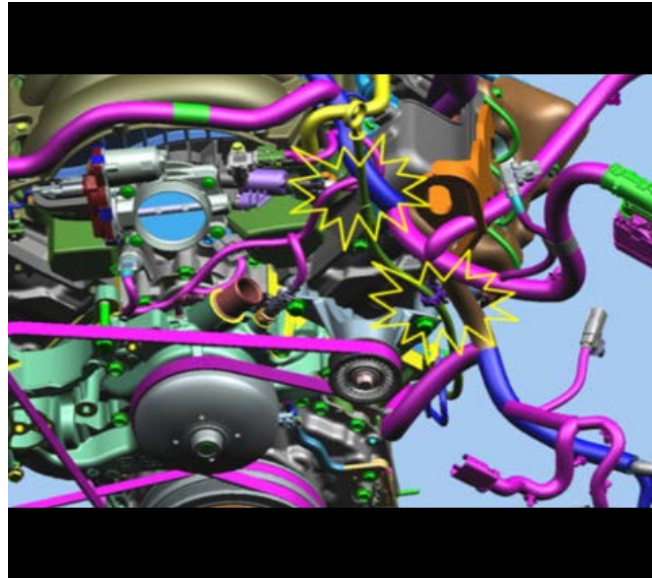
These concerns could be caused by engine wiring harness chafe on underhood components at various locations such as: Front corner of the left hand cylinder head, drive belt idler pulley bracket, or oil dipstick bracket; noted by the circled and starred areas in the graphics above.

This harness chaffing could cause shorting of any number of circuits to ground. Due to the number of circuits in the harness, there is a wide variety of different symptoms that could occur depending on which circuit(s) are damaged.

To correct this concern, repair the damaged wiring following the SI wire-to-wire repair procedures. Once repaired, protect and reposition the engine wiring harness to prevent future harness damage.

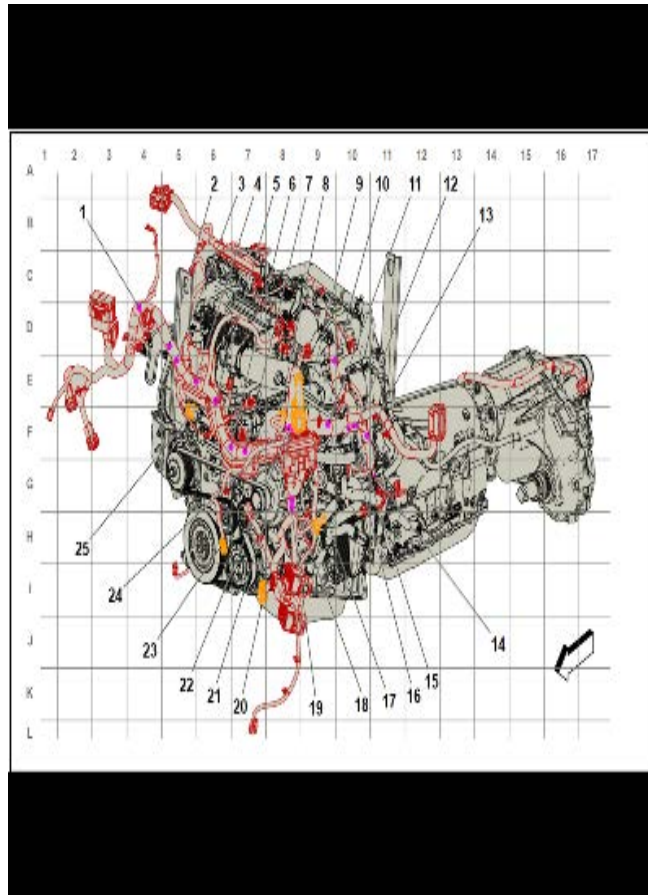
6163833

1. The engine harness pinched/shorted/chaffed at grid coordinates G-8, as shown above. This location is approximately 18 inches from the ECM connectors (1) and on top of the generator (2), as shown below. Due to the number of circuits in the harness, there is a wide variety of different symptoms that could occur, depending on which circuit(s) are damaged.

2. The engine harness shorted/chaffed at grid coordinates C-9, as shown above. The engine harness could be shorted out on the PVC hose clamp at the crankcase pressure regulator, as shown below (6). This is located approximately 4 inches from the crankcase sensor connector pigtail harness breakout.

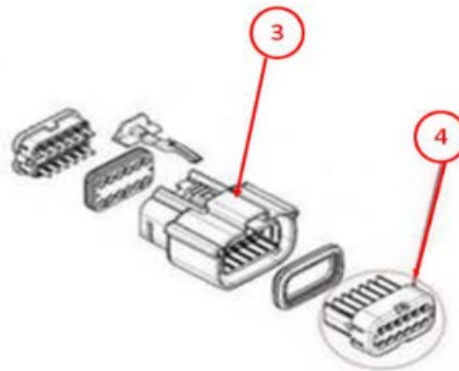
5643650

1. Inspect for poor terminal tension at connector X160, shown in the grid above, as callout 25. While inspecting X160 make sure the terminal locking feature (4), shown below, is not missing.

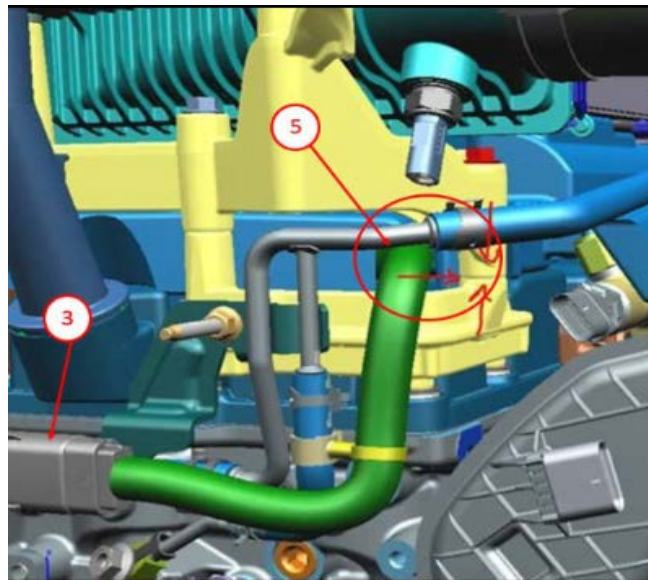
5643651

2. Inspect the fuel injector connectors to make sure they are fully connected/seated.
3. Inspect the fuel injector wiring harness near the X160 connector (3) for being pinched/shorted/chaffed, as shown below (5).

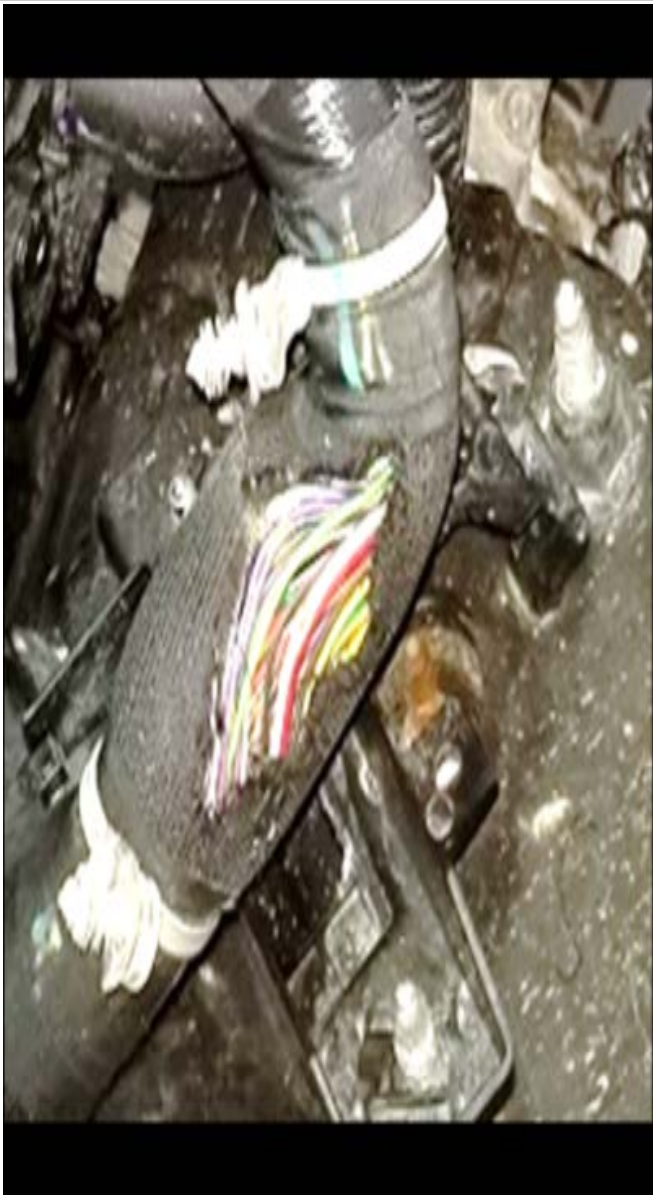
5868347

Examples of extreme wire chaffing.

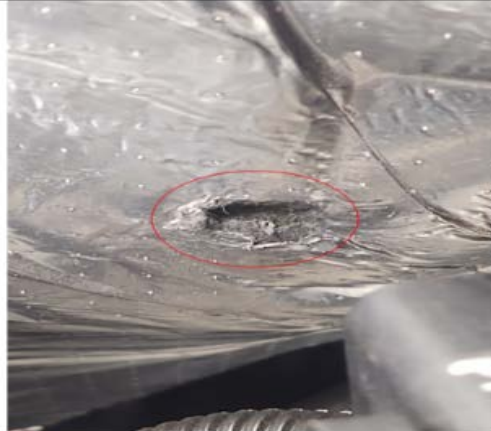
5949751

An example of firewall insulator chaffing

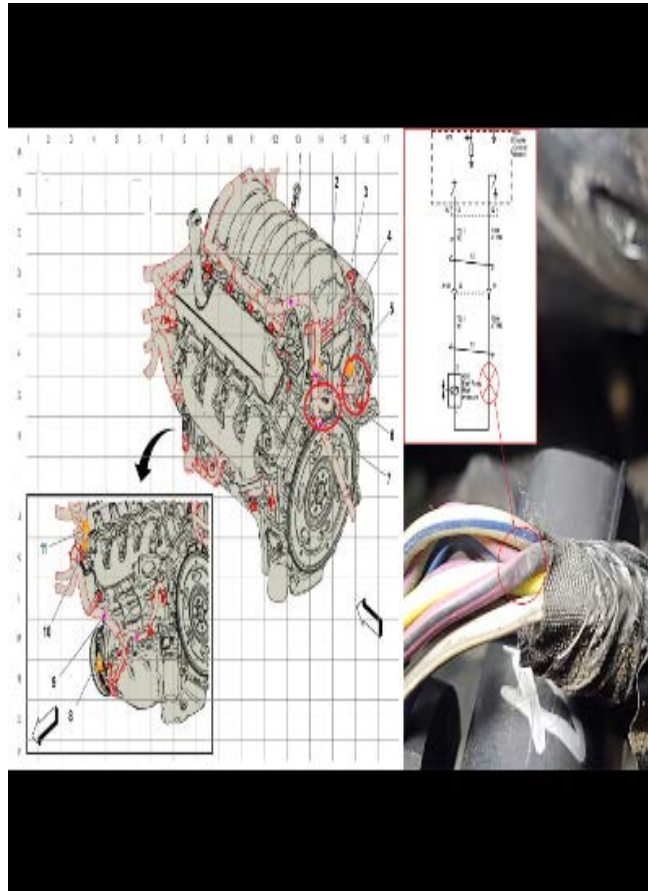
5949755

Other areas of concern.

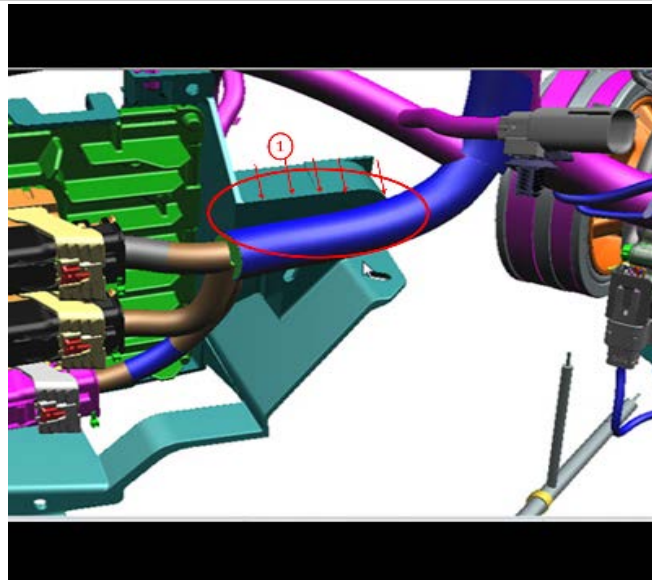
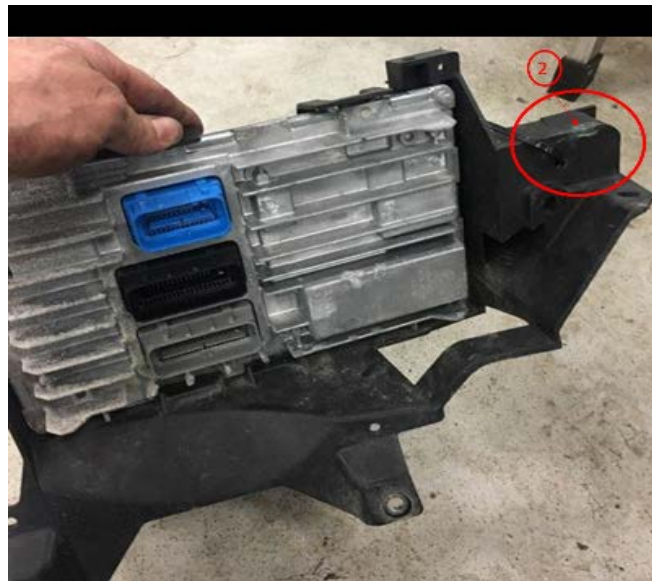
The cause of the condition may be an engine wire harness clip was removed during production due to ergonomic issues (hand clearance and branch stiffness). This led to an uncontrolled branch that came into contact with a sharp edge (1) & (2) on the ECM/TCM bracket, driver side upper control arm, and/or shock tower and caused chaffing during engine vibration and roll.

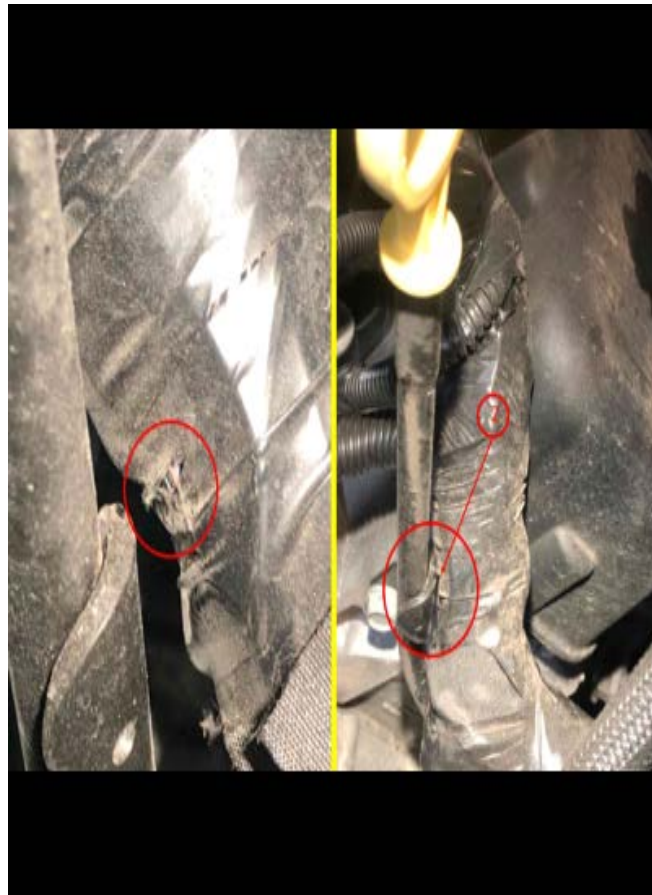
5911722

This Correction pertains to vehicles equipped with engine 4.3L, LV3 only.
Note: The first graphic below is a before, and after (2), repair example of harness chaffing at the Oil Dipstick bracket.

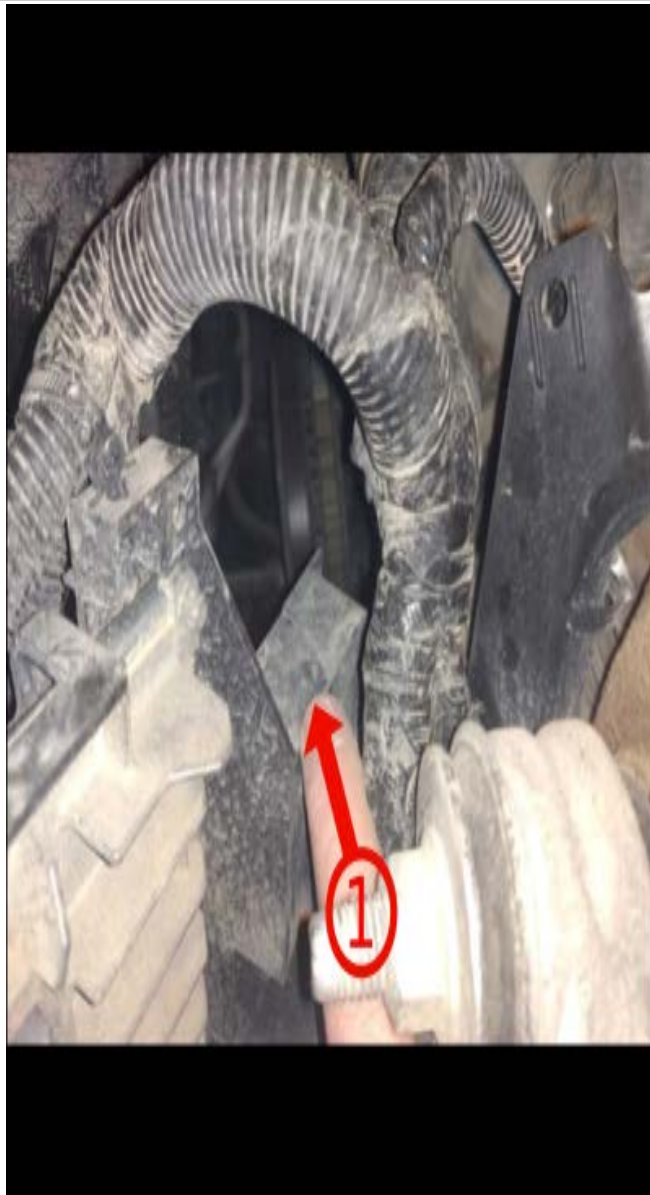
5868349

3. Locate the three contact points where the wire harness is chaffing, the ECM/TCM black bracket (1), the upper control arm (2), and the shock tower bolt (3).

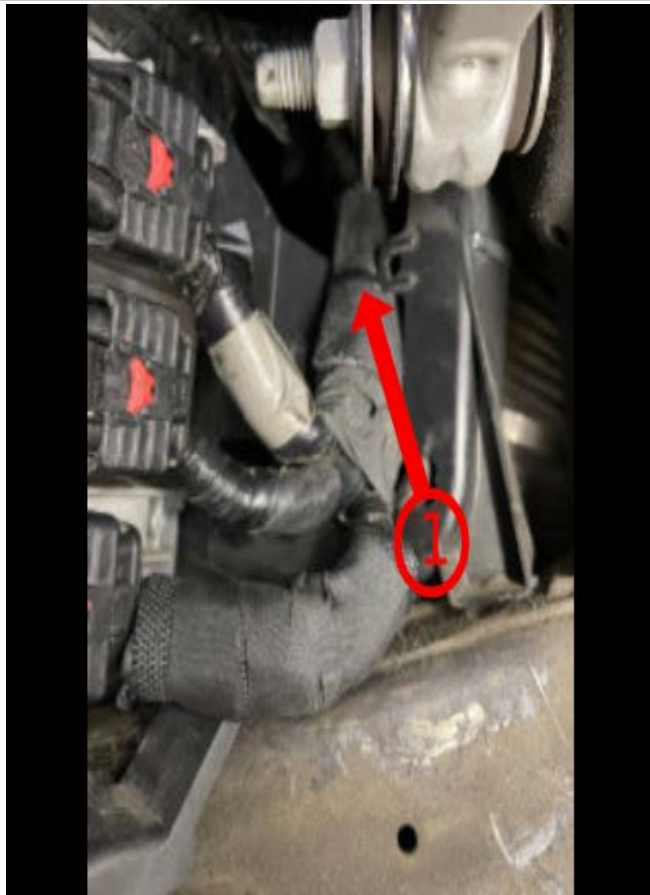
5868350

4. At the ECM/TCM bracket, locate the wire harness laying against the ledge (1).

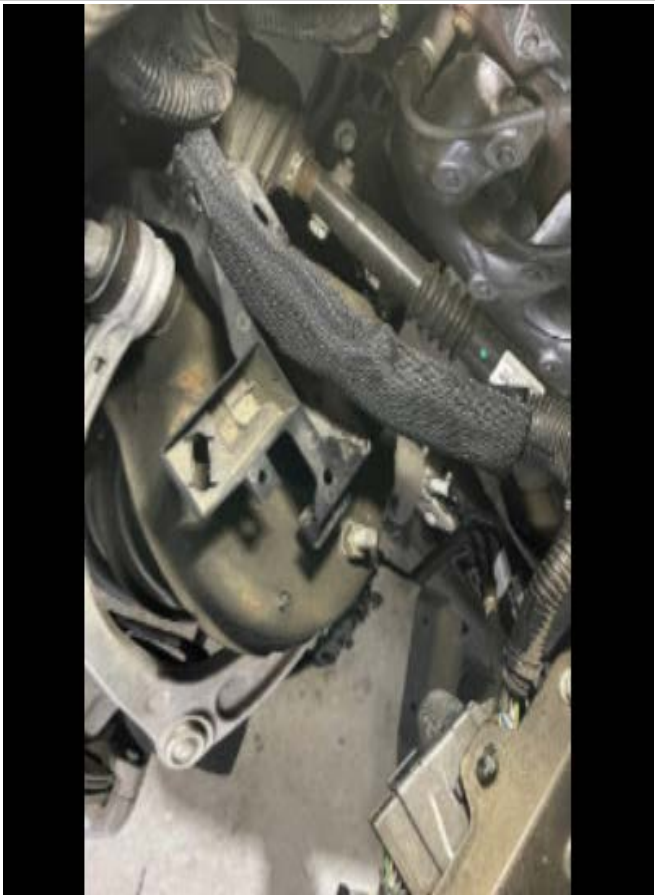
5868358

9. At the shock tower point there is a wire harness canal (1).
