Technical Service Bulletin

30 Transmission leak from service opening of the lower bellhousing

30 22 31 2053597/6 December 1, 2022. Supersedes Technical Service Bulletin Group 30 number 20-30 dated November 9, 2020, for reasons listed below.

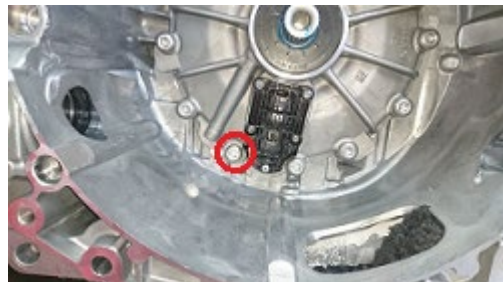
Figure 1. Bolt location.

1. Remove the lower bolt of the cover on the passenger's side of the plastic cover (Figure 1 and Figure 2).

1. Remove all bolts of the clutch cover (*Do not remove the dual clutch only the bolts are being replaced*).
2. Clean the bolt holes.
3. Install 12 new bolts for the clutch cover with the part number WHT 002 459 C:
 - Tightening torque: 12Nm + 90°.
 - The tightening sequence is a diagonal pattern as described in the repair manual.
4. Reinstall the dual mass flywheel into the transmission per the repair manual.
5. Reinstall the transmission into the vehicle per the repair manual.
6. Check and adjust the transmission ATF level.
7. Road test for proper operation.

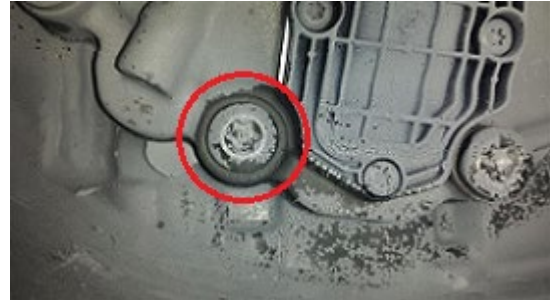
Figure 2. Leak location.

Leaking through the bolt holes of the clutch cover.

2. If there is oil residue in the bolt hole, continue with this TSB repair. If there is no oil residue in the bolt hole, create an Audi Technical Assistance Center contact with pictures of the leak and a diagnosis log attached. Then contact Audi Technical Assistance Center for diagnosis assistance.
