Service Action Code: 97FY

Subject	Volkswagen ID.4 Update Package															
Release Date	December 09, 2022															
Revision Summary	The owner's manual ordering information for the Technical Literature Ordering Center has been updated															
Affected Vehicles	<p>Vehicles included in this service action are being released in preselected phases.</p> <ul style="list-style-type: none"> The first group will be released and visible in ELSA in December 2022. Customer notification for the first group will take place in December 2022 as well. Dealers will receive updates when future groups/waves are released and customer notifications are scheduled. As always, dealers should ensure the service action shows OPEN in ELSA on the day of repair before performing any work under this service action.

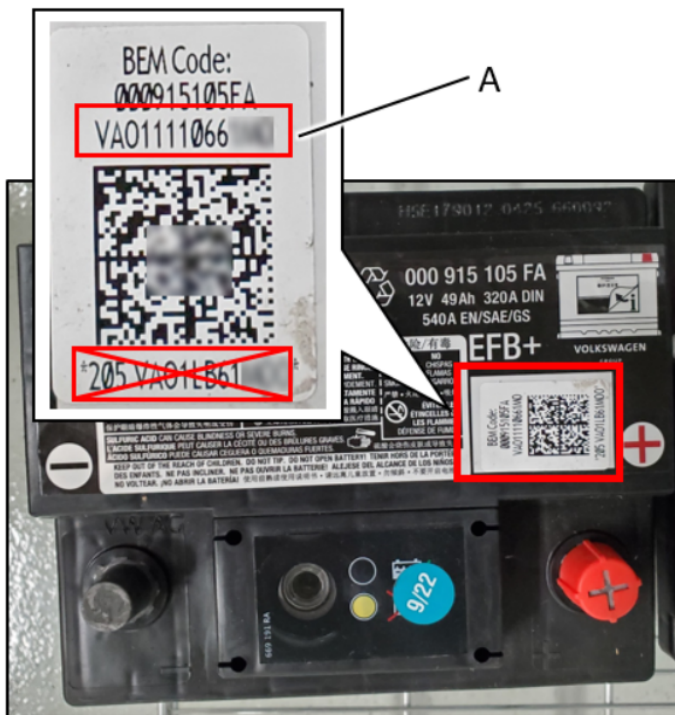
- Unfortunately, in individual cases there is the possibility that in preparation for this service campaign there may have been an above average storage of the 12V battery and, as a result, a sufficient charge level can no longer be ensured.
- Therefore, with sufficient time before starting an update, check the charge level of the battery to be fitted using no-load voltage measurement.
- If the voltage is greater than or equal to 12.5V, then the charge of the battery that took place during the update is sufficient.
- If the voltage is between 12.3V and 12.5V then the battery must be charged for at least 6 hours in advance. If the voltage is less than 12.3V, check the battery with the battery tester VAS 6161 and proceed according to the specification of the tester.

Part Number	Part Description
000-915-105-FA DSP	12 Volt Battery

- Before installing the 12V battery, record the following from both the NEW and the OLD 12V batteries:
 - Serial number <A>
 - Battery capacity
 - Battery manufacturer
- This will be required later when performing the 12V battery replacement test plan.

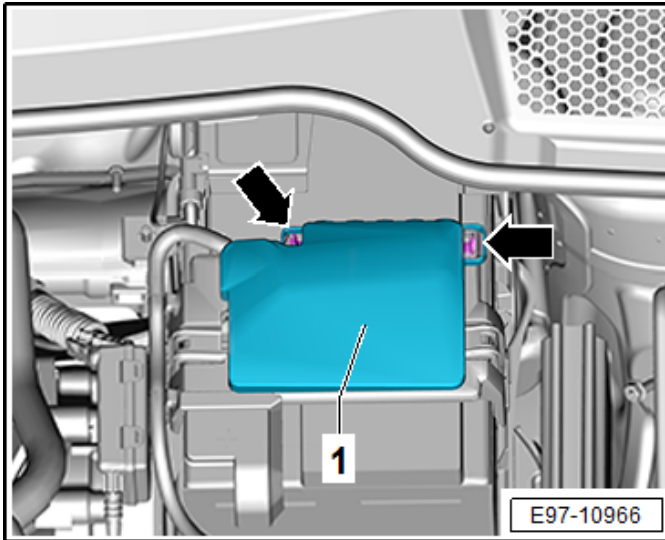
Risk of short circuit

The battery cable cover <1> must be installed before tightening the battery negative terminal clamp.
