Technical Service Bulletin

Rear parking aid sensor bracket separates from bumper

91 22 52 2068573/1 December 1, 2022.

Model(s)	Year	VIN Range	Vehicle-Specific Equipment
Q7, and SQ7	2020 – 2022	All	Not Applicable

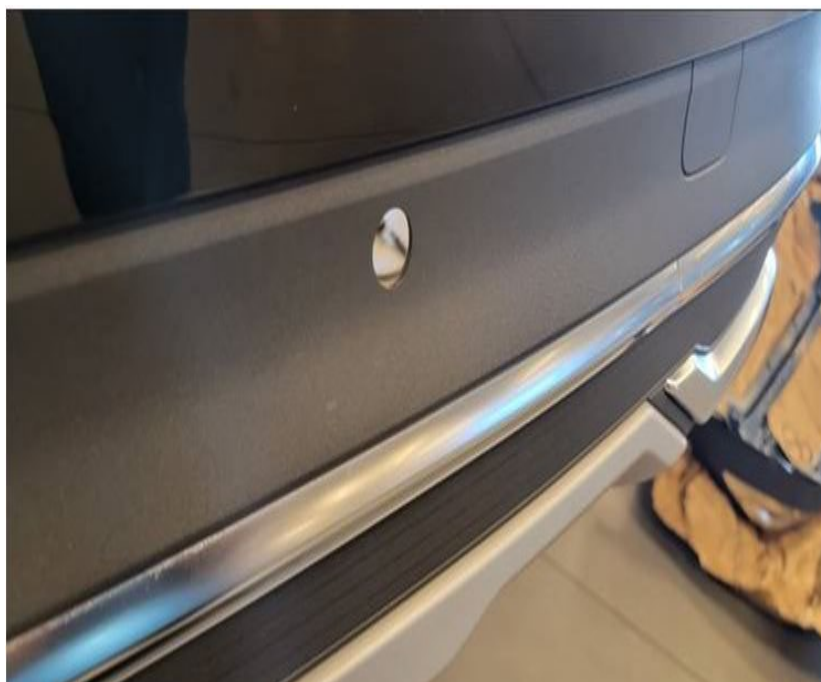
The adhesive strength of the parking aid bracket is not sufficient.

Over time, one or more of the sensor mounts may separate from the rear apron.

Figure 1: The parking aid mount has come loose.

If one or more of the sensor brackets has come loose from the rear bumper, use the steps below to re-attach the mounts.

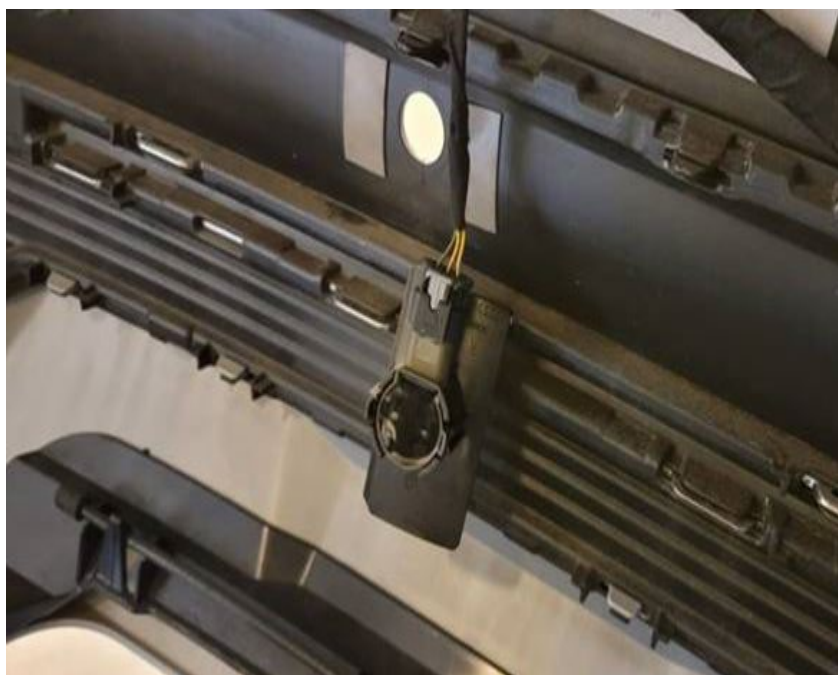
It is possible that the parking aid sensor(s) issue false warnings when the mounts start to separate.

Figure 2: The parking aid mount has come loose.

For a customer concern relating to false detection of obstacles it is important to check each of the sensors on the rear apron for correct installation.

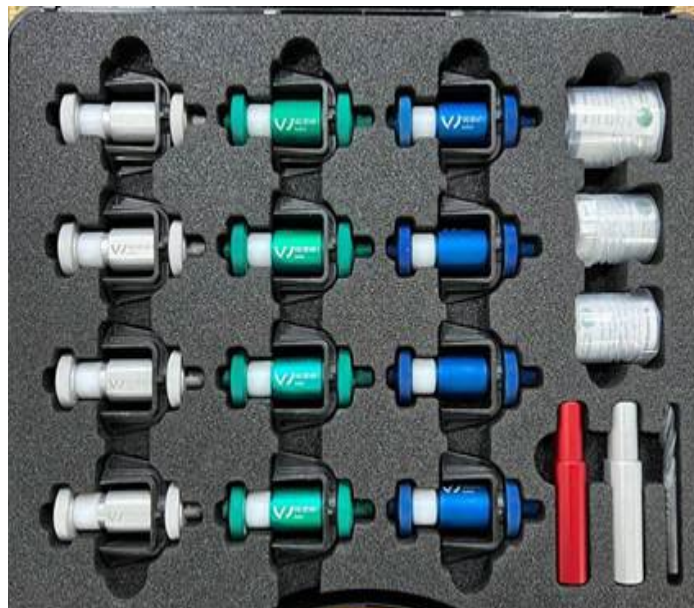
Figure 3: VAS 6614/C contents.

- Special tool **VAS 6614/C** will be used to complete this repair.
- Inside there are 3 sets of holders in various diameters to accommodate different size PDC sensors.
- Use the appropriately sized holder to center and clamp the mounts.

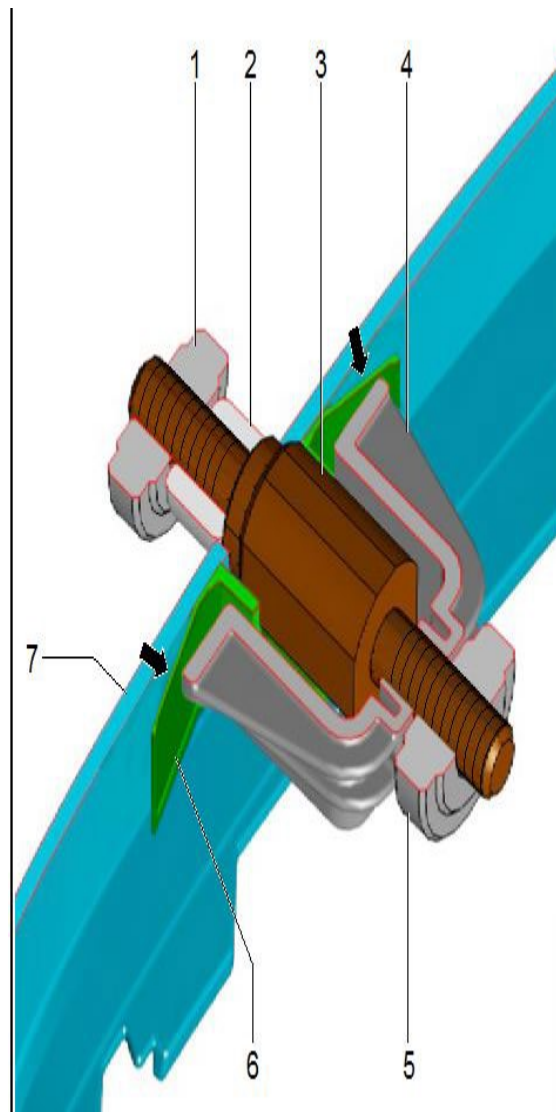
Figure 4: VAS 6614 assembled with PDC mount on rear apron.

- Slide parking aid bracket -6- onto centering pin -3- (VAS 6614) and push through rear apron -7- as seen in Figure 4.
- Slide on counter hold tool -2- from outside and tighten knurled nut slightly.
- Align bracket -6- in correct position and according to markings on rear apron.
- Slide on clamp -4- and screw in knurled nut -5- but do not tighten yet.

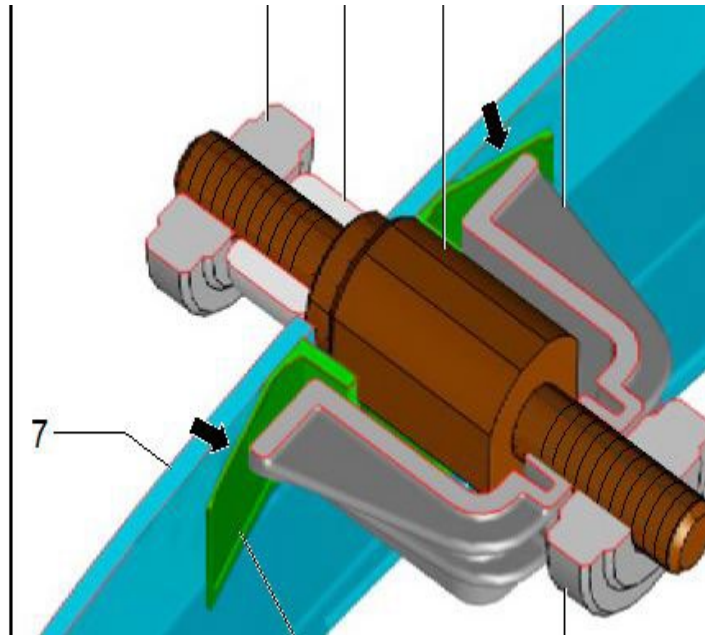
Figure 5: Arrows mark location for adhesive.

Apply plastic adhesive **D 180 KU2 A1** to areas marked by arrows between the parking aid bracket and rear apron (Figure 5).

- The first 3-5 cm of adhesive from the mixing nozzle may not be properly mixed and must therefore be discarded.

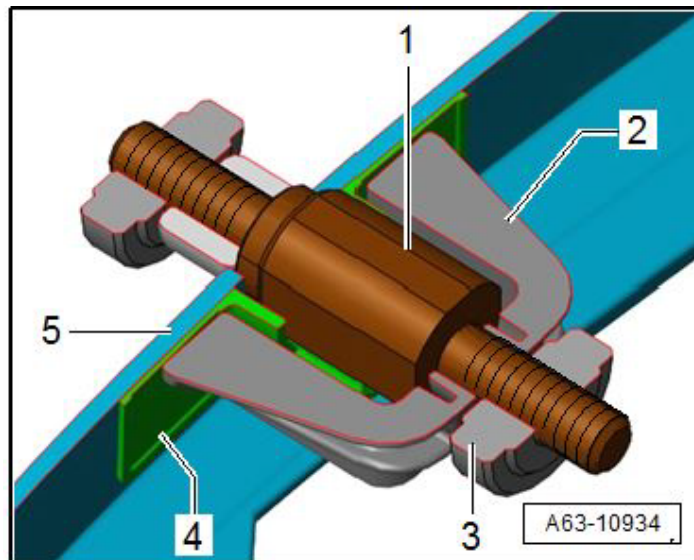
Figure 6: Mounts compressed to spoiler.

- Tighten knurled nut -3-.
- This results in clamp -2- pushing tabs of bracket -4- flat onto rear apron/spoiler -5-.
- Perform this step for all affected brackets.
