GROUP	MODEL
ELE	2022MY EV6 (CV)
NUMBER	DATE
276 (Rev 1, 12/09/2022)	December 2022

TECHNICAL SERVICE BULLETIN

SERVICE ACTION: EXTERNAL AMP REPLACEMENT FOR NOISE/NO SOUND ISSUES (SA520)

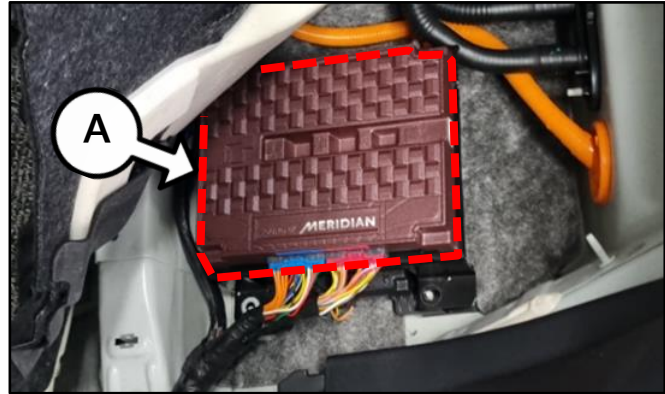
This bulletin provides the procedure to replace the external amplifier on some 2022MY EV6 (CV) vehicles produced from November 17, 2021 through January 7, 2022, that may exhibit symptoms of "noise", "no sound", "intermittent noise", and/or "intermittent no sound". Follow the procedure outlined in this publication to replace the external amplifier. Before conducting the procedure, verify that the vehicle is included in the list of affected VINs.

1. Replace the External AMP (A) by referring to “Body Electrical System → Audio/AVNT System → External AMP → Removal and Installation” in the applicable Shop Manual on KGIS.
