**Campaign 551**

# Service Campaign 551: Levante Check water infiltration in the windshield area

DATE: NOVEMBER 17, 2022

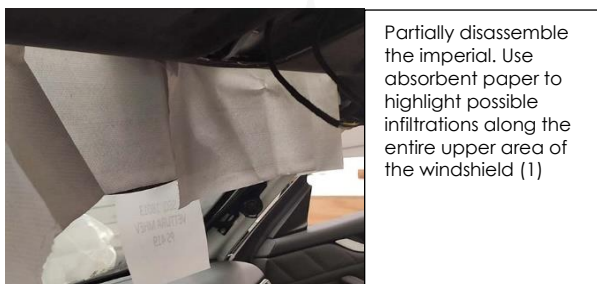
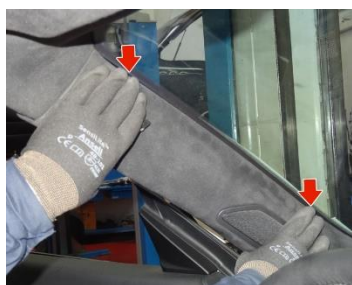
Remove the inner covers of the A-pillar to inspect any infiltration along the edges of the windscreen (2).

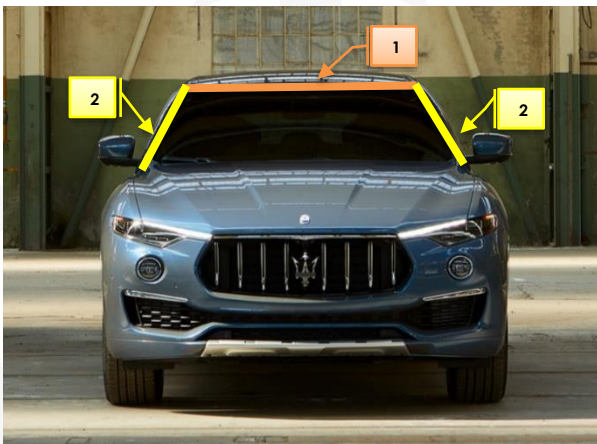
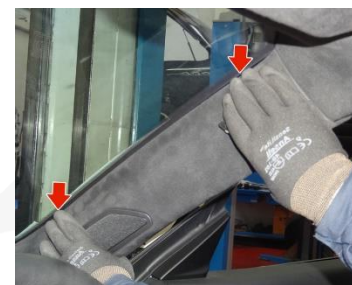
Remove the inner covers of the A-pillar to inspect any infiltration along the edges of the windscreen (2).

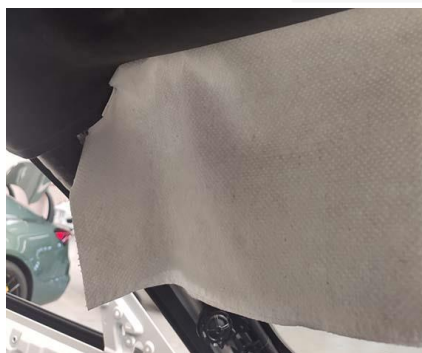
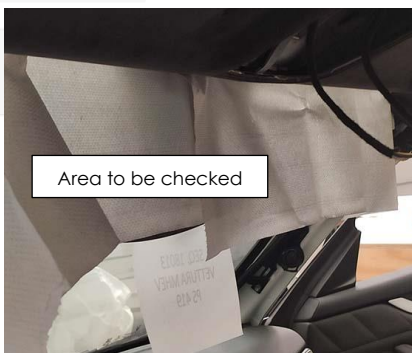
4. Follow the procedure for dismantling the side pillars according to the instructions in the workshop manual:
  - **09.44.001 00** **RH WINDSCREEN PILLAR COVERING**
  - **09.44.002 00** **LH WINDSCREEN PILLAR COVERING.**
5. Proceed subsequently with the removal of the central ceiling light according to the instructions in the workshop manual:
  - **08.10.001 00** **FRONT DOME LIGHT**
6. Continue by disassembling the sun visors and their fixings, always following the procedure in the workshop manual:
  - **09.45.003 00** **DRIVER-SIDE SUN VISOR**
  - **09.45.002 00** **PASSENGER'S SIDE SUN VISOR**
  - **09.45.010 00** **PASS. SIDE SUNSCREEN FIN SUPPORT**
  - **09.45.011 00** **PILOT SIDE SUNSCREEN FIN SUPPORT**
7. Take the utmost care, lower the inner canopy, and place sheets of absorbent paper (paper towel) as shown in the following images:

8. Use a water hose to carry out and simulate heavy rainfall towards the windscreen for a cycle of 10 minutes. **NOTE:** Do not use high pressure water jets.
9. Evaluate the outcome of the "water test", inspecting the area of the A-pillar and assessing the presence of water on the absorbent paper used.
  - If the test does not show any kind of water infiltration, then the vehicle passed the water test. Proceed to **Step 10**.
  - If, on the other hand, there are signs of infiltration, it will be necessary to replace the windshield. Open BOL for "SUPPORT REQUEST" attach pictures and await further instructions.
10. Reassemble all removed parts by following the removal procedure in reverse order.
11. Once finished, the procedure is complete.
