**Unintentional VIDA Wi-Fi Connection Leading to 12V Battery Drain**

<b>REF NO:</b> TJ 36426.1.1	<b>ISSUING DEPARTMENT:</b> Technical Service	<b>CAR MARKET:</b> United States and Canada	
<b>PARTNER:</b> 3 US 7510 Volvo Car USA		<b>ISSUE DATE:</b> 2022-11-14	<b>STATUS DATE:</b> 2022-11-21
<b>FUNC GROUP:</b> 3111	<b>FUNC DESC:</b> Battery, complete	<b>Page 1 of 53</b>

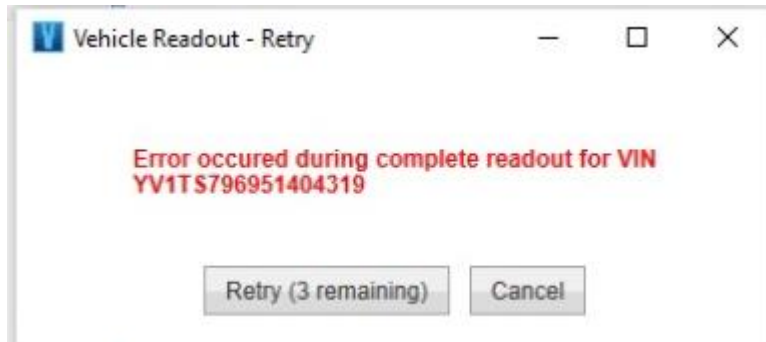
Below error message is shown in VIDA instead of a successful readout of the vehicle.

#### 12.1.1 Perform a battery reset of the vehicle.

If above error message is shown, then start with performing a battery reset of the vehicle.

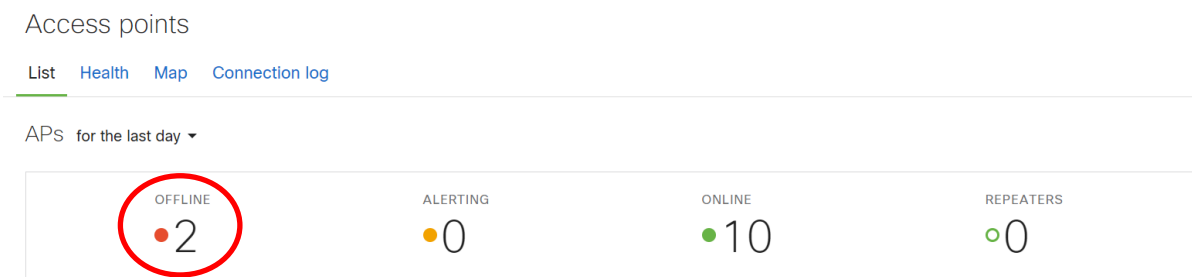
AP possibly connected to wrong network:

Navigate to **Wireless -> Access Points** and verify that all access points are **ONLINE**. The Access Points table should show all access points with a valid local IP address (depends on the network setup). Here are some examples of workshops with issues:

#	Status	Name	MAC address	Model	Connectivity	Usage	Clients with Usage	Current clients	Local IP	
1	●	BR-QMI-6BR7960-AP01	e0:cb:bc:bf:e4:7b	MR33	●	None	0	0	192.168.0.216	
2	●	BR-QMI-6BR7960-AP02	e0:cb:bc:bf:e3:01	MR33	●	None	0	0	192.168.0.208	
3	●	BR-QMI-6BR7960-AP03	34:56:fe:c8:21:fb	MR74	●	None	0	0	10.0.0.100

**Recommendation to workshop:** Make sure all access points are installed in the right position and location. They should also be connected to the right local network and always have internet connection.

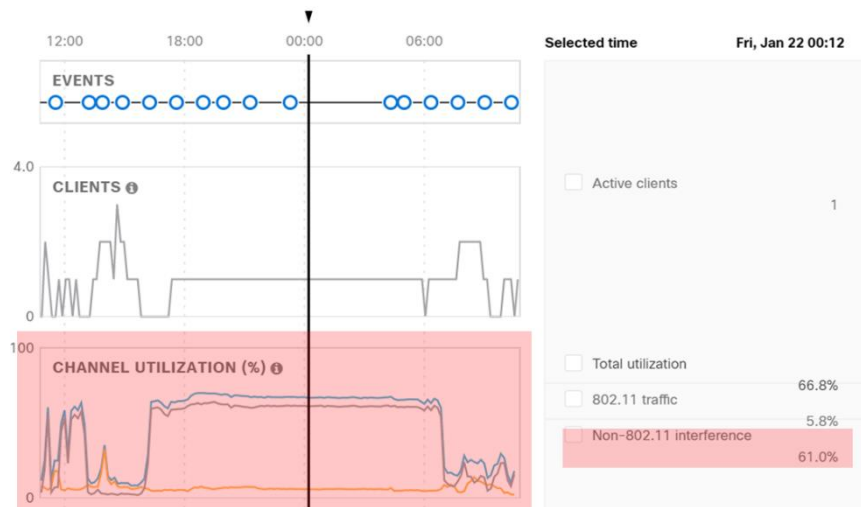
Wireless troubleshooting for the 2.4 GHz radio for the last day

To discover non Wi-Fi interference issues in Meraki, navigate to **Wireless -> Access points** and click on an access point. In the access point view click on the **RF** tab at the top of the window. Select **“for 2.4 GHZ radio”** and **“for the last week”**. Check the channel utilization graph and see if there is high **Non-802.11 interference**. Analyze to see if there’s any time pattern in the channel utilization graph.

**Recommendation to workshop:** The following devices can also cause RF interference degrading the performance of the wireless network. These devices should be kept as far as possible from the workshop area:

- Microwave ovens
- Cordless phones
- Bluetooth devices
- Wireless video cameras
- Wireless peripherals
- Zigbee devices
- Fluorescent lights

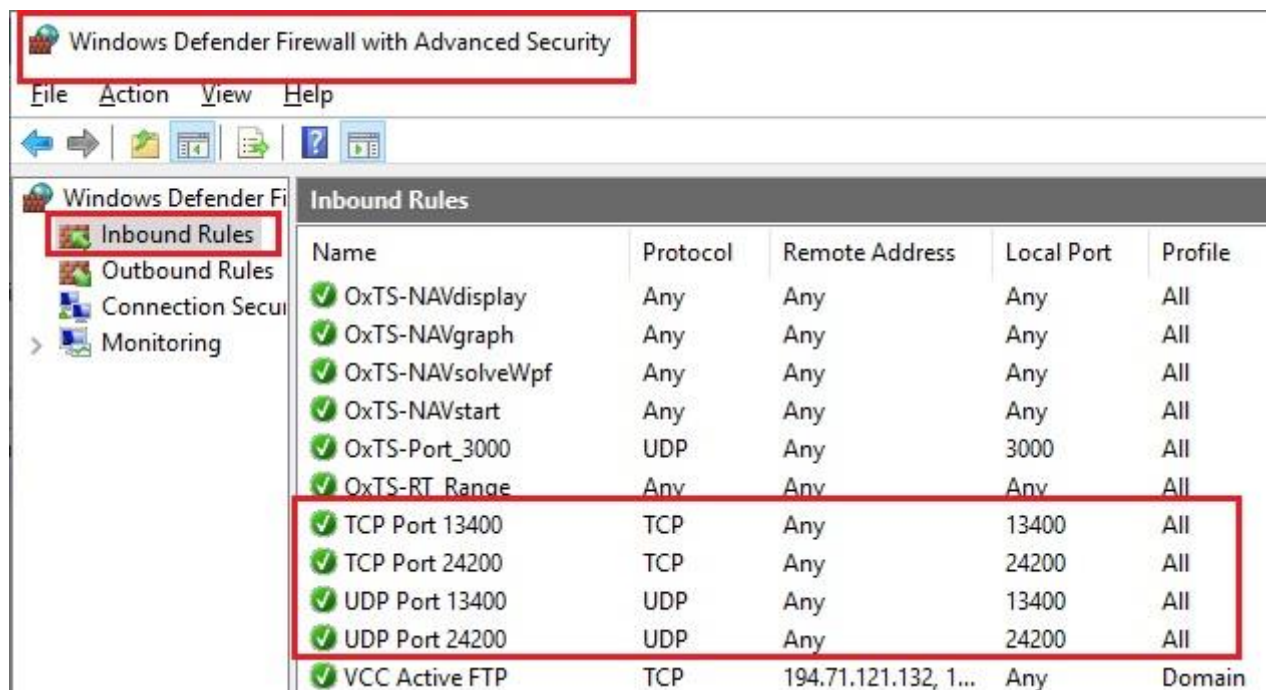
Communication (TCP and UDP port 24200 and 13400) blocked on computer. This affects only Windows 10 due to a difference in how Windows 7 and 10 Windows handles the configuration of Ports in the local firewall. The issue will also cause the same issue when trying to connect to the vehicle using P2P

Below firewall rules are missing

#### How to resolve the issue:

Order VIDA through Service-Now even if VIDA is already installed and even if VIDA has been ordered through Service-Now in the past.
