Odor Remediation After Water Intrusion

Service Category Vehicle Interior

Section Interior Panels/Trim

Market USA

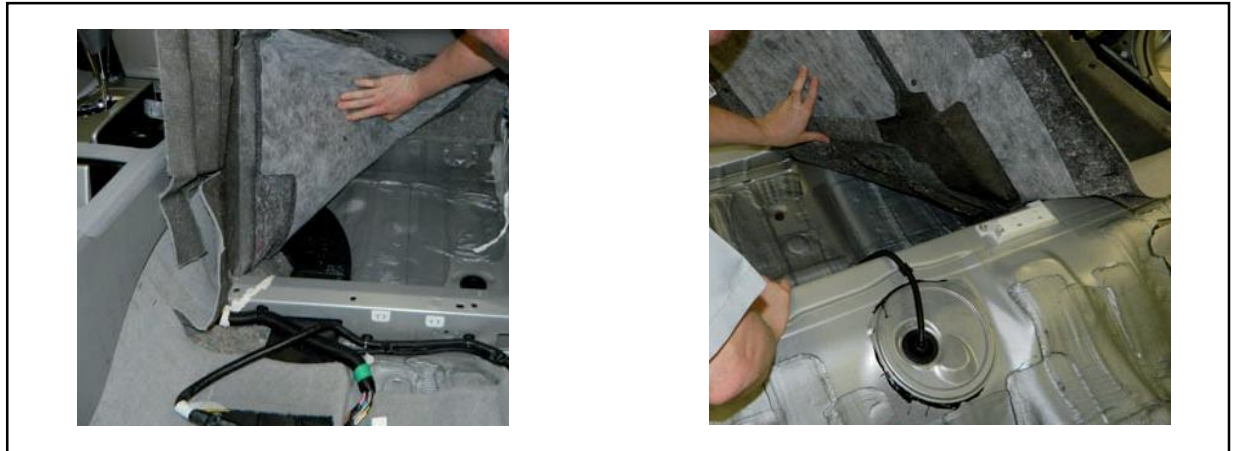
- Complete a thorough inspection of the entire interior floorboard areas to ensure ALL affected areas are identified.

Figure 2. Floorboard Inspection

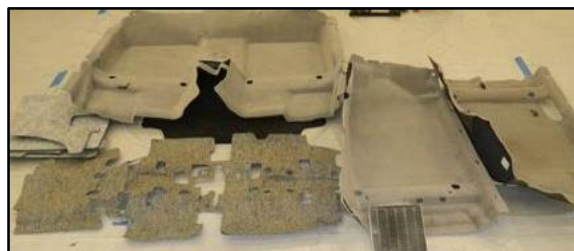
- Soft parts include items that DO HAVE an absorbent quality that will require them to be removed and replaced with NEW parts if they have come into contact with moisture.
- Keep ALL soft parts that will be replaced away from the parts that will be reused.
Soft parts include:
 - Floor mats.
 - Carpet/Carpet padding/Jute padding.
 - Insulated pads/Styrofoam pads.
 - Dash panel insulator assembly (located behind instrument panel/dash pad).
- These parts should NOT be reused and require replacement with NEW parts once the remediation has been completed.

Figure 3. Example of Soft Parts

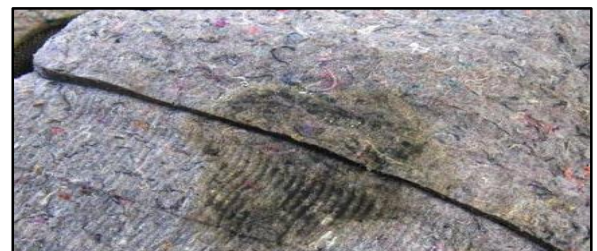
- Inspect ALL soft parts for organic matter growth and/or staining that would indicate water contact.

Figure 4. Example of Staining/Organic Matter

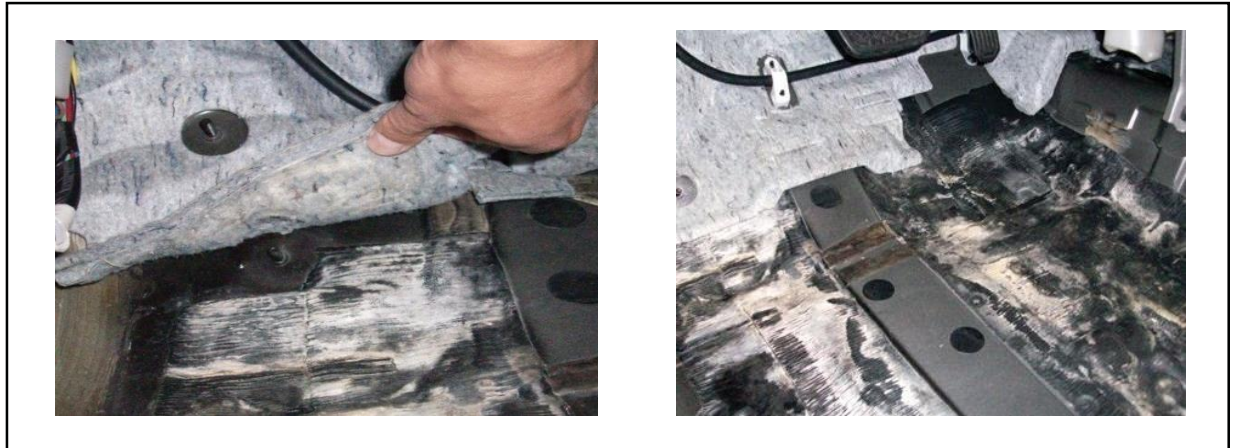
Figure 5. Examples of Organic Matter Growth Due to Water Intrusion Found During Vehicle Inspection

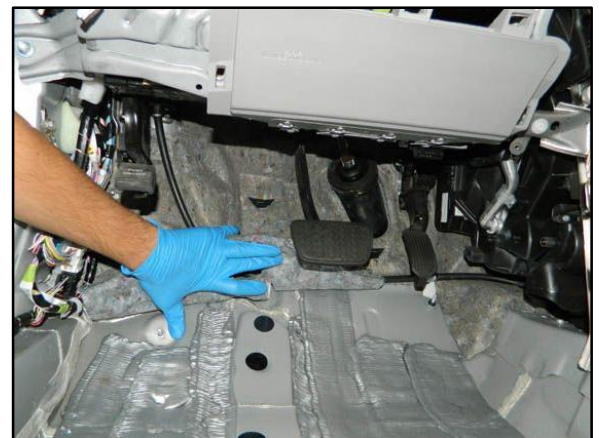
6. Inspect the dash panel insulator assembly along the base of the instrument panel and floorboard area for ANY signs of water or organic matter growth. Perform this inspection on BOTH the driver AND passenger sides of the vehicle. If ANY sign of organic matter growth and/or staining that would indicate water contact has occurred is found, the dash panel insulator assembly will need to be replaced.

Figure 6. Driver Side Dash Panel Insulator Assembly Inspection

3. If the dash panel insulator assembly was found to be affected by water contact during the initial inspection, remove and replace the dash panel insulator assembly. Refer to TIS, applicable model and model year Repair Manual for instructions.

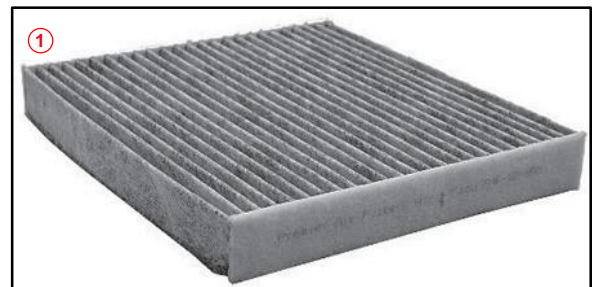
Figure 7. Cabin Air Filter

The Cabin Air Filter Should Not Be Installed in the HVAC During the Remediation Process

1. If equipped, remove the cabin air filter and discard.

- There should **NOT** be a cabin air filter installed in the HVAC during the remediation process.
- A **NEW** high-performance charcoal filter should be installed **AFTER** the entire remediation process has been completed.
