Driveline Vibration Under Deceleration Between 30 - 10 mph

Category Drivetrain

YEAR(S)	MODEL(S)	ADDITIONAL INFORMATION
2016 - 2023	Tacoma	VDS(s): AZ5CN, CZ5AN, EZ5CN, GZ5AN, RZ5CN, SZ5AN Drive Type(s): 2WD, 4WD Transmission(s): 6AT

T-SB-0124-20

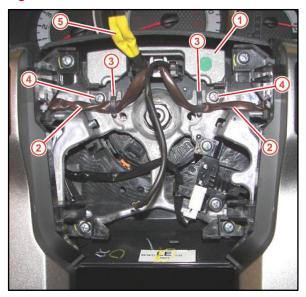
Figure 2.

1	Damper
2	Steering Wheel Switch Wire Harness
3	Damper Bracket Wire Retainer Hook
4	Screw
5	Driver Side Airbag Wire Harness

4. Install the steering wheel damper using two NEW screws in the locations shown.

Secure the steering wheel switch wires to the steering wheel damper bracket hooks as shown.
