# Coolant Leak From Rear of Engine - Water Outlet Pipe Joint Misalignment

YEAR(S)	MODEL(S)	ADDITIONAL INFORMATION
2022	Tacoma

## Coolant Leak From Rear of Engine - Water Outlet Pipe Joint Misalignment

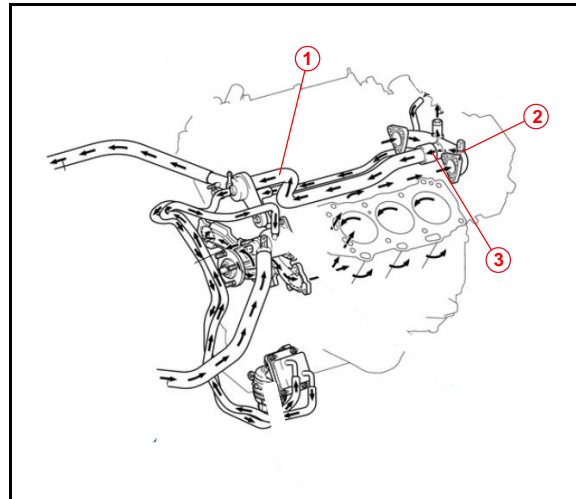
**Figure 1.**

Some 2022 model year Tacoma vehicles may exhibit a coolant leak, coolant dripping onto the ground, or high engine coolant temperature. The coolant leak may occur from the rear of the engine and drip down the transmission bell housing. Upon further inspection, coolant may be leaking from the union between the Rear Water By-Pass Joint and the No.1 Water Outlet Pipe (see Figure 1). Follow the Repair Procedure in this bulletin to address this condition.

<b>1</b>	<b>No. 1 Water Outlet Pipe</b>
<b>2</b>	<b>Rear Water By-pass</b>
<b>3</b>	<b>Leak Point</b>

Does the vehicle exhibit a coolant leak present between the Rear Water By-Pass Joint and the No.1 Water Outlet Pipe (see Figure 1)?

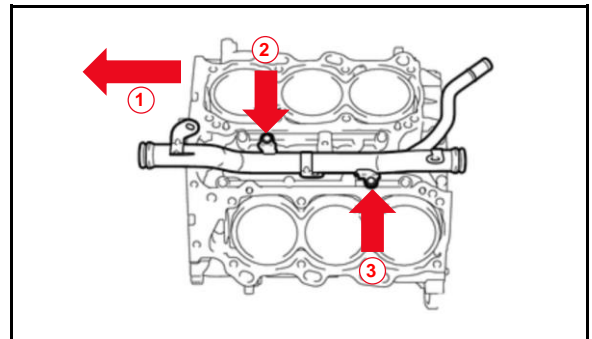
**Figure 3.**

<b>1</b>	<b>Front</b>
<b>2</b>	<b>No. 1 (Front) Bolt</b>
<b>3</b>	<b>No. 2 (Rear) Bolt</b>

4. Remove the two bolts that hold the water outlet tube assembly to the block.

**NOTE**  
A magnetic socket is useful when removing the bolts to prevent them from being dropped.

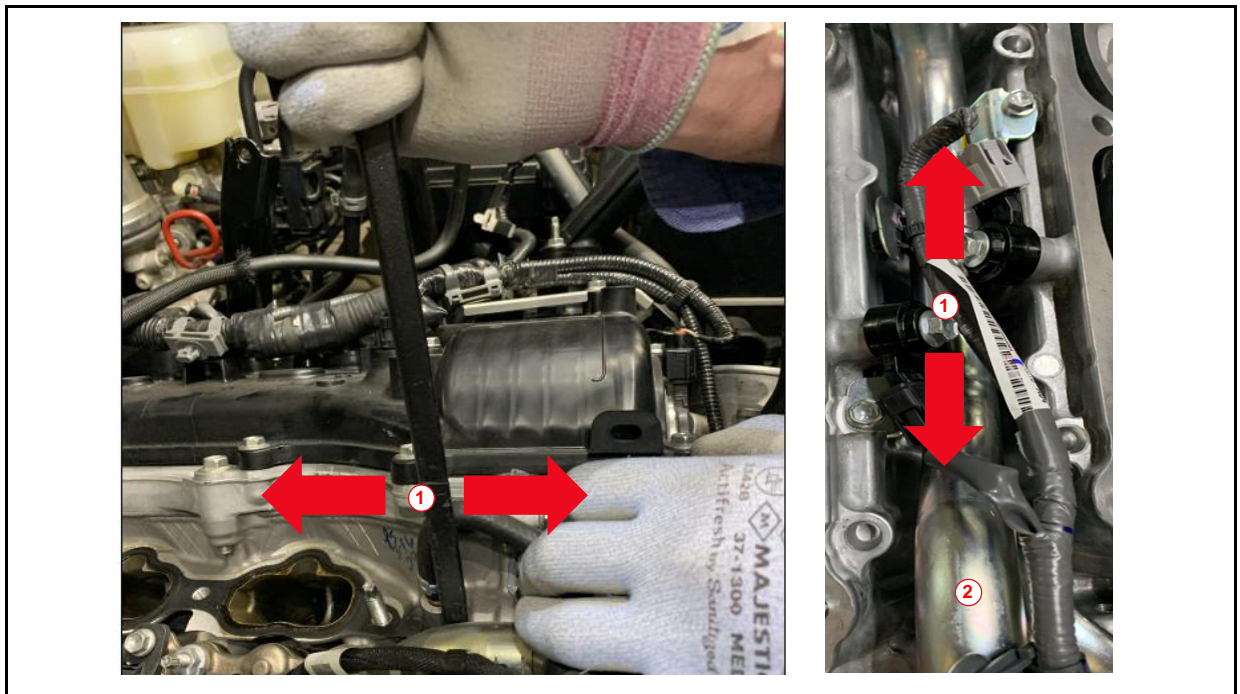
Figure 4.

- This back-and-forth motion effectively allows the heater pipe to find its natural alignment to the water joint openings and reseats the O-rings simultaneously.
- The O-ring is **NOT** able to be inspected using this method. O-ring damage is not likely to occur as a result of joint misalignment.

5. Reposition the water outlet pipe for proper alignment to the water joints:

Using a large screwdriver or by hand, move the water outlet pipe assembly back and forth (toward the bulkhead, then toward the front of the vehicle, and then again toward the bulkhead).

1	Move Heater Pipe in Front/Rear Direction 3 – 4 times and Retighten
2	Outlet Pipe

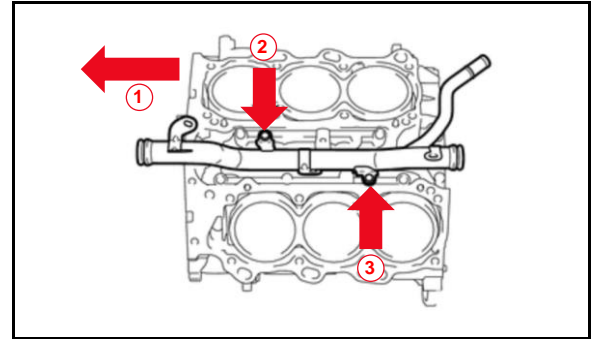
**Figure 5.**

<b>1</b>	Front
<b>2</b>	No. 1 (Front) Bolt
<b>3</b>	No. 2 (Rear) Bolt

- Install the two outlet pipe bolts and torque to specification (7 ft./lb.).

Start with the No. 1 (front) bolt, and then move to the No. 2 (rear) bolt.

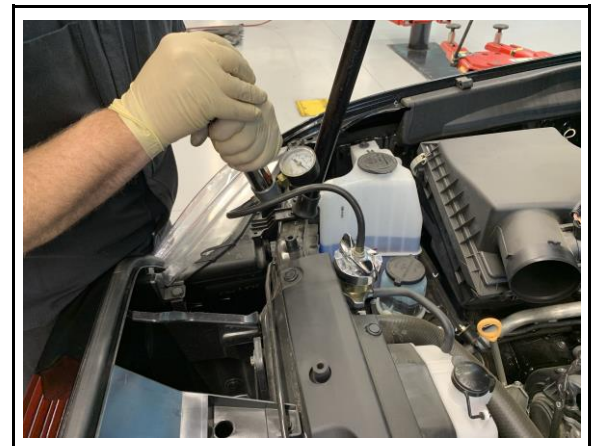
**Figure 6.**

- YES** — The leak may be due to an issue not related to outlet pipe misalignment. This bulletin does NOT apply. Continue diagnosis using the applicable Repair Manual.
- NO** — Continue to step 8.

- With the intake still removed, perform a cooling system pressure test, and confirm no leaks are present at the front or rear water joints.
