STAR ONLINE PUBLICATION

Case Number: S2223000030

Symptom/Vehicle Issue: Blind Spot Inoperative With Mirror Indicator On. C00C4-97 And Or C00C5-76 Wrong Mounting Position DTCs Set.

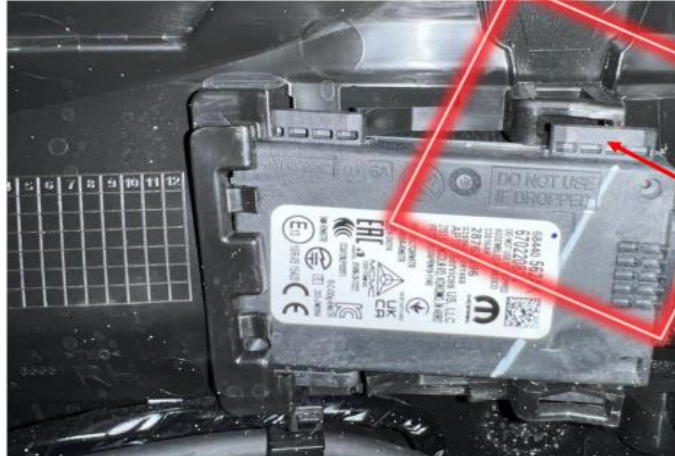
Discussion: Perform published diagnostics for any Rear Radar Module DTCs retrieved with wiTECH. In addition, also inspect the mounting of both MRRRL and MRRRR (Mid Range Radar Rear Left /Mid Range Radar Rear Right) modules. Modules not fully snapped into place may cause DTCs and the condition described in this document. See the figure below for an example of the condition.

Example of a Mid Range Rear Radar not fully snapped in
