STAR ONLINE PUBLICATION

Case Number: S2223000031

Symptom/Vehicle Issue: Front Fascia Gap At Headlamp And Or Clips Visible Under Headlamp

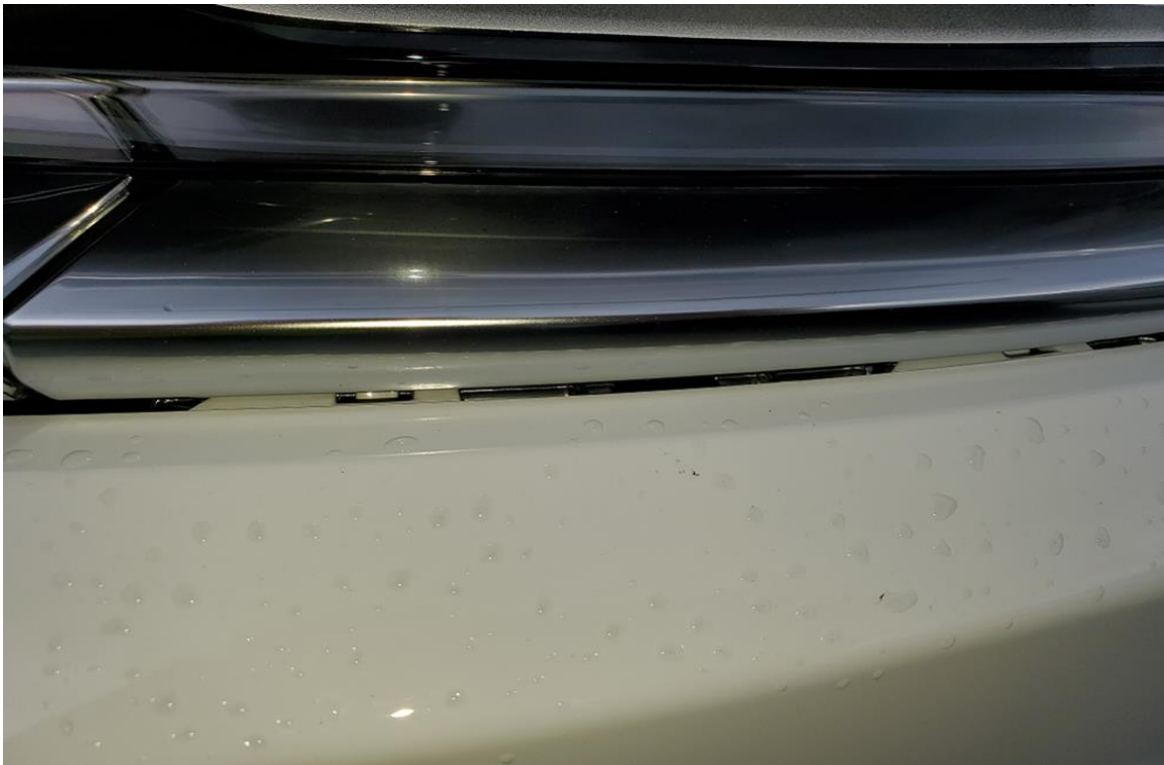
Example of front fascia not fully installed (clips exposed)

1. Not fully installed- Attempt to push fascia to fully seat (there should be a noticeable click to denote the fascia tabs are fully seated into the bracket). If fascia cannot be installed, inspect fascia tabs to determine whether they have been bent and have taken a permanent set. Fascia requires removal to inspect. Refer to Service Library 13 - Frame and Bumpers / Bumpers / FASCIA, Front / Removal and Installation. If the tabs on the fascia are damaged, fascia replacement is required.

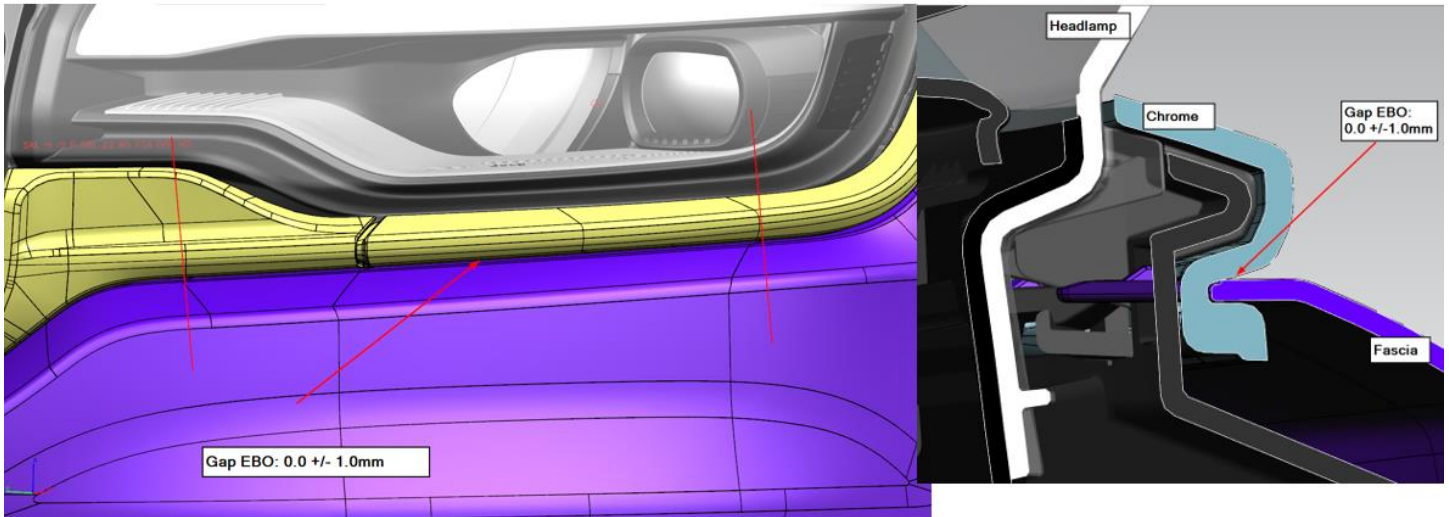
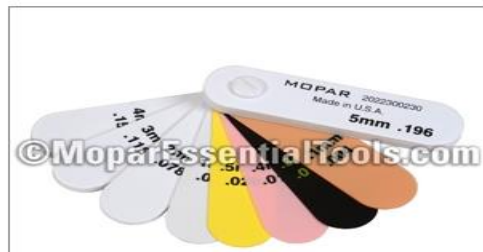
Discussion: Front fascia to headlamp gap specification is 0.0mm +/- 1.0mm. To measure the gap use MOPAR Essential Required Tool- Non marring feeler gauge set 2022300230

If the gap exceeds 1.0mm there are 2 possible root causes:

1. Fascia not fully installed
2. Fascia/fender bracket not properly installed (missing rivets) or damaged.

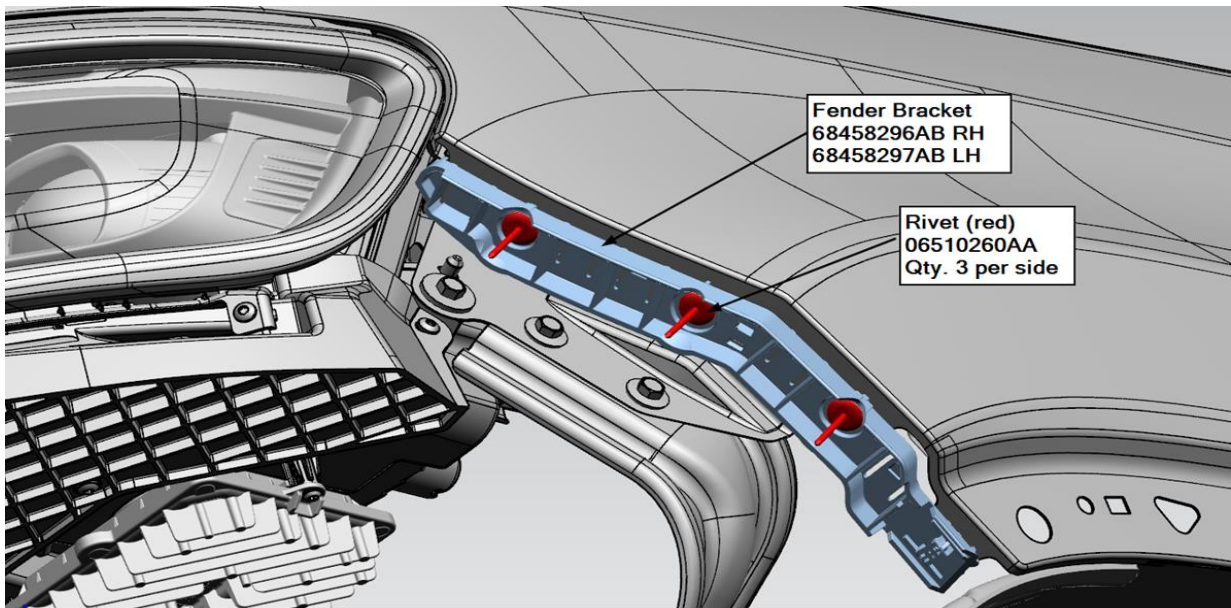
2. Fascia fender bracket not properly installed (missing rivets) or damaged- Remove the front fascia to inspect the bracket and mounting rivets. Refer to Service Library 13 - Frame and Bumpers / Bumpers / FASCIA, Front / Removal and Installation.

Install fascia and inspect fitment.
